SNC • LAVALIN

Northwich

Section 19 Flood Investigation - Interim Report

November 2020

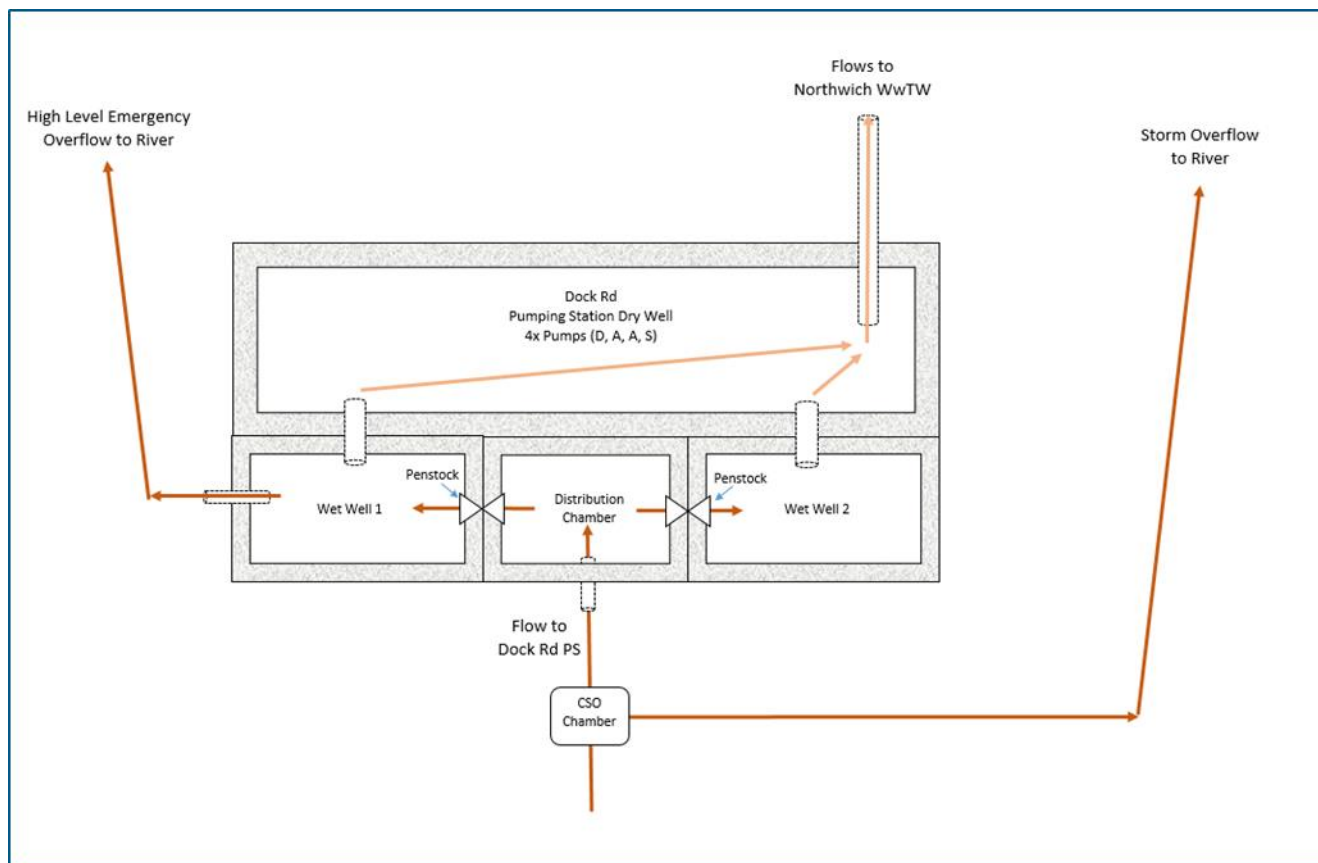
Figure 4-4 - Dock Road Pumping Station Arrangement

| | | | | | | Flood Warnings | |
|---|---|---|---|---|---|---|---|
| 27/10/2019 16:00 | Dock Road PS | Process standby called to Dock Road to assist network. 2 pumps were found to be operational. Found Pump 4 was not running on arrival. Pump restarted in manual whilst repairs were made to flooded ultrasonic level instrument. | | | | | |

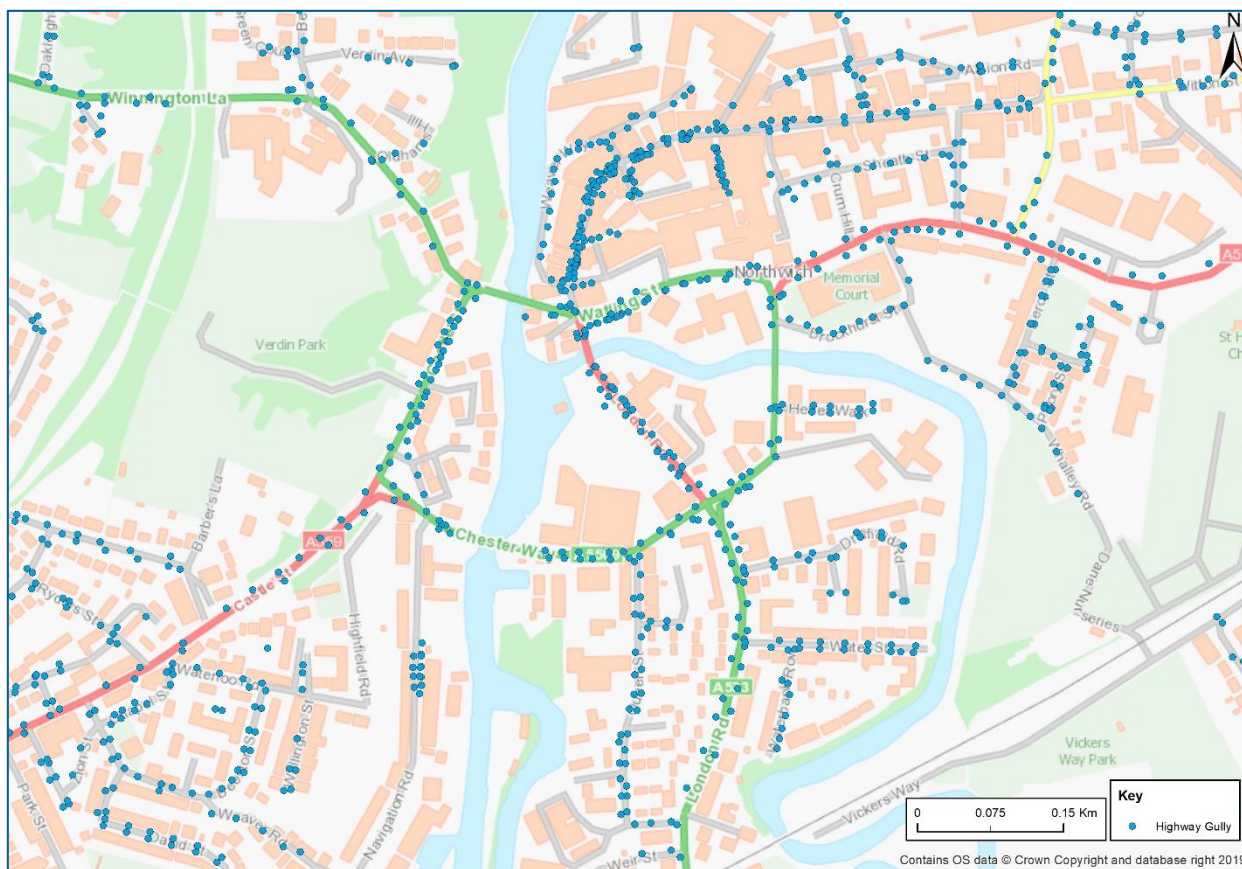
Figure 4-5 - CWaC Highway Gullies

There are a number of highways drainage gullies which provide drainage to the roads in Northwich Town Centre. These are maintained by the Highways Authority, CWaC. Records of the highway drainage network, between gully and discharge point is not available. It is assumed, through consultation with CWaC, that localised networks consisting of small diameter pipes provide conveyance to the River Weaver. The location of these gullies can also be seen in Figure 4-5 below. Please note Figure 4-5 represents gully locations only. A survey to confirm the drainage pathways to river outfall points, and the status of the outfall as to whether it has a working flap valve or not is recommended.

- CWaC Council to survey Northwich town centre highway gully drains in the affected areas to confirm discharge points, identify blockages and any sections in poor repair;

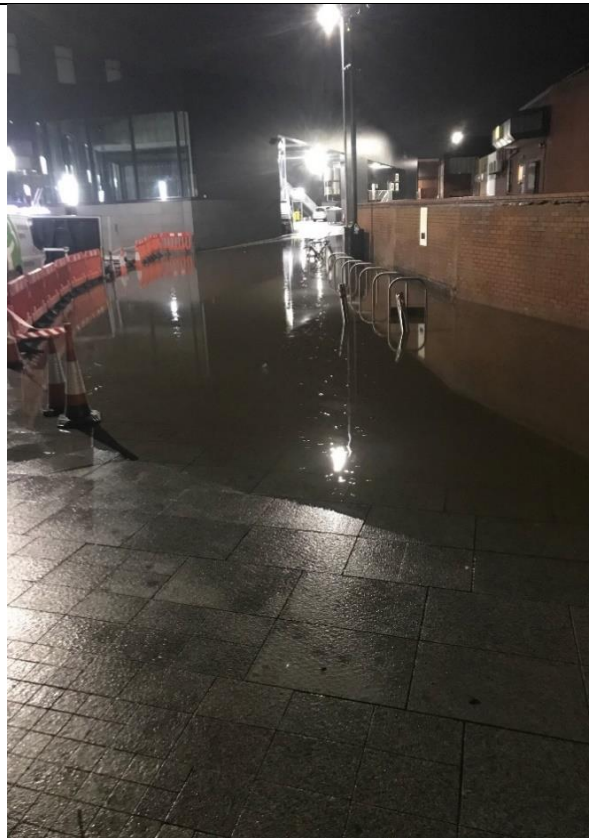
Figure 7-5 - Photograph evidence of flooding at Weaver Way/ High St

01:08 27/10/2019
Baron's Quay
Source: EA

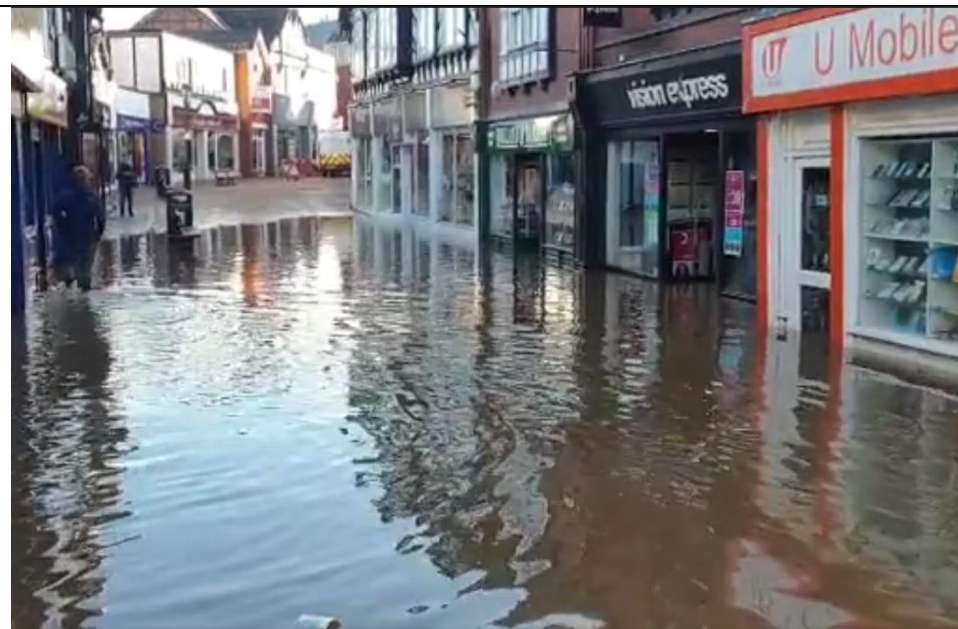
11.00 27/10/2019
High St
Source: EA

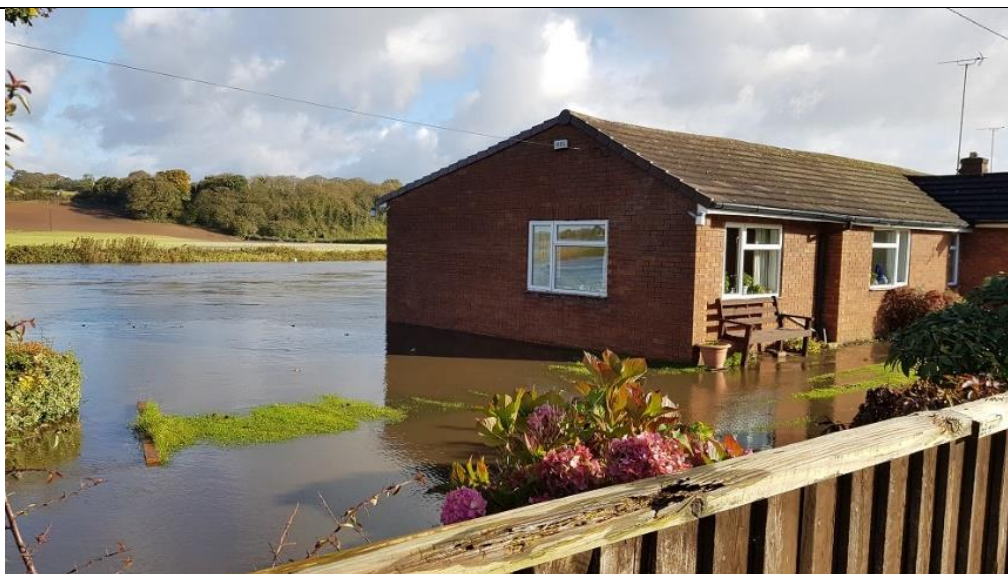
Figure 7-7 - Photograph evidence of flooding at Sandy Lane

27/10/2019

Sandy Lane property

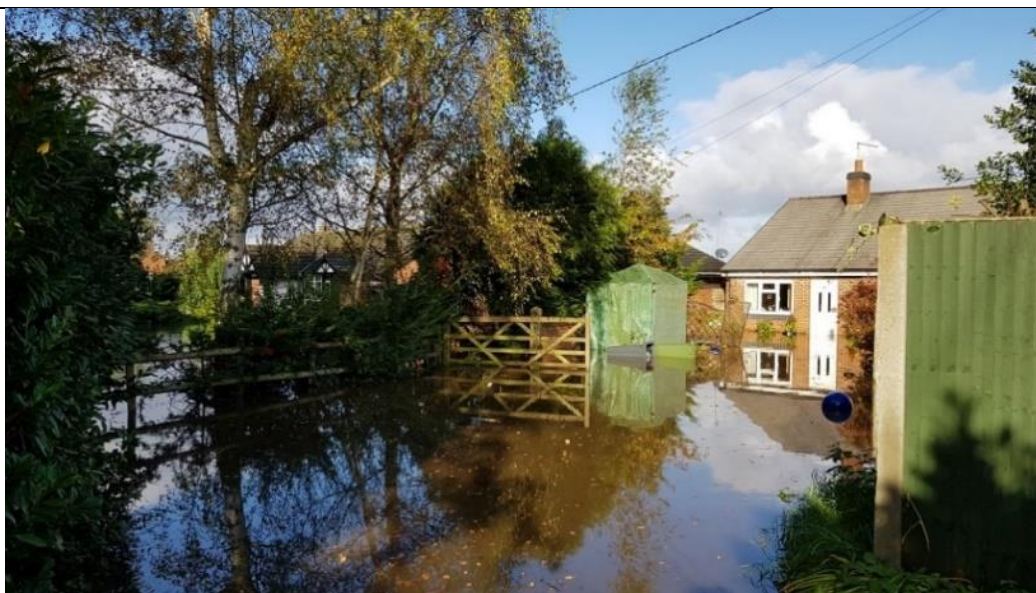
27/10/2019

Sandy Lane property

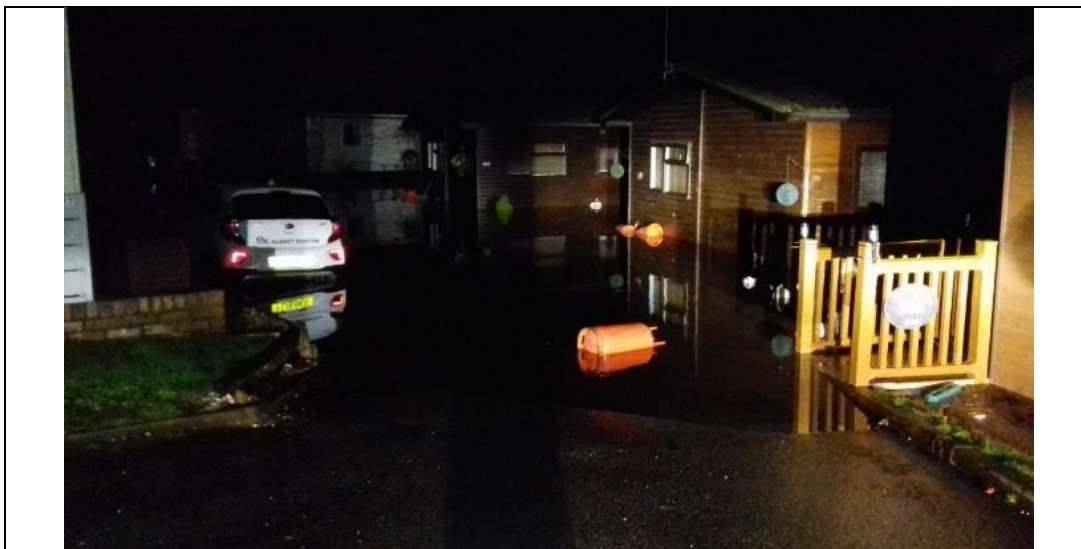
Figure 7-9 - Photograph evidence of flooding at Lakeside Caravan Park

26/10/2019

Lakeside Caravan Park

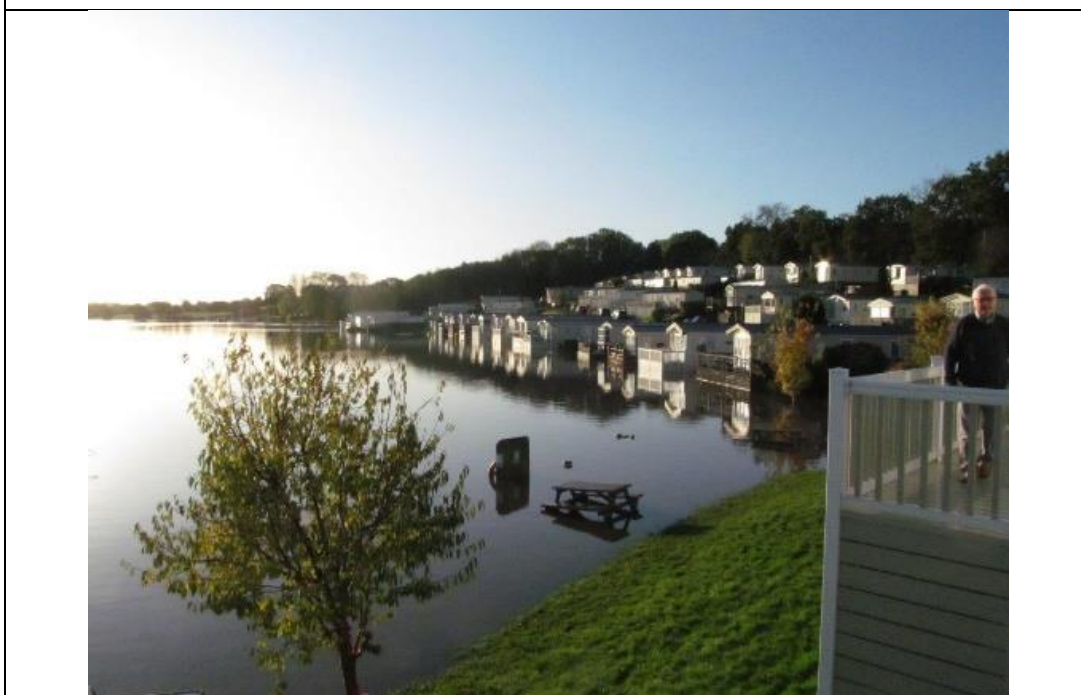
27/10/2019

Lakeside Caravan Park

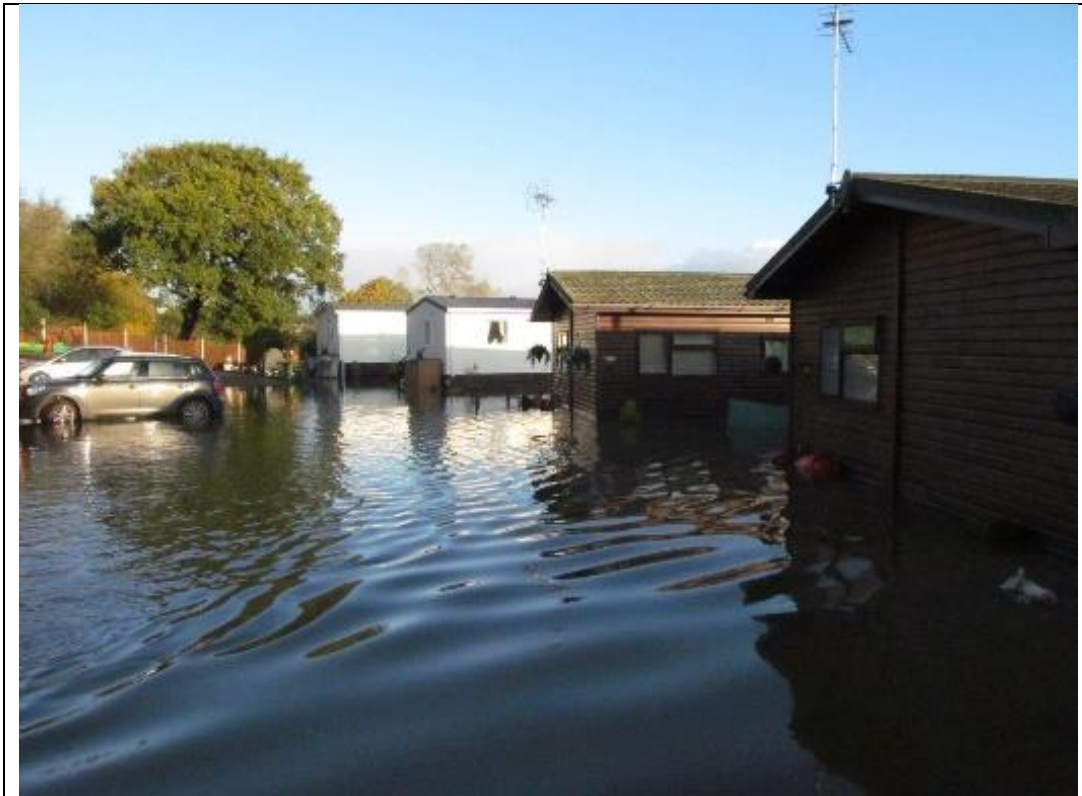
27/10/2019

Lakeside Caravan Park
