Acton Bridge and Weaverham Final Report Details

Project:	Storm Christoph Section 19 Final Report		
Area:	Acton Bridge and Weaverham		
Date:	31/08/22	Project No.:	5150735

Acton Bridge and Weaverham Main Report Details

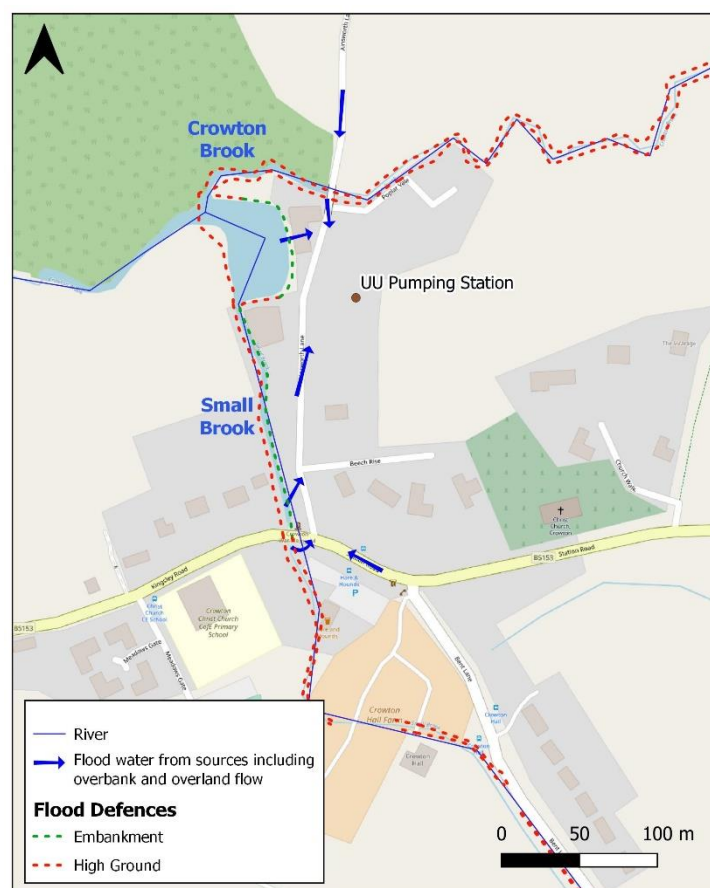
Figure 1 - Crowton flood overview

During the Storm Christoph event, it was observed that water levels in Small Brook and Crowton Brook were raised, water was turbulent and fast flowing. The retaining walls for small Brook at Pool Bank, just after the Kingsley Road culvert, collapsed and Ainsworth Lane flooded. Water backed up at the entrance to the culvert under Ainsworth Lane, the water level in Crowton Brook rose 1.2m. Ainsworth Lane is the low point within the village and was inundated with water from each direction.

- Small Brook, flowing past the Hare and Hounds Pub, came out of bank, flooding Station Road and the pub car park. Water appeared to be backing up from the point where the brook is culverted under Kingsley Road. The water level at this culvert is frequently up to the culvert soffit (weekly in winter).

- Water then flowed down Ainsworth Lane from the Station Road junction.
- Small Brook in Pool Bank, downstream of the Station Road / Kingsley Road Bridge, came out of bank (damaging the retaining wall within the property) and flowed through the garden onto Ainsworth Lane and down the hill to the Old Mill properties.

- The pond just before the weir at the confluence of Small Brook and Crowton Brook (within Pool Bank property) overflowed due to the high water levels and flowed east onto Ainsworth Lane.

- Water appeared to be backing up where Crowton Brook is culverted under the Ainsworth Lane bridge which subsequently overtopped the southern wall just upstream of the bridge.

- CWaC to increase its gully emptying frequency for the area covered by this Section 19 investigation in line with its risk-based approach to gully emptying.

- Individual property owners to investigate opportunities to install individual property level protection measures. CWaC, as LLFA, to provide support and guidance.

- CWaC, as LLFA, to investigate whether there are opportunities to provide upstream storage.
- Establish whether the UU pumping station is vulnerable to flooding and whether any action is required to ensure foul water is unable to escape.

- Establish ownership, and hence responsibility, of the culvert under Ainsworth Lane.
- Residents to be encouraged to sign up to the EA flood alert service for the River Weaver and LLFA and EA to consider the feasibility of implementing a flood warning service.

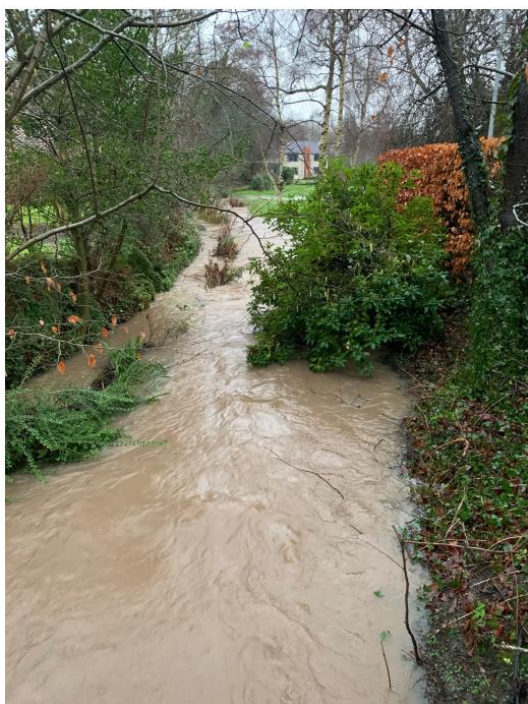
Figure 2 - Small Brook. 16:09 20/01/21

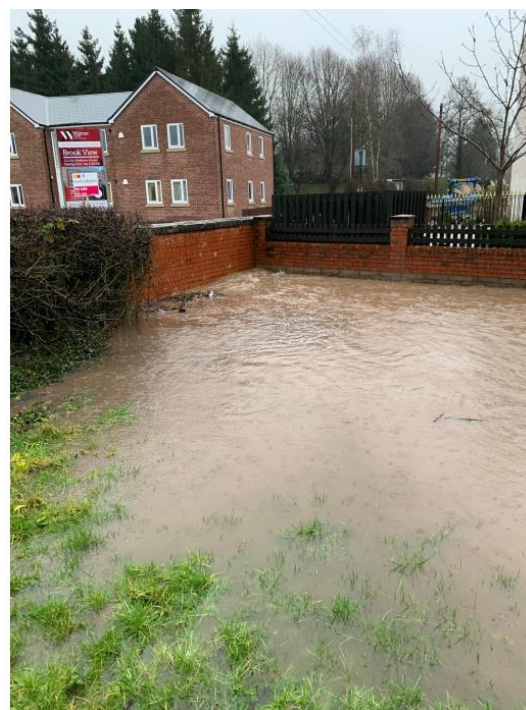
Figure 3 - Ainsworth Lane culvert inlet. 15:59 20/01/21

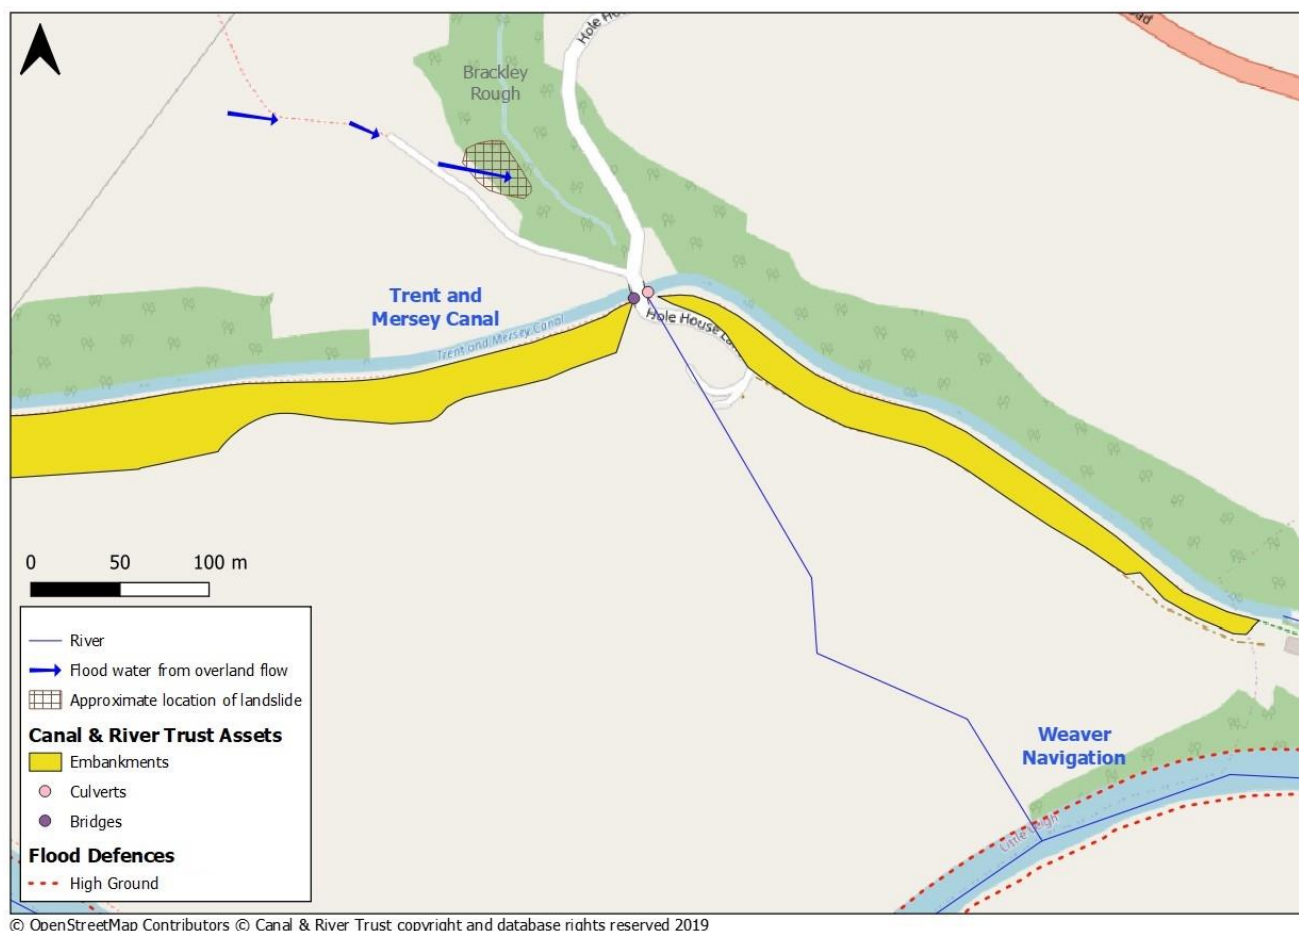
During the event, water ran off from the agricultural land and into a ditch on the north-western boundary of the property, adjacent to a public right of way. Normally, water drains into the ditch and is cleared via a series of underground 75mm pipes to discharge into Brakeley Rough. However, during the event, the drainage system in place was not able to effectively take the water away from the area and the ditch overtopped. Water flowed down the public right of way, before flowing across the affected property's front garden and driveway before flowing to Brakeley Rough.

Local residents believe that the culvert beneath the Trent and Mersey Canal is partially blocked by silt which caused water to back up, contributing to the landslide.

Figure 4 - Little Leigh flood overview shows the direction of overland flow towards the property affected and the area of land which collapsed into the Rough. This plan was developed in consultation with CWaC, as LLFA, and the affected property owner.

- Resident to install new drainage pathways for surface water down the property driveway to the south, to alleviate some of the flood water that flowed over the property driveway eastwards into Brakeley Rough.
- CWaC to engage with the Trust to investigate the condition of the culvert beneath the canal and, if applicable, undertake works to clear and repair.
- LLFA to investigate whether there are opportunities for attenuation to the east of Brakeley Rough.
- LLFA to promote the use of the FloodHub for information on flooding.

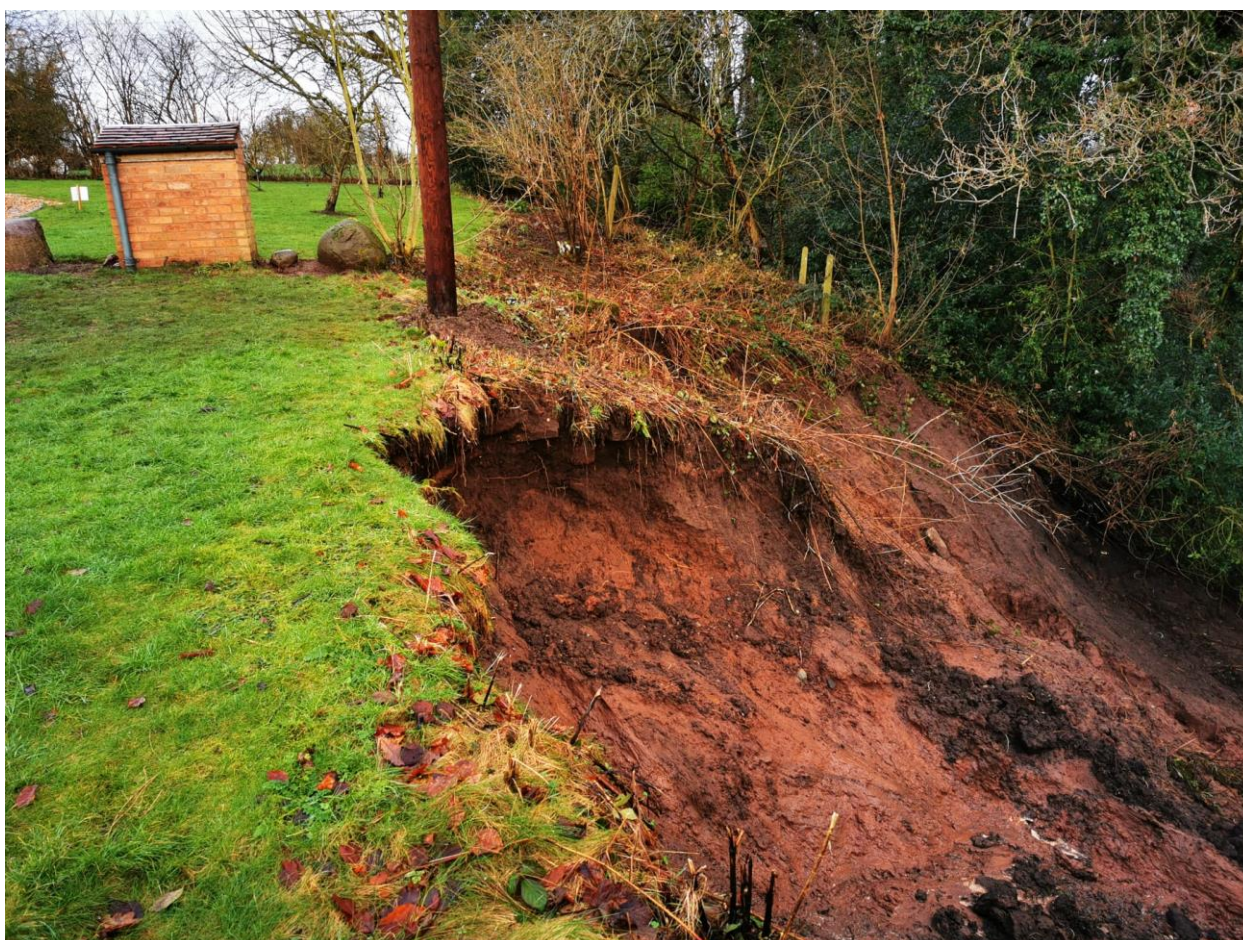
Owing to the amount of water, the ground became saturated and eventually gave way as a large landslide into Brakeley Rough. A considerable number of trees and shrubs were swept down into the gorge along with a significant volume of earth.

Figure 5 - Little Leigh landslide

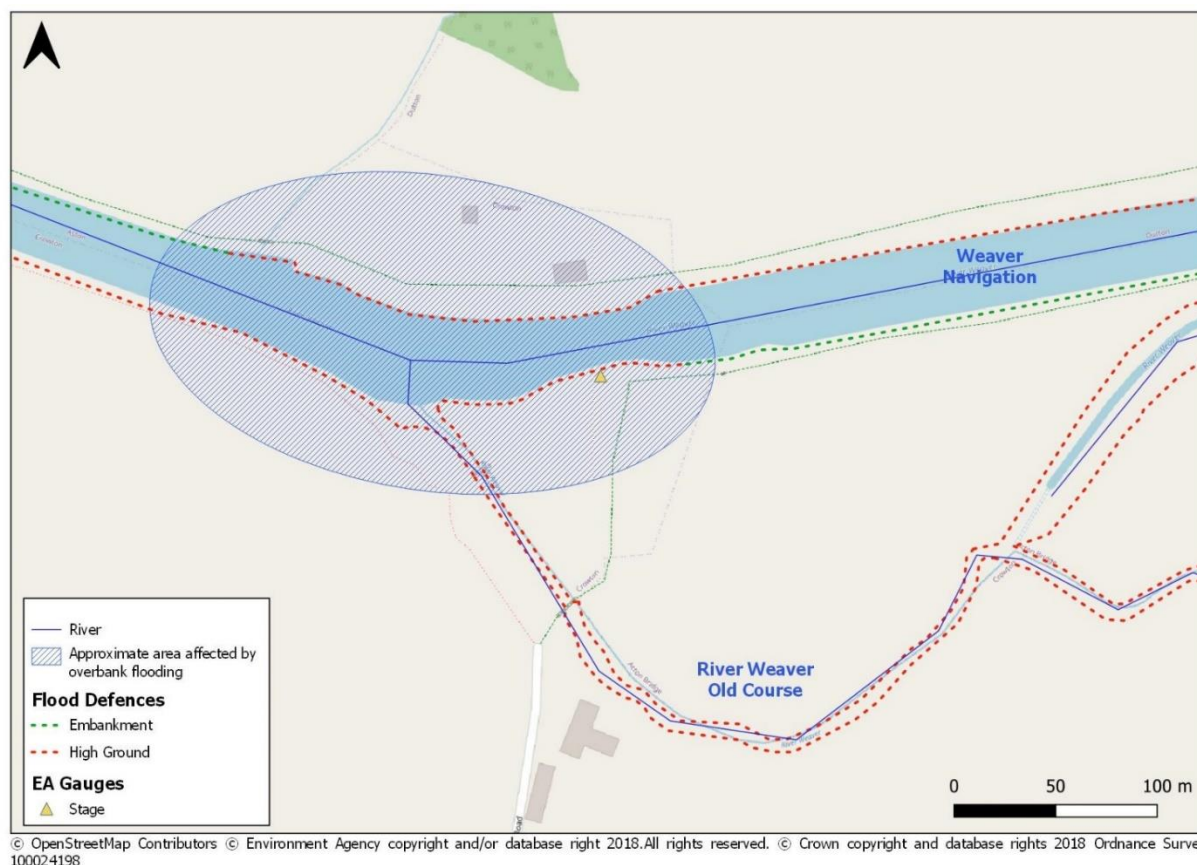
Figure 6 – Pickering's Lock Flood Overview

During the Storm Christoph event, the River Weaver overtopped the banks at Pickering's Lock. The period of high water associated with fluvial flow coincided with a high tide which caused the river levels to remain high for several hours after the initial peak.

Of the two properties located on the north bank, only one property was flooded internally. Water came onto the gardens directly from the Weaver to the south and, water flowed towards the houses from the west due to backing up in the watercourse that runs behind the properties.

On the south bank of the river several properties and a caravan park were flooded. One property located between the River Weaver and the old course of the River Weaver was internally flooded although it was unoccupied at the time. Residents report that the old course of the River Weaver is heavily silted and vegetated. Some residents in the caravan park have constructed structures over the old course that reduce its capacity.

It is evident that the overwhelming flooding at Pickering's Lock occurred as a direct result of high water levels on the River Weaver and subsequent out of bank flow. Despite the Pickering's Cut water level gauge being inundated to the point of being unable to confirm peak water level, water levels recorded at Pickering's Lock were the highest on record.

- CWaC, as LLFA, ensure that future modelling work should include the Pickering's Lock area.
- LLFA and the EA to review the existing maintenance regime of the old course of the River Weaver and determine whether any changes to this regime, or management thereof, could reduce flood risk.
- Residents, the EA and CWaC, as LLFA, to discuss and develop an emergency response plan that enables safe evacuation during flood events. The Woodland Trust should be consulted in the development of this plan to ensure access routes are available.

- Residents to consider implementation of Property Level Protection measures. The EA and CWaC, as LLFA, to provide guidance as appropriate.
- LLFA to promote the use of the FloodHub for information on flooding.
- Residents to be encouraged to sign up to the EA flood warning service.

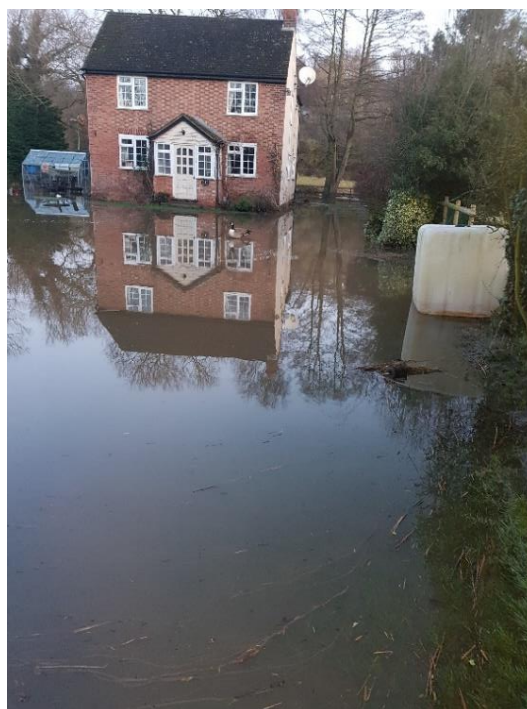
Figure 7 – Pickering's Lock, North Bank. 21/01/21

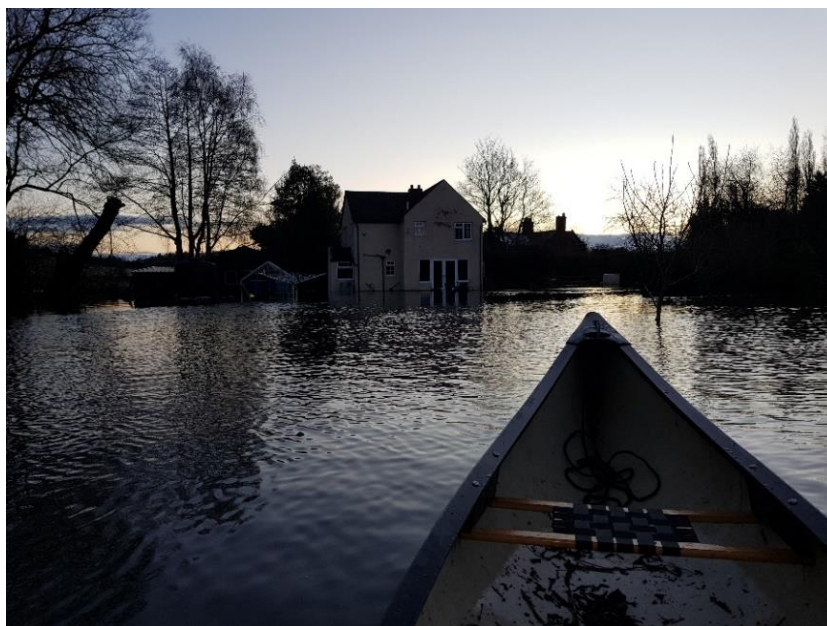
Figure 8 – Pickering's Lock, North Bank. 21/01/21

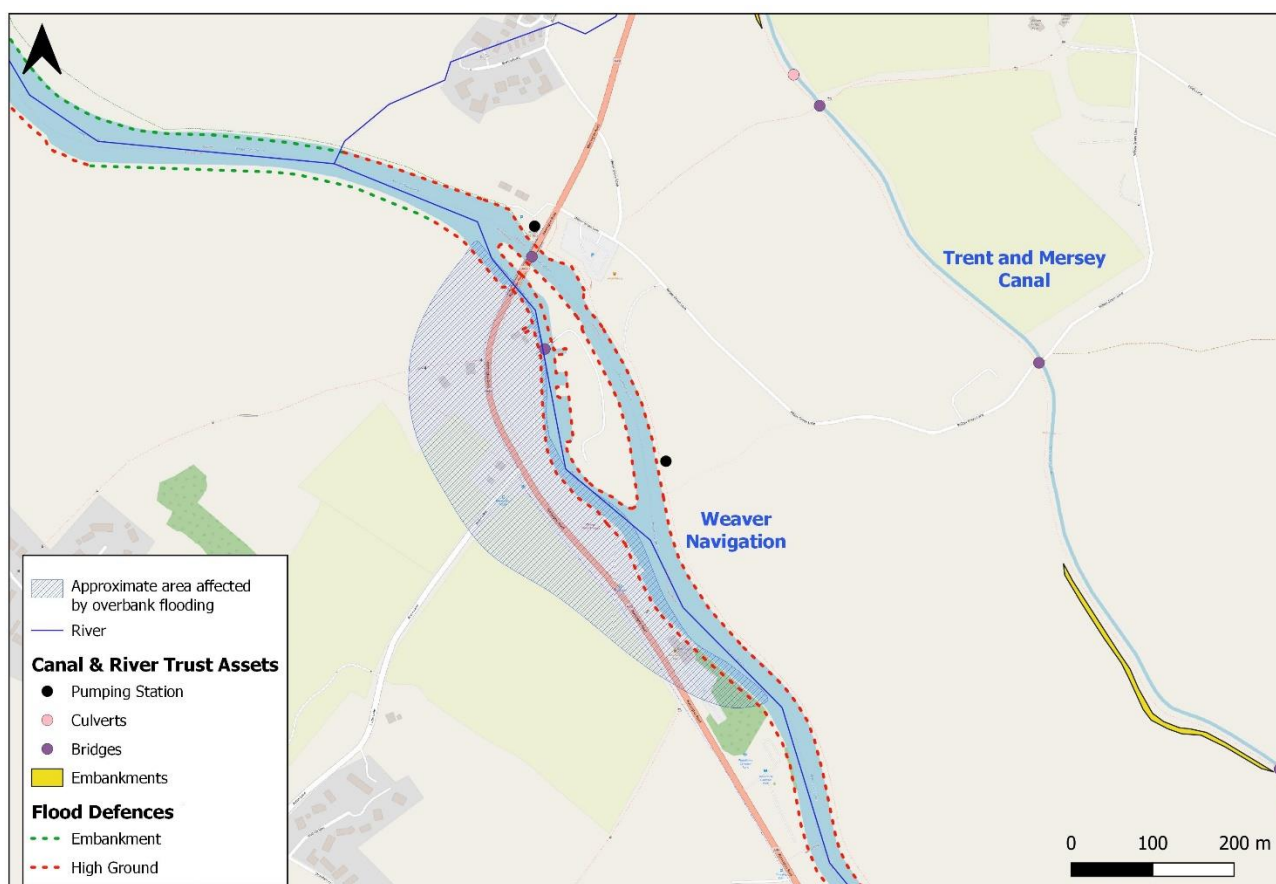
Figure 9 - Acton Bridge flood overview

During the Storm Christoph event properties on Warrington Road were affected initially from surface water coming from the road and subsequently by water spilling out of bank from the River Weaver. Water was first observed to begin pooling on Warrington Road between the Riverside Inn and the Woodbine Caravan Park, as the amount of water unable to discharge through the highways drains increased, water began to flow northwards on the road, spilling down towards the riverside properties. Surface water flowed directly from the fields to the west onto the road, increasing the amount of water that was flowing towards and inundating the property. It is worth noting that the affected riverside properties on Warrington Road are lower than the road itself. Subsequent to the initial surface water flooding, the River Weaver began to flow out of bank which caused further flooding to the property.

The junction between Warrington Road and Acton Lane is located in a low spot and as such water pooled in this area causing internal flooding to property on Acton Lane. This area retained water after the River Weaver water levels dropped, interventions were required to drain this water by way of a temporary drainage channel running northwards to discharge to the Weaver downstream of the Acton Swing Bridge.

The River Weaver overtopped its banks at Acton Bridge causing out of bank flow. At the point when fluvial flooding commenced surface water flooding was already occurring.

Surface water flooding was the initial cause of flooding on the A49. The system could not take the volumes of water on the highway, contributed to by overland flow from the surrounding fields, resulting in surcharge and the build-up of surface water. The highway system discharges directly to the river and its ability to discharge is linked to river levels.

The onset of flooding occurred as a result of surface water flooding, this was from a combination of overland flow from surrounding fields and water unable to enter the highway drainage network. This was the initial cause of flooding to property.

Subsequent to the surface water flooding, the River Weaver spilt out of bank and further increased water depth. Water levels were high in the River Weaver due to heavy rainfall, further artificial increases in depth may have resulted as two gates were being serviced at Dutton Sluices. However, without detailed hydraulic modelling of the event it is not possible to determine the impact of the Dutton Sluices to water levels at Acton Bridge.

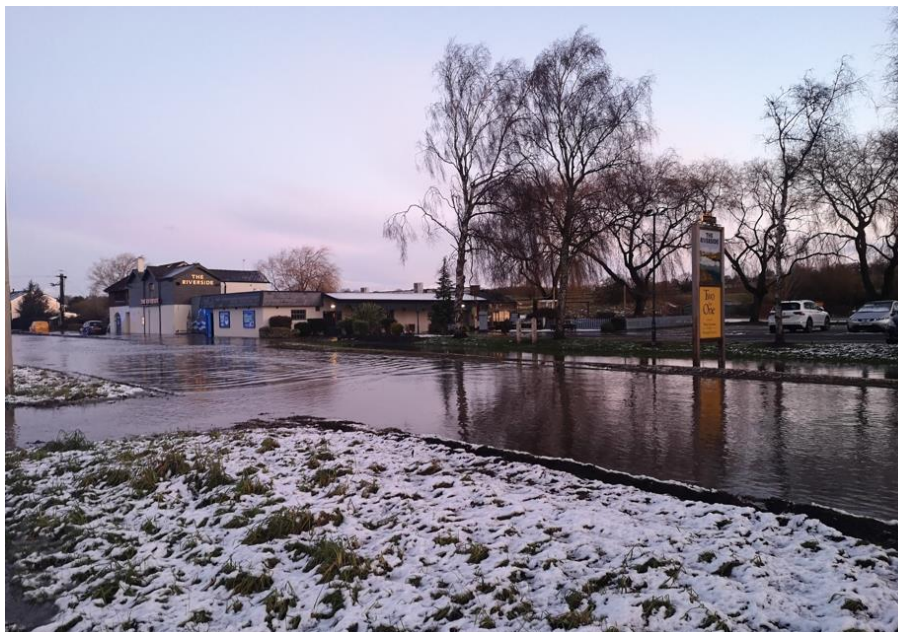
- Water levels were reportedly 1m inside the property on Warrington Road and up to 2m of flooding affected the stables.
- Vehicular traffic on Warrington Road continued throughout the afternoon of the 20th January 2021 until the evening causing waves of water towards the affected property, residents believe this contributed to the initial flood impact.

Figure 10 – Warrinton Road. 8:00am 21/01/21

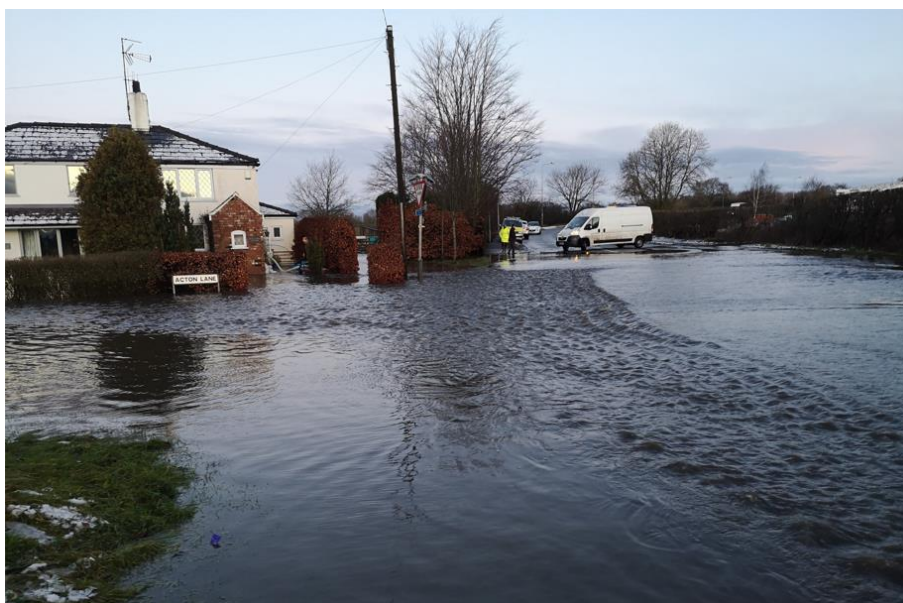
- Pumps were deployed at the low spot of Acton Lane and Warrington Road for 3 days with little impact. This area was successfully drained after the excavation of a temporary relief channel to the north.

Figure 11 – Junction of Acton Lane and Warrington Road. 8:00am 21/01/21

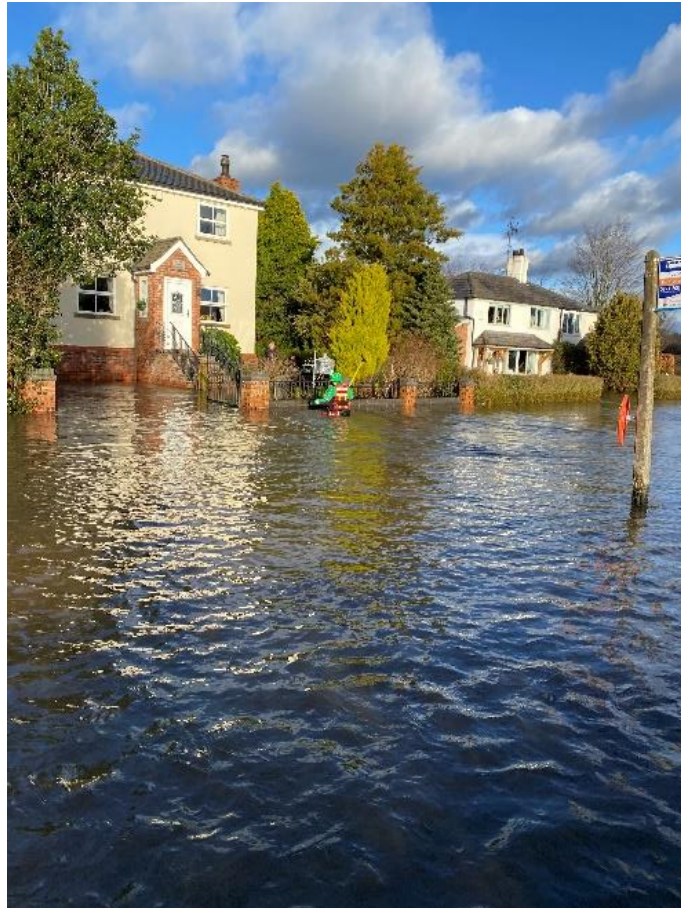
Figure 12 - Acton Bridge. 21/01/21

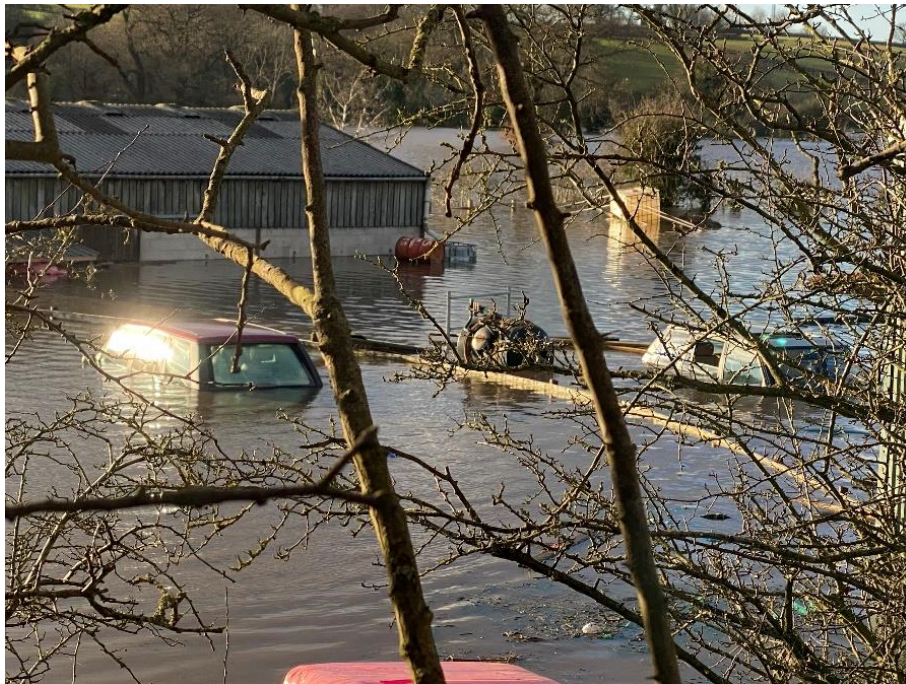
Figure 13 - Acton Bridge. 21/01/21

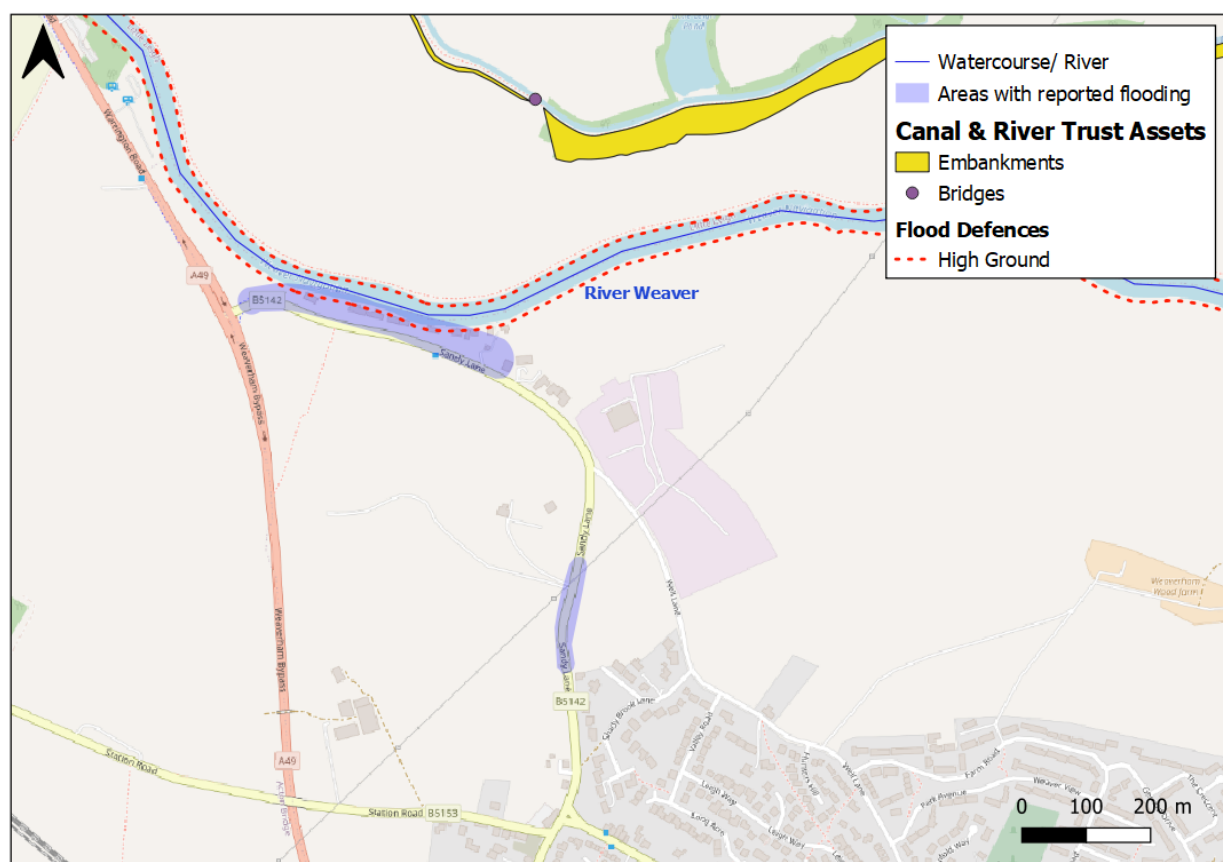
Figure 14 - Weaverham flood overview

Seven properties are reported to have flooded internally on Sandy Lane in Weaverham. Figure 14 shows details the flooding, developed in consultation with CWaC, as LLFA.

During the Storm Christoph event water began to pool on the fields to the south of Sandy Lane and on Sandy Lane itself. The highway drainage system was not able to drain the amount of water that was accumulating. It is not known whether the surface water in isolation caused internal flooding to property. Subsequently, as the River Weaver rose, the water flowed out of bank and caused flooding to the properties on Sandy Lane adjacent to the River Weaver. There was reportedly over 1m depth of water on Sandy Lane at the peak depth.

The initial onset of flooding to Sandy Lane was caused by surface water unable to drain away. Subsequent to this, water levels in the River Weaver rose causing out of bank flow which inundated the south bank of the Weaver. Properties were affected, leading to their evacuation.
