Ashton Hayes Main Report Details

Project:	Storm Christoph Section 19 Main Report		
Area:	Ashton Hayes		
Date:	27/06/22	Project No.:	5150735

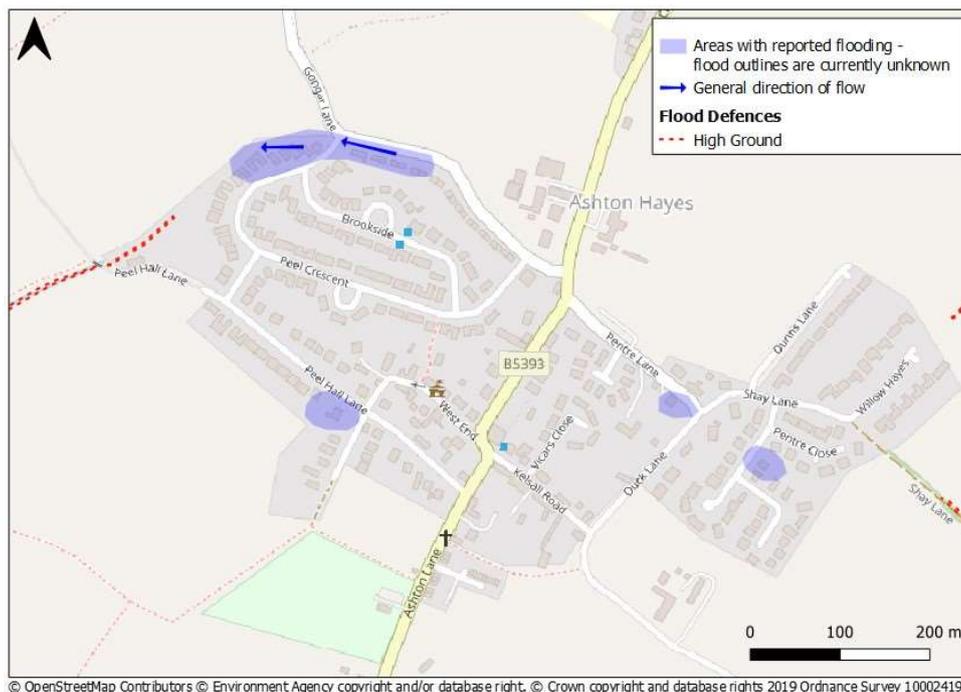
Figure 1 - Flood overview

Flooding occurred on The Meadows, Pentre Lane, Shay Lane and Gongar Lane due to the significant volume of water flowing through the open and culverted sections of the drainage network, surface water flooding and the large volume of overland flow on Shay Lane from the high ground to the east of the village. Collectively, this water caused multiple properties to be flooded, resulting in their evacuation, and a car to be written off. There were reports of open land drains overtopping at the junction between Kelsall Road and Duck Lane and between the Kelsall bypass and Old Hall Court, flooding from the latter drains caused damage to a local wall. This water ultimately ended up on Pentre Lane before flowing to The Meadows and Peel Crescent.

Figure 1 below shows details of the flooding, developed in consultation with Cheshire West and Chester Council (CWaC), as Lead Local Flood Authority (LLFA), and affected property owners.

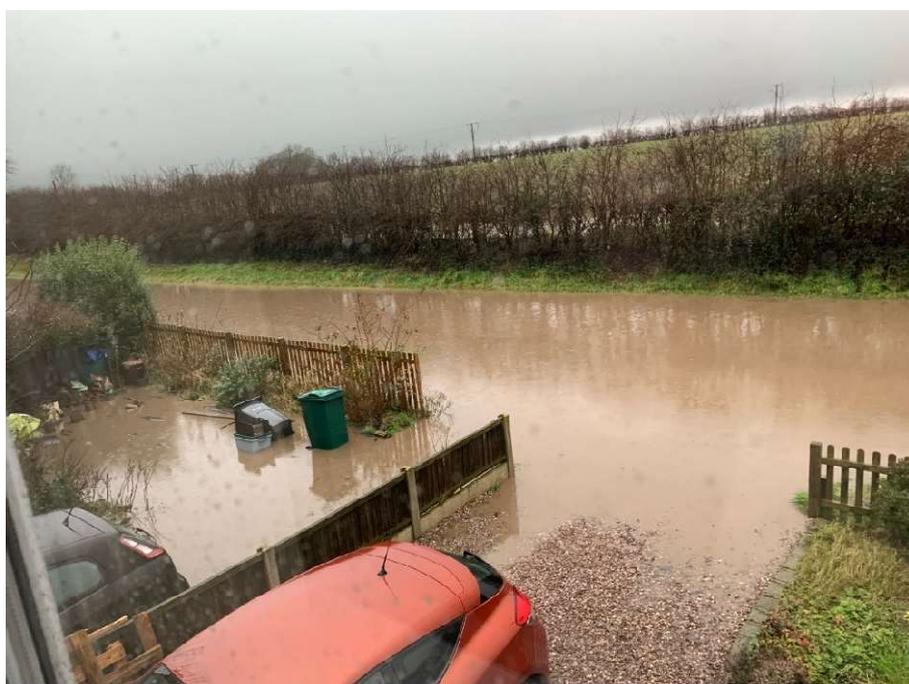
Figure 2 – Flooding Outside a Property at The Meadows

- Water levels at The Meadows (on Gongar Lane) rose rapidly, rising to 1.3m depth in places. This was as a direct result of the excess water from the surcharged culvert in addition to significant overland flow from Shay Lane, Pentre Lane and Church Road.
- Properties at Peel Crescent were flooded from the excess water flowing overland from The Meadows and Gongar Lane.
- They had concerns regarding the maintenance of the highway and wider drainage networks in the area.
- Emergency access was restricted to The Meadows and Peel Crescent. They also raised safety concerns of standing water within front gardens.
- Water escaped from manholes on The Meadows and Peel Crescent although no photographic evidence is available.
- The culvert on Shay Lane surcharged, causing a significant volume of overland flow.

Figure 2 below shows the extent of flooding outside The Meadows at approximately 15:00 on January 21st, 2021. This shows the raised water level on the street and the growing threat to property.

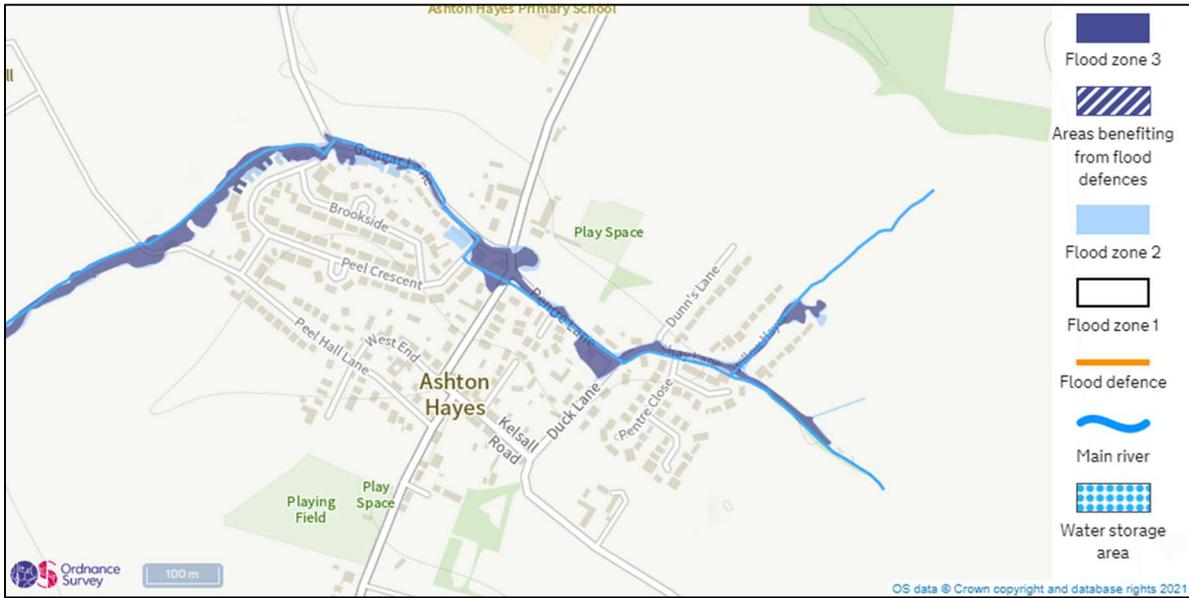
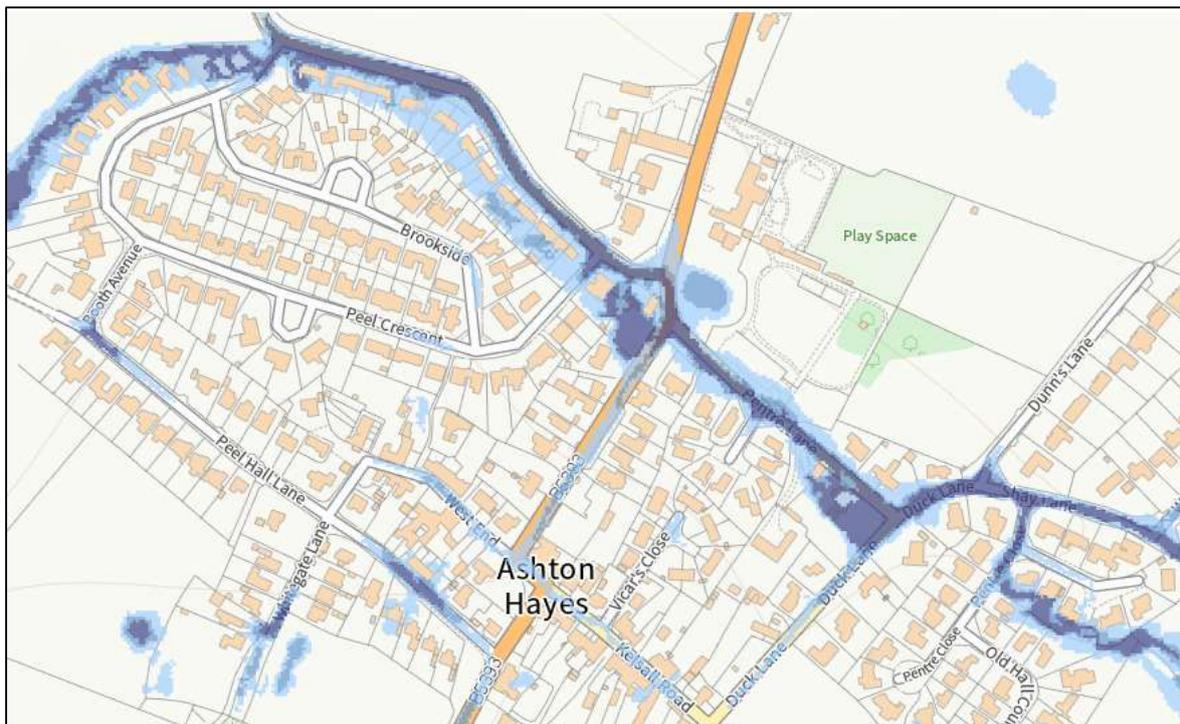
Extent of flooding from surface water

A number of properties in Ashton Hayes are of high risk of surface water flooding, included those that were affected by Storm Christoph in January 2021. For further details of the areas at risk refer to Appendix I.
