Ashton Hayes Main Report Details

Project:	Storm Christoph Section 19 Main Report		
Area:	Ashton Hayes		
Date:	27/06/22	Project No.:	5150735

This Ashton Hayes specific Main Report should be read in conjunction with the Section 19 Flood Investigation – Main Report (January 2021 Storm Christoph Flooding Event).

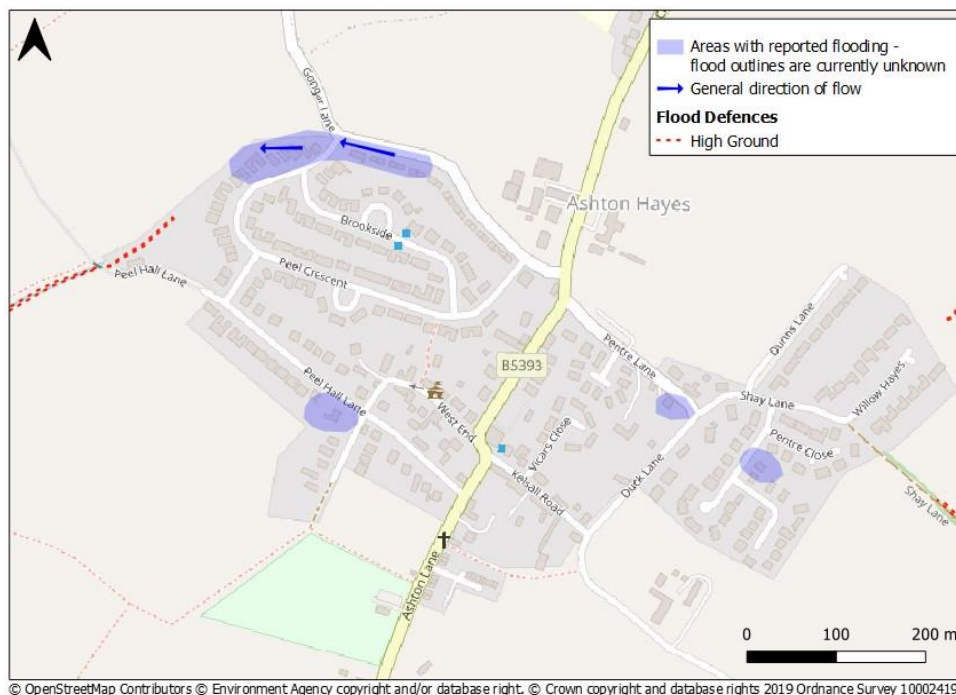
Figure 1 - Flood overview

Flooding occurred on The Meadows, Pentre Lane, Shay Lane and Gongar Lane due to the significant volume of water flowing through the open and culverted sections of the drainage network, surface water flooding and the large volume of overland flow on Shay Lane from the high ground to the east of the village. Collectively, this water caused multiple properties to be flooded, resulting in their evacuation, and a car to be written off. There were reports of open land drains overtopping at the junction between Kelsall Road and Duck Lane and between the Kelsall bypass and Old Hall Court, flooding from the latter drains caused damage to a local wall. This water ultimately ended up on Pentre Lane before flowing to The Meadows and Peel Crescent.

Figure 1 below shows details of the flooding, developed in consultation with Cheshire West and Chester Council (CWaC), as Lead Local Flood Authority (LLFA), and affected property owners.

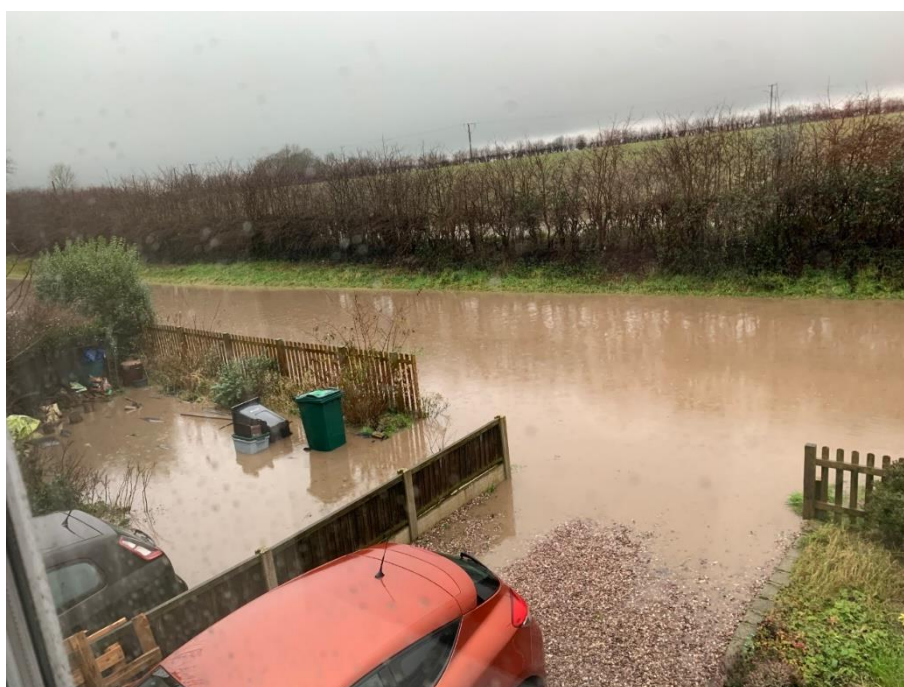
Figure 2 – Flooding Outside a Property at The Meadows

- Water levels at The Meadows (on Gongar Lane) rose rapidly, rising to 1.3m depth in places. This was as a direct result of the excess water from the surcharged culvert in addition to significant overland flow from Shay Lane, Pentre Lane and Church Road.
- Properties at Peel Crescent were flooded from the excess water flowing overland from The Meadows and Gongar Lane.
- They had concerns regarding the maintenance of the highway and wider drainage networks in the area.
- Emergency access was restricted to The Meadows and Peel Crescent. They also raised safety concerns of standing water within front gardens.
- Water escaped from manholes on The Meadows and Peel Crescent although no photographic evidence is available.
- The culvert on Shay Lane surcharged, causing a significant volume of overland flow.

Figure 2 below shows the extent of flooding outside The Meadows at approximately 15:00 on January 21st, 2021. This shows the raised water level on the street and the growing threat to property.

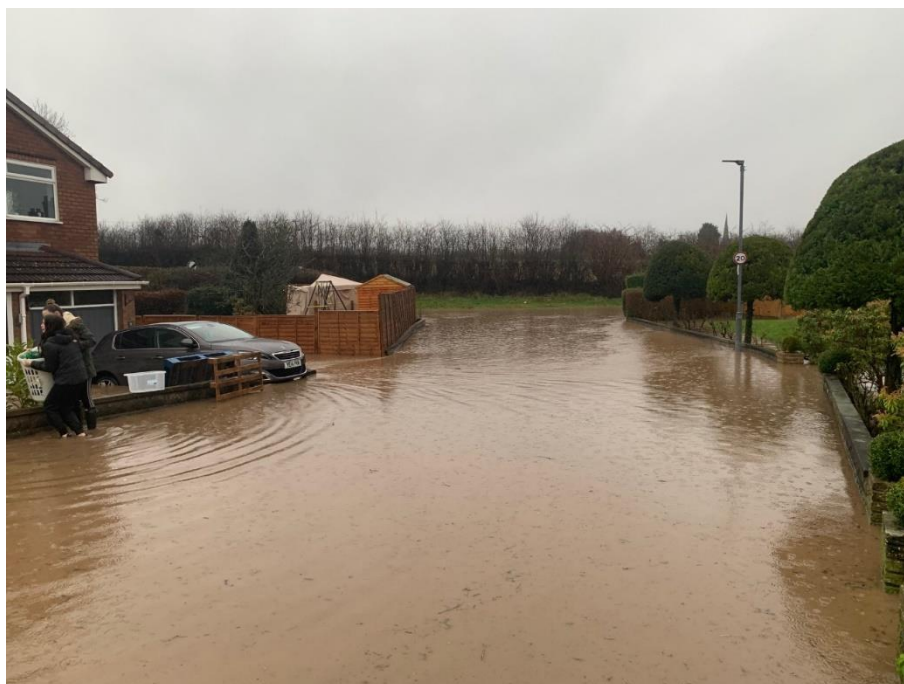
Figure 3 – Flood Water on Peel Crescent

Figure 3 below shows the extent of the flooding at junction of Peel Crescent and Gongar Lane, this shows the water level and extent of flooding which affected property.

The highway drains in the area of Peel Crescent and Gongar Lane became surcharged, unable to cope with the volume of water entering the system, causing water to spill out onto the highway.

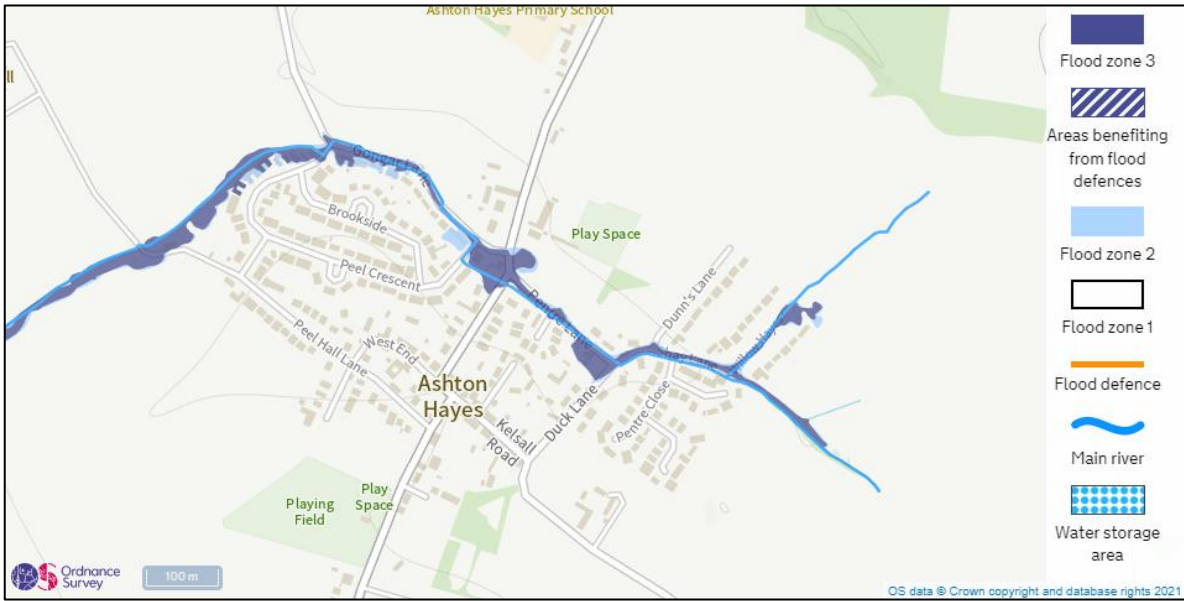
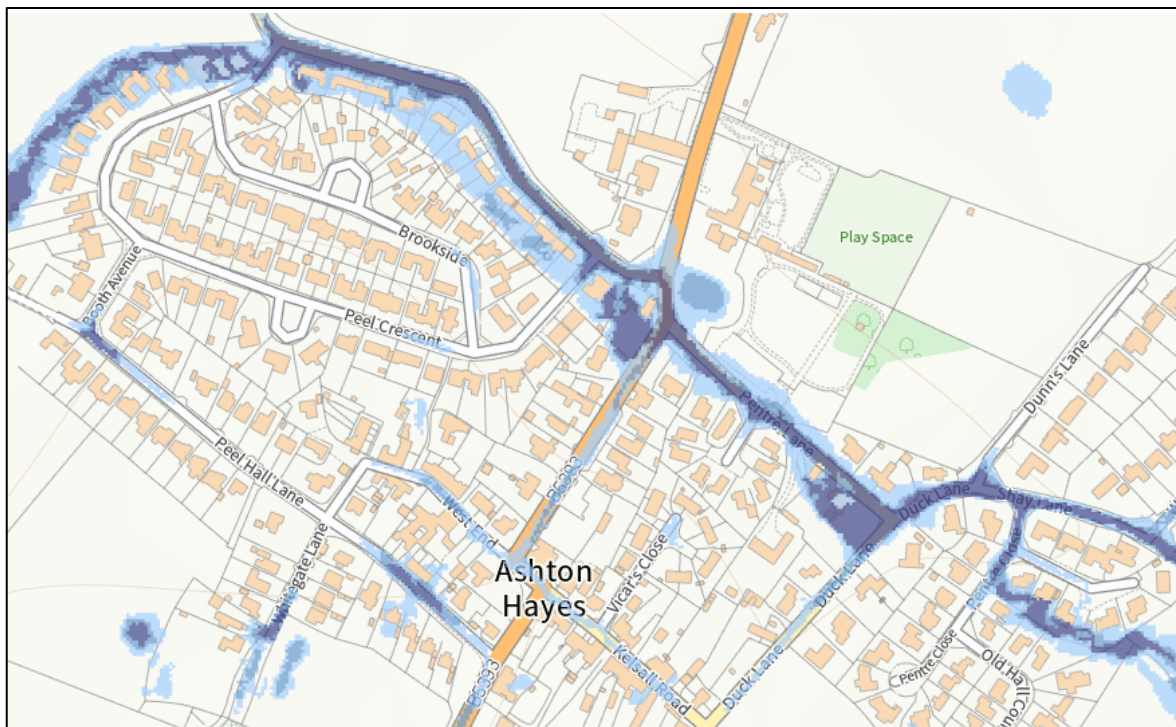
Appendix I – Maps

A number of properties in Ashton Hayes are of high risk of surface water flooding, included those that were affected by Storm Christoph in January 2021. For further details of the areas at risk refer to Appendix I.

Extent of flooding from surface water
