## Davenham Main Report Details

Project:	Storm Christoph Section 19 Main Report		
Area:	Davenham		
Date:	10/08/2022	Project No.:	5150735

This Davenham specific Main Report should be read in conjunction with the Section 19 Flood Investigation – Main Report (January 2021 Storm Christoph Flooding Event).

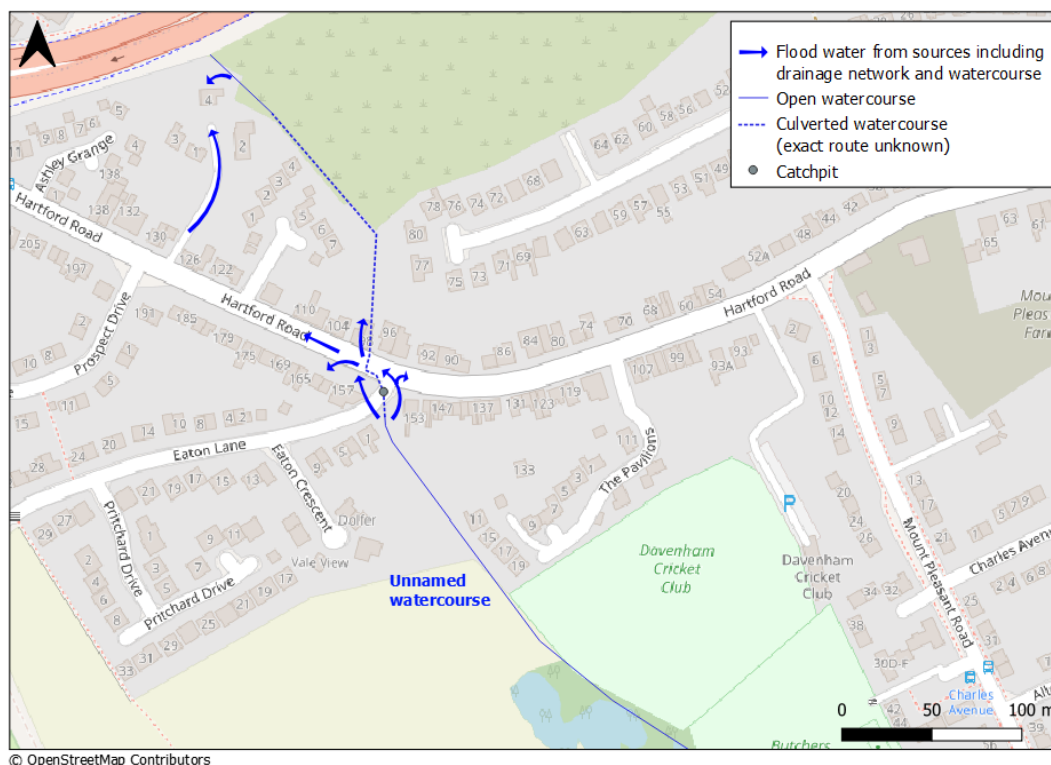
Figure 1 - Davenham Flood Overview

During the Storm Christoph event, flooding in Davenham was reported on Davenham Meadows, Eaton Lane and Hartford Road, internally flooding four properties, one of which was affected by foul water flooding. Figure 1 shows details of the flooding developed in consultation with Cheshire West and Chester Council (CWaC) and the affected property owners.

At the point where the watercourse is culverted under Eaton Lane, the watercourse overtopped and flooded the junction of Eaton Lane and Hartford Road. Water ran down Hartford Road and flooded properties on both the north and south side of Hartford Road. Manholes on Eaton Lane and Hartford Road associated with the culverted watercourse also surcharged. The combined sewer system surcharged at one manhole along Hartford Road; residents reported backing up of toilets. During the event, the flooded section of Hartford Road was closed.

The watercourse is culverted under properties on Hartford Road and then flows to the west behind properties on Rookery Gardens and Davenham Meadows before flowing in a culvert under the A556. Drainage maps suggest the watercourse is culverted along this entire section, however the watercourse is in open channel behind properties on Davenham Meadows. It is understood that the poor condition of the pipe restricted flow causing the watercourse to flow above ground as an open channel before dropping back into the culvert at a manhole just before flowing under the A556. During the event, the levels in this watercourse were reported to be up to 2 m high and water flowed through gardens and into a property on Davenham Meadows. Water flowed overland on Davenham Meadows from Hartford Lane.

- LLFA to investigate the drainage network on Hartford Road and Eaton Lane and to check for structural damages or blockages.
- LLFA to undertake CCTV inspection of the culverted watercourse to fully establish its route and condition and if required, undertake de-silting activities.

- LLFA to establish land ownership and responsibility for maintenance and repair of the watercourse behind Davenham Meadows.
- LLFA to undertake maintenance of the highway gullies and catchpit to remove debris and check for blockages.

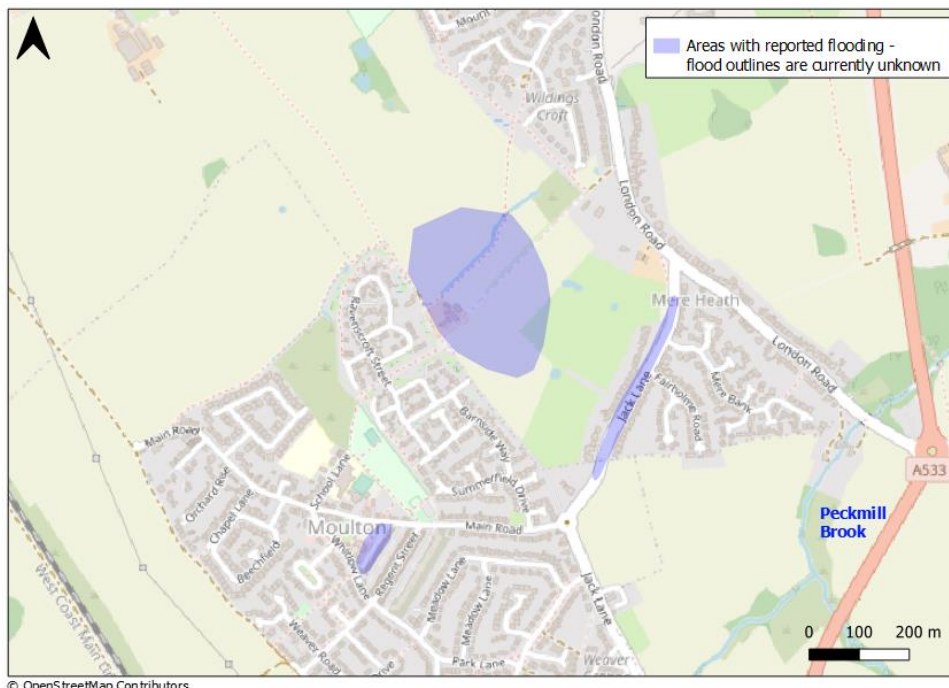
**Figure 2 - Moulton Flood Overview**

South of the village, towards Moulton, flooding was also reported to impact a number of properties on Jack Lane and The Dairy Farm on Beehive Lane, internally flooding one property. London Road and Church Street were also reported to flood. The exact details of this flooding are not currently known. Figure 2 shows details of the flooding developed in consultation with CWaC.

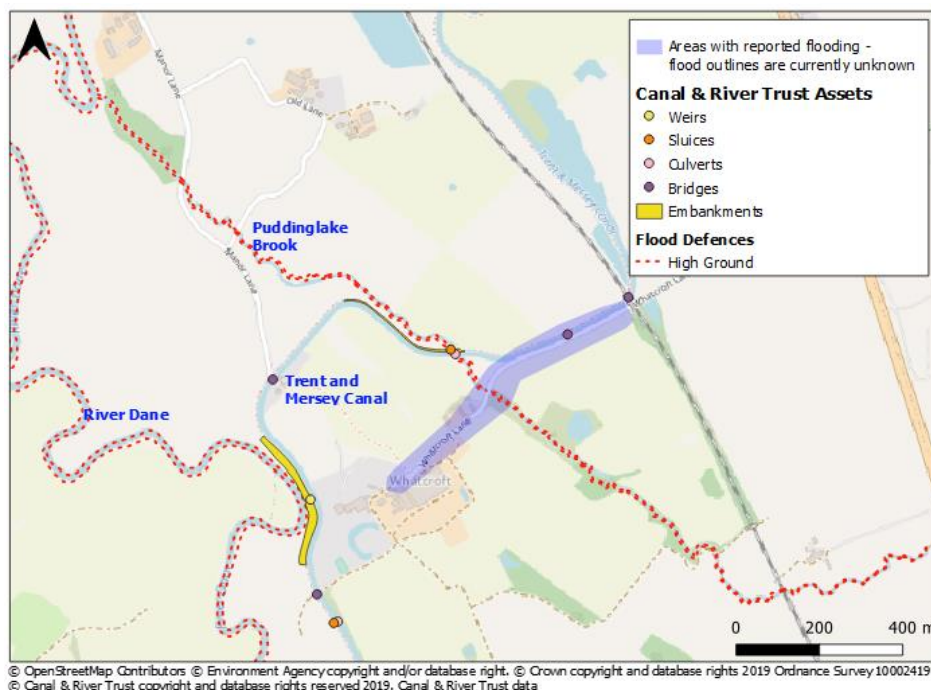
**Figure 3 - Whatcroft Flood Overview**

Whatcroft Hall Lane was reported to flood, blocking access to properties. Residents raised concern regarding a sinkhole on Whatcroft Lane that has been temporarily repaired but is beginning to sink again. CWaC highways team attended the site during the event to pump flood water away. Figure 3 shows details of the flooding developed in consultation with CWaC.
