# Ellesmere Port Main Report Details

Project:	Storm Christoph Section 19 Main Report		
Area:	Ellesmere Port		
Date:	10/08/2022	Project No.:	5150735

This Ellesmere Port specific Main Report should be read in conjunction with the Section 19 Flood Investigation – Main Report (January 2021 Storm Christoph Flooding Event).

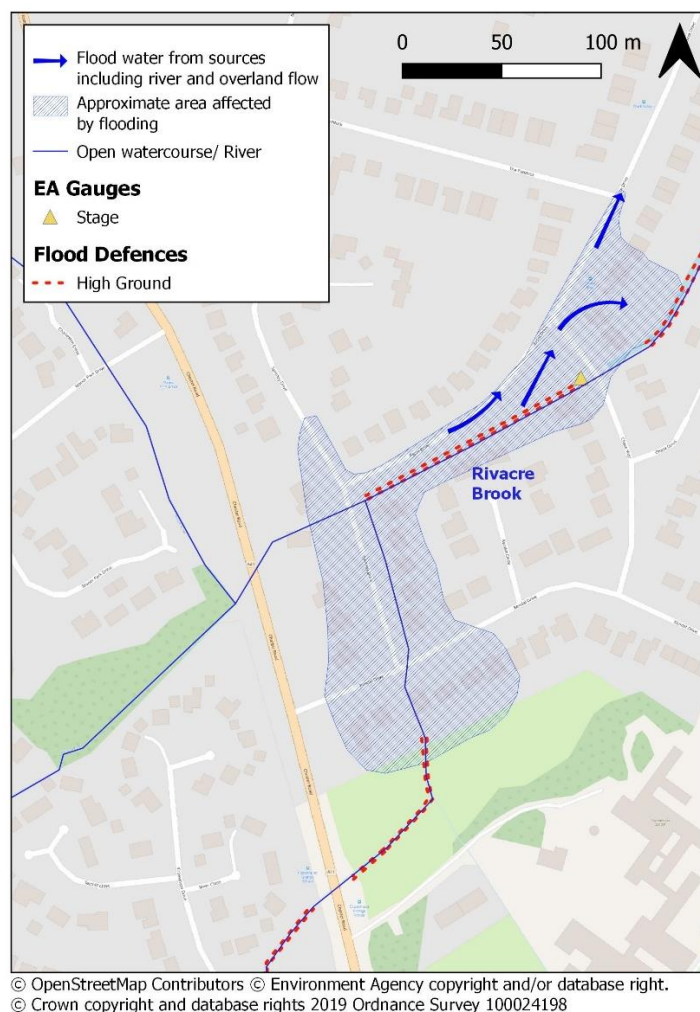
**Figure 1 - Great Sutton Flooding Overview**

Flooding occurred at Great Sutton due to the capacity of the channel being insufficient for the volume of water, which led to overtopping which combined with surface water to cause extensive flooding. Flooding was reported at properties on Kendal Drive, Spinney Drive, Ascot Drive and Chase Way. The exact details of the flooding at properties on Kendal Drive and Spinney Drive are not known. Figure 1 shows details of the flood route for properties on Ascot Drive and Chase Way, developed in consultation with CWaC, as Lead Local Flood Authority (LLFA), and the affected property owners.

The Rivacre Brook catchment responds very quickly to heavy rainfall meaning that there is very little time between rain falling and the water flowing through the brook. During the Storm Christoph event, levels rose rapidly in Rivacre Brook, which then backed up at the culvert under Chase Way and overtopped the bank. The overbank flow then joined with the surface water flooding on Ascot Drive. Flood water travelled past properties on Chase Way and down Ascot Drive, the water flowed down driveways and through rear gardens of properties on Ascot Drive to re-enter the Rivacre Brook Channel downstream of Chase Way.

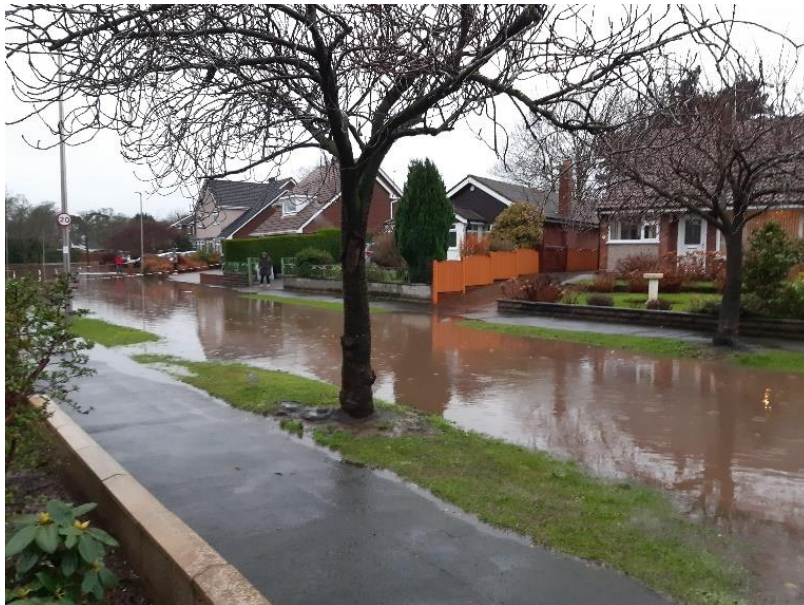
It is reported that Ascot Drive regularly floods during heavy rain; water often pools at the low-lying section of the road where road gullies are unable to cope with heavy rain. The road gullies discharge to Rivacre Brook.

**Figure 2 - Ascot Drive. 20/01/21 15:05.**

- The police were asked to close the affected roads on Ascot Drive and Chase Way but were unable to complete these closures during the peak of flooding which allowed vehicles to pass, pushing water into property.

- A more proactive traffic management strategy should be adopted for the affected area. The LLFA should take the lead in developing this strategy in collaboration with residents and the emergency services to ensure vehicles do not push water towards, and into, property.

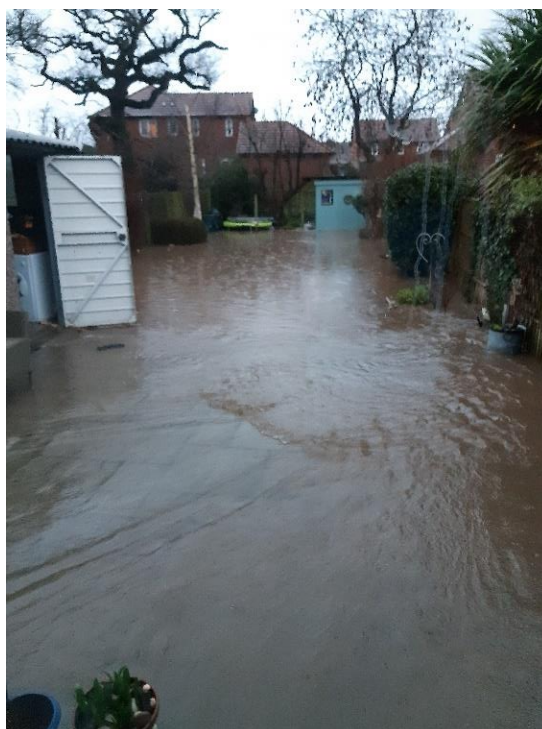
- They did not receive a flood warning on the day of the event prior to water coming out of bank, this reportedly occurred when water was already close to entering properties.
- Residents took down fence panels at the rear of gardens on Ascot Drive to allow flood water to re-enter the channel downstream of Chase Way.
- Traffic on Ascot Drive and Chase Way sent waves of flood water into properties. During the event residents contacted the police to try and get the roads closed, however it reportedly took 10 hours before police visited the area to close the roads.
- Water levels were up to 600mm deep within properties.
- Residents are concerned that upstream development in the catchment is contributing additional flows during storm events. They are particularly concerned of the impact of the development of up to 2,000 homes on land near Ledsham Road in Little Sutton.

**Figure 3 - Rear garden of Ascot Drive Property. 20/01/21 16:14.**
