Great Barrow Main Report Details

Project: Storm Christoph Section 19 Main Report

Area: Great Barrow

Date: 10/08/2022 Project No.: 5150735

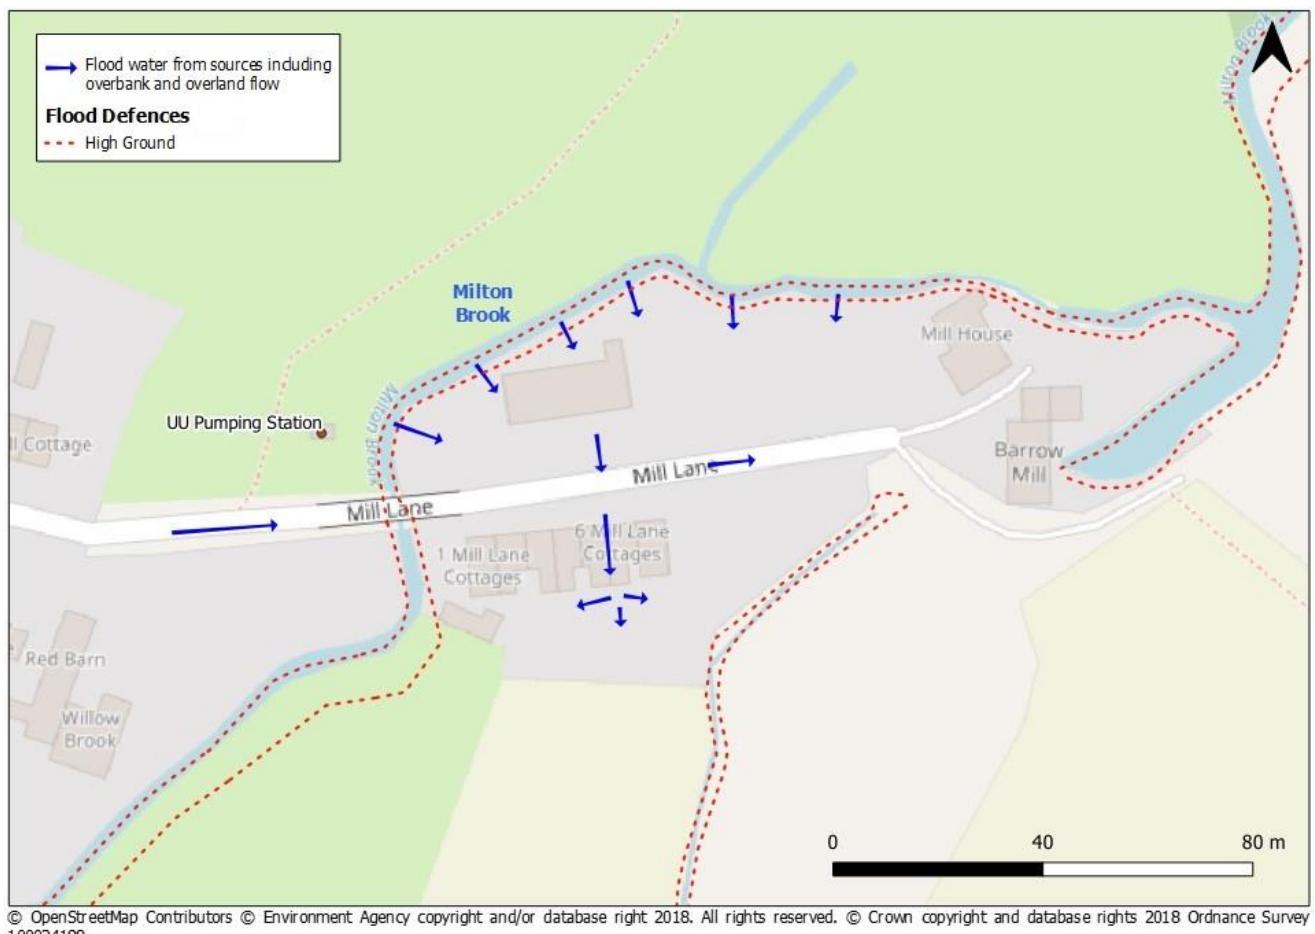
Figure 1 – Mill Lane Flood Overview

During Storm Christoph event a single property was flooded from water as it flowed out of Milton Brook, over Mill Lane, through an alleyway between properties to the south of Mill Lane before re-joining the watercourse system.

Overland flow was observed flowing eastward along Mill Lane from Main Street, which has a high elevation, this water pooled to the west of the road bridge until the water levels in the brook reduced.

It is reported that foul water escaped the surcharged sewerage system, flowing from manholes and combining with flood water from the brook.

- The water levels in Milton Brook rose until they overtopped the bank and flooded a property between the brook and Mill Lane. Contributing to this was water backing up from the Mill Lane bridge.
- Surface water flowed eastward from Main Street and pooled at the Mill Lane bridge.
- The United Utilities (UU) sewerage system was surcharged which led to foul water flooding (this was not reported to UU).

- CWaC, as LLFA, to undertake site visit of new development to the North of Mill Lane to assess whether there are opportunities to redirect out of bank flow back towards Milton Brook and away from property.

- CWaC, as LLFA, alongside the EA to assess whether there are economic and technically viable options to provide upstream storage, potentially utilising agricultural land or historic ponds.

- CWaC, as LLFA, confirm that the Mill Lane Bridge is clear of debris and in good condition and, that it is of sufficient capacity.
- Residents to be encouraged to sign up to the EA flood alert service and LLFA and EA to consider the feasibility of implementing a flood warning service.

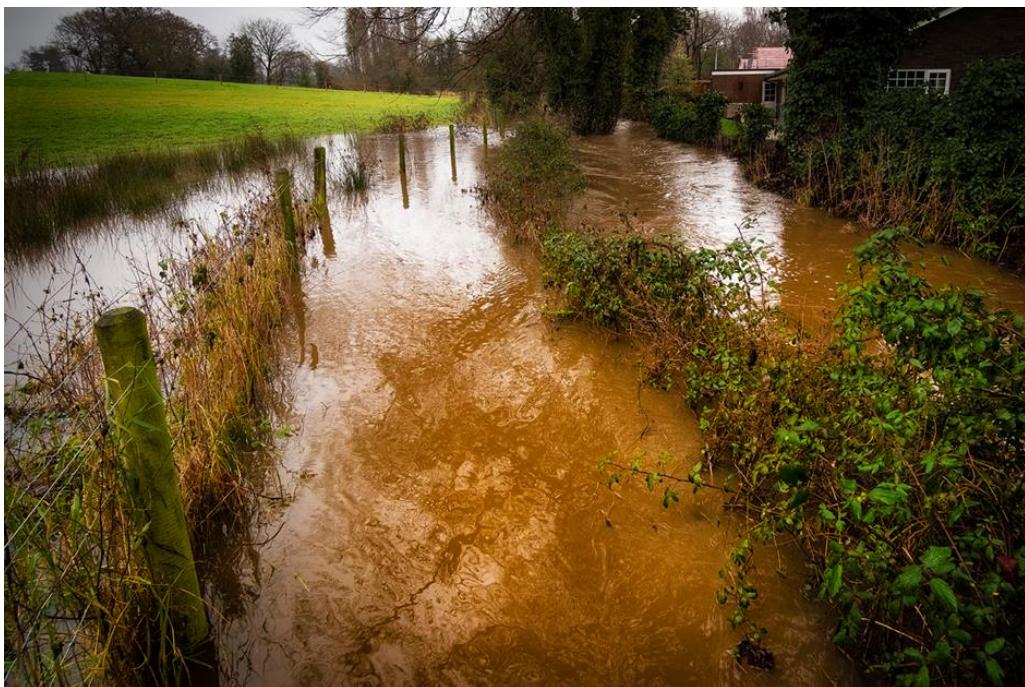
Figure 2 – Milton Brook. 20/01/21

Photographs that illustrate the severity of the flood event in Mill Lane can be seen in Figure 2. A detailed timeline of the event is given in Appendix II.

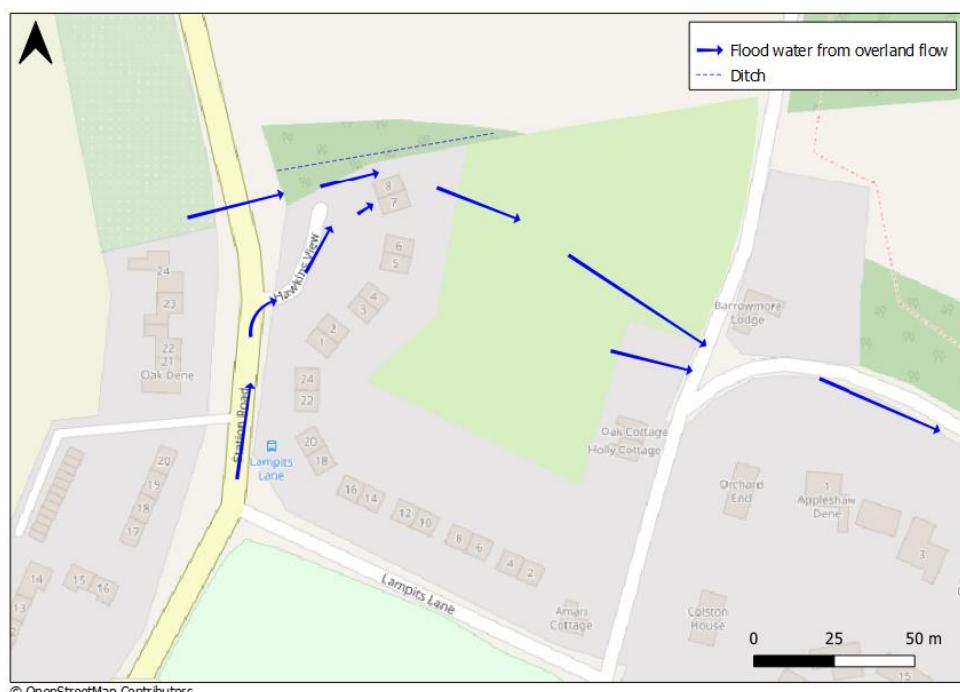
Figure 3 – Hawkins View Flood Overview

During the Storm Christoph event two properties were flooded from surface water. It was reported that flood water runs off from fields to the west of Hawkins View and across the road to properties on Hawkins View. Flood water also comes down the B5132 (Station Road) from the south and runs down Hawkins View. After running through the properties, the flood water continues to follow the topography of the land and runs east, across fields to, and then down, Heath Lane.

North of Hawkins View there is a ditch, however this is overgrown and therefore the course of the ditch and any inlets into the ditch are currently unknown.

- CWaC, as LLFA, to investigate the condition and land ownership of the drainage network in the area, paying particular attention to the ditch to the north of Hawkins View and consider whether this could be used to divert flow away from affected property.
- Individual property owners to investigate opportunities to install property level protection resilience. CWaC, as LLFA, to provide support and guidance.
- LLFA to promote the use of the FloodHub for information on flooding.

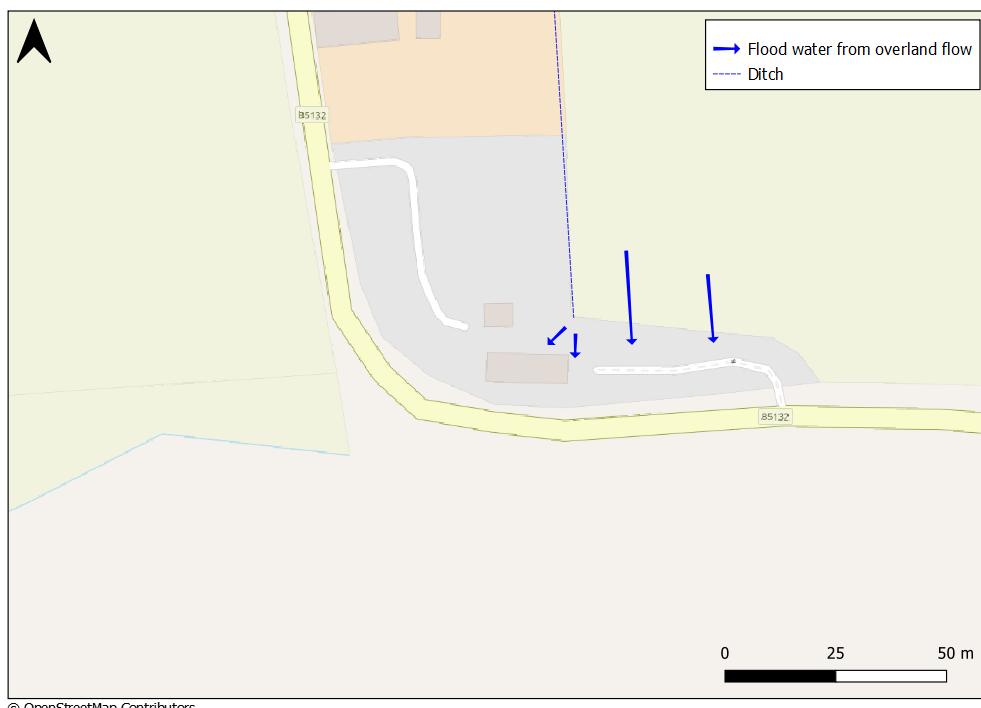
Figure 4 - Plemstall View Flood Overview

During the Storm Christoph event, the ditch overtopped at the inlet, and flood water flowed into the property. Floodwater also flowed southwards overland from the adjacent fields.

- CWaC, as LLFA, to assess whether there are economic and technically viable options to provide low-cost Natural Floodplain Management approaches to delay water entering the ditch.
- Property owners to investigate the route and condition of the culvert under the property. LLFA to provide support and guidance.
- Individual property owners to investigate opportunities to install property level protection resilience. CWaC, as LLFA, to provide support and guidance.
- LLFA to promote the use of the FloodHub for information on flooding.

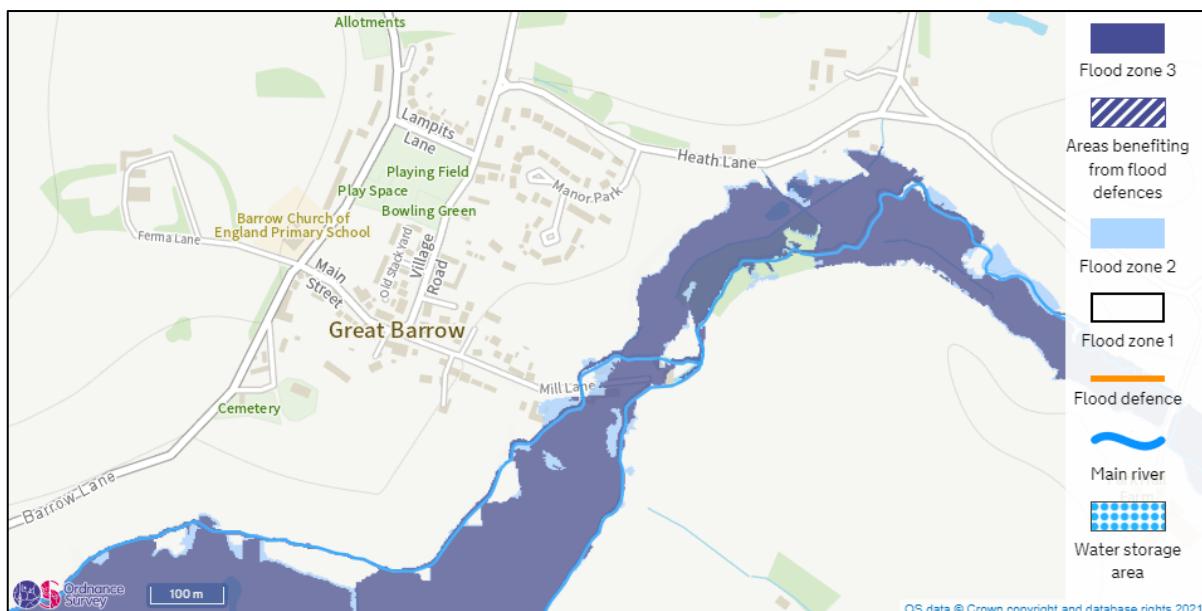
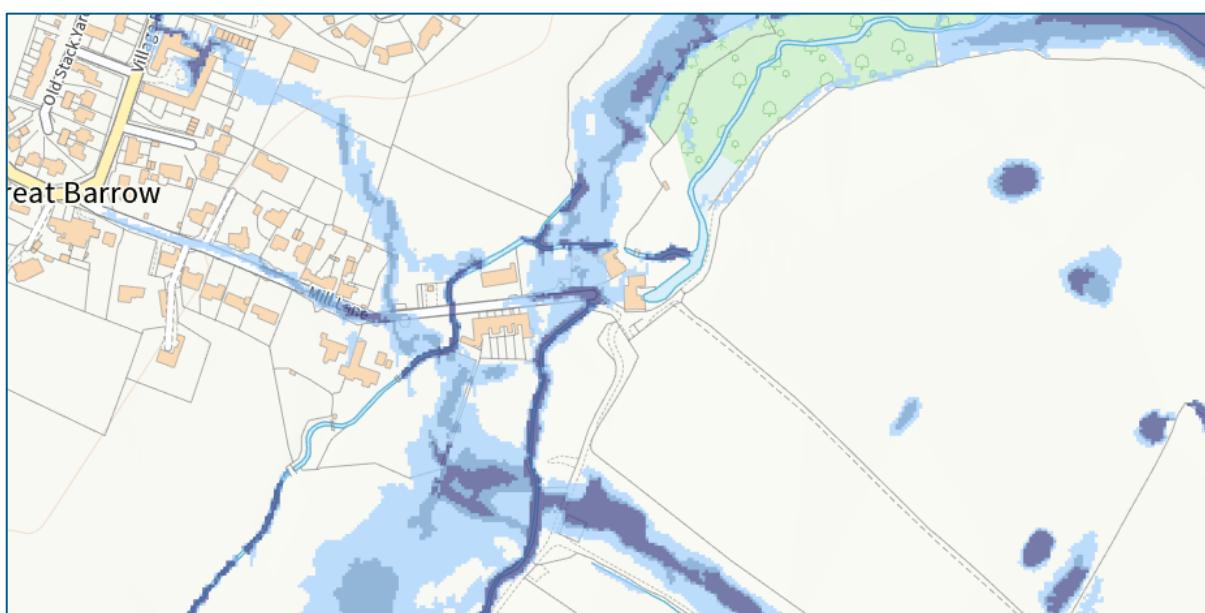
Mill Lane flood zones

Properties on Mill Lane, in the area of the flooded property, are located within the Environment Agency (EA) Flood Zones 2 and 3. The properties are within the low-risk surface water flood risk zone (Appendix I).

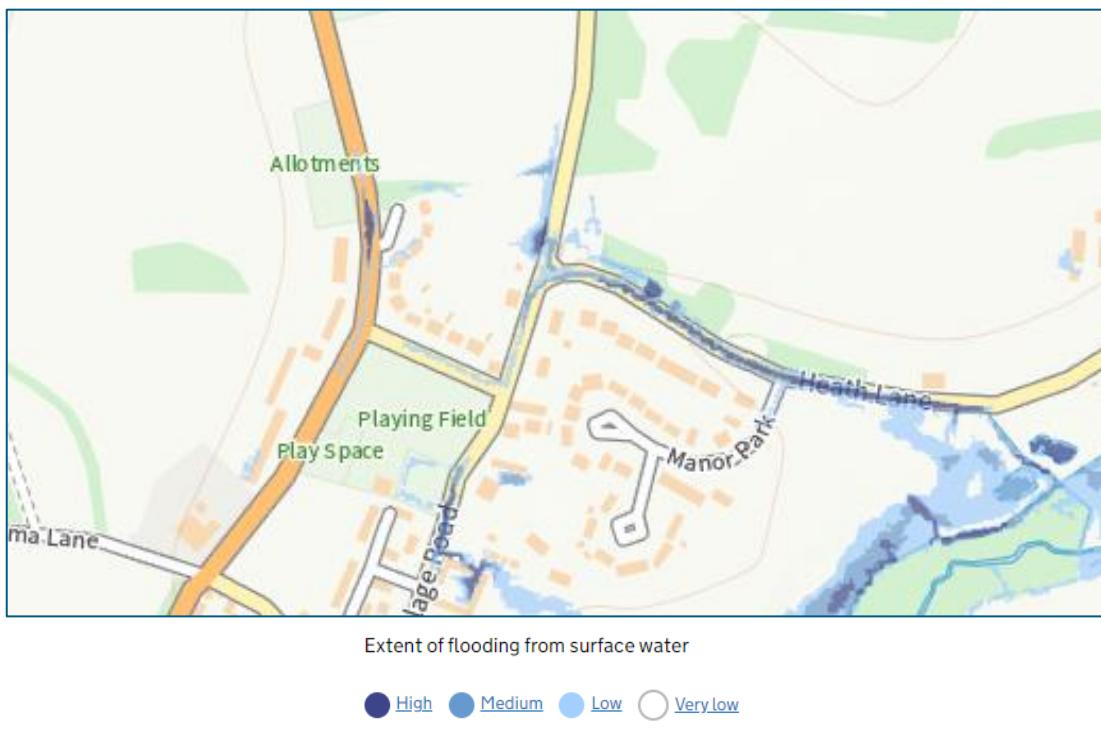
Hawkins View flood zones

Two properties on Hawkins View flooded internally. Properties on Hawkins View are located within the EA Flood Zone 1. The properties are within the low-risk surface water flood risk zone (Appendix I).

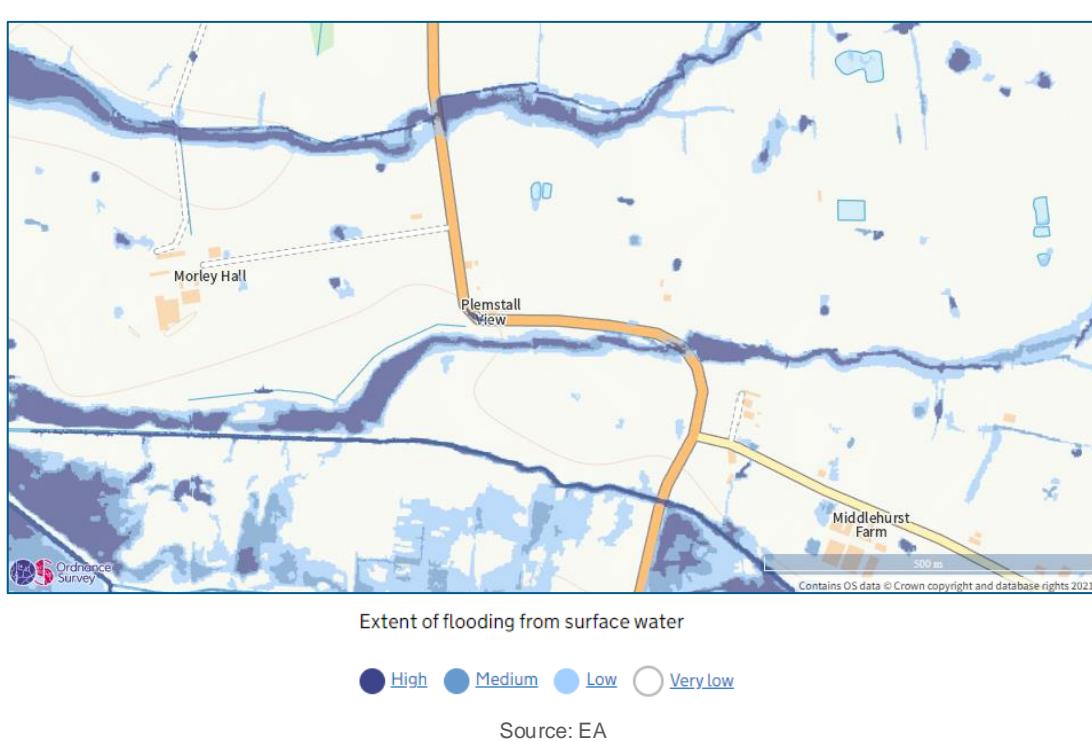
Plemstall View flood zones

Properties at Plemstall View, in the area of the flooded property, are located within the EA Flood Zone 1. The properties at Plemstall View are within the very low risk surface water flood risk zone (Appendix I).
