Kingsley Report Details

Project: Storm Christoph Section 19 Main Report

Area: Kingsley

Date: 10/08/22 Project No.: 5150735

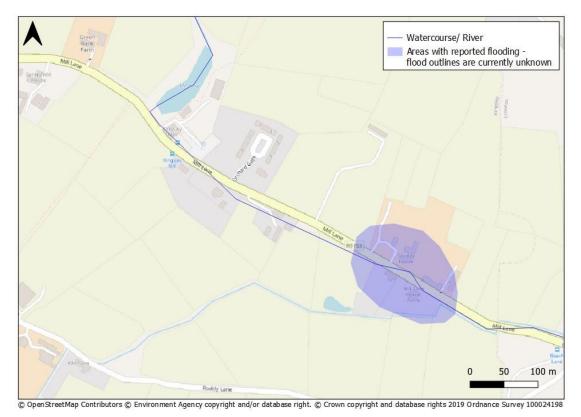
Figure 1 - Flood Overview at Kingsley

It is understood that flooding occurred in Kingsley due to a combination of factors including insufficient capacity of the culvert through the village, capacity limits in the culvert beneath Mill Lane and a general poor state of maintenance of open drainage ditches which restricts conveyance.

A single property in Kingsley experienced internal flooding which led to its evacuation. This property was affected by water backing up from the culvert beneath their driveway and spilling out to surround their property. In addition, although this didn't flow into the property due to high kerb stones, water flowed down Mill Lane.

- Confirm connectivity of the two drainage ditches running along Mill Lane.
- Include the area as being at risk of flooding in the risk-based gully maintenance system.

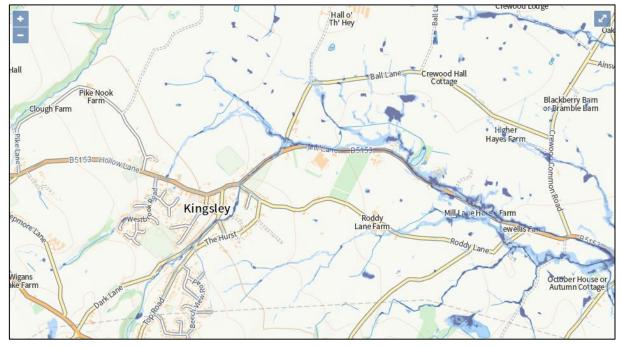
Extent of flooding from surface water

Flooding occurred within the village 20 years ago, reportedly because of an insufficient capacity of the culvert. The village of Kingsley mostly has a low risk of flooding from Surface Water, with some areas of higher risk around Mill Lane. The area of Mill Lane is within the Environment Agency (EA) Flood Zone 2. Refer to Appendix I for these plans.
