## Northwich Main Report Details

Project:	Storm Christoph Section 19 Main Report		
Area:	Northwich		
Date:	31/08/2022	Project No.:	5150735

# Northwich Main Report Details

This Northwich specific Main Report should be read in conjunction with the Section 19 Flood Investigation – Main Report (January 2021 Storm Christoph Flooding Event).

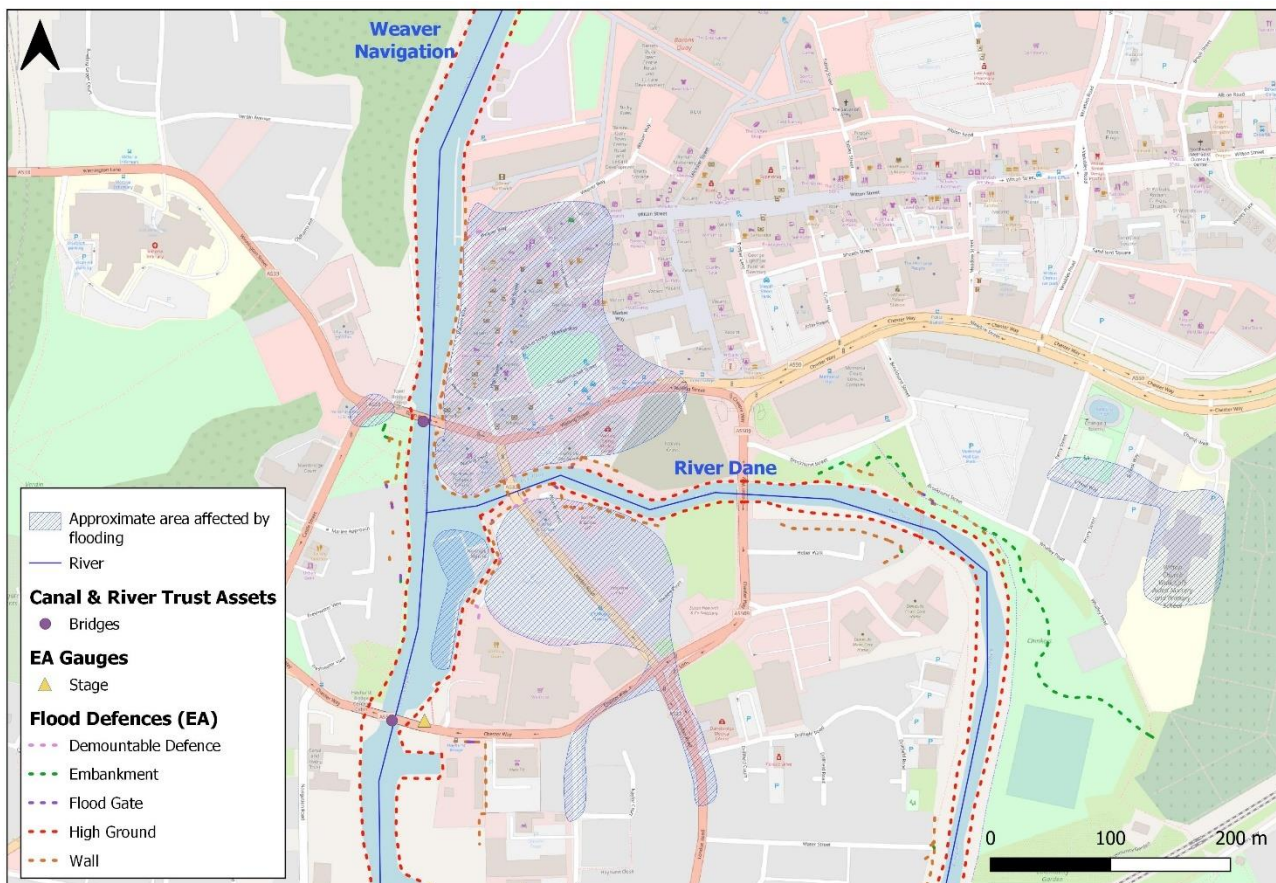
**Figure 9 - Flood Overview**

Figure 9 shows details the flooding, developed in consultation with CWaC, as LLFA, and affected property owners.

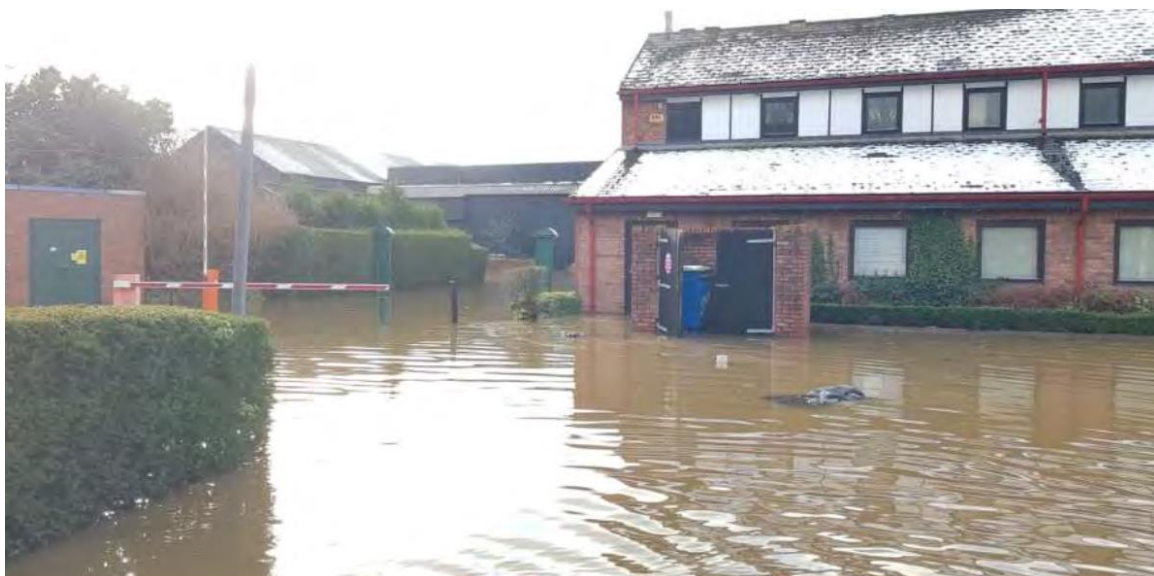
**Figure 10 - Theatre Court. 21/01/21**

Flooding Incident Information	<ul style="list-style-type: none"> <li>Water started collecting on London Road south of Dane Bridge at the entrance to Waitrose at 10:00 on 20/01/21</li> <li>Water was reported to come into Theatre Court properties from London Road and Theatre Court (reportedly to be around midday).</li> <li>Sewage was noted in the floodwater in Theatre Court. This was not reported to UU during the event and therefore, they did not attend and investigate.</li> <li>At the deepest level internal flooding in Theatre Court was 700-800mm</li> <li>London Road was flooded from Chester Way to Dane Bridge.</li> <li>Danebridge Medical centre and Queen Street also reported flooding</li> </ul>
Flooding Impacts and Observations	<ul style="list-style-type: none"> <li>London Road was closed as per the operational procedures for the deployment of defences. Water surcharging from drains occurred at a rate greater than the over-pumping contingency could cope with, and water levels rose on the landward side of the defences.</li> <li>Significant Property damage to Weaver Court, Theatre court</li> <li>Additional stress and mental anguish on the community over such an event happening again</li> </ul>

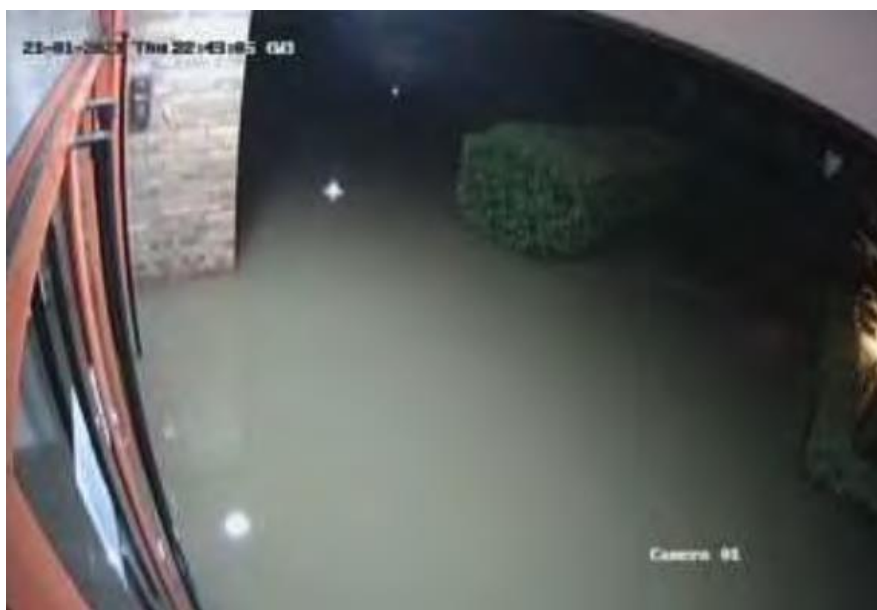
**Figure 11 - Theatre Court at peak flood level. 21/01/21 22:49**

<b>Time</b>	<b>London Road and Theatre Court</b>
21 <sup>st</sup> Jan 12:20	Water began to enter properties in Theatre Court.
21 <sup>st</sup> Jan 22:50	Flood levels reached their peak.

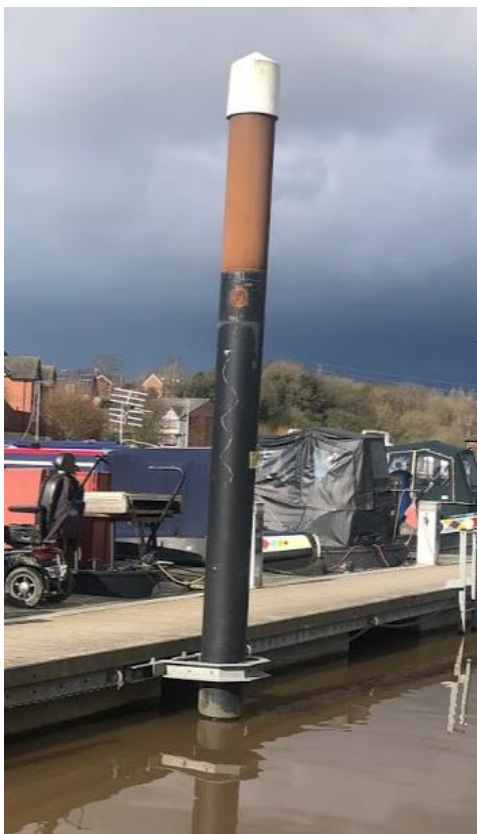
**Figure 12 - Northwich Quay Pile. February 2020**

Flooding Incident Information	<ul style="list-style-type: none"> <li>River levels were within centimetres metres of overtopping flood defences and the floating dock was reported to be at its highest level (up to the white mark on the pile, Figure 12)</li> <li>Flooding within the Bull Ring due to surface water and the surcharging of the drainage network. The outfalls were river locked.</li> <li>At 23:00 on 20/01/21 a minor leak was observed in the raised defences at the Bull Ring and a small pump deployed. At 01:40 the temporary pump was removed and call made for a CW&amp;C tractor unit pump support</li> <li>At 04:00 the tractor pump became active at Bull Ring</li> <li>UU's pumping station 'Bull Ring' was affected by Scottish Power cutting the power supply to the area for safety.</li> </ul>
Flooding Impacts and Observations	<ul style="list-style-type: none"> <li>Highway Flooding (Watling St, Dane St/Weaver Way) Roads were closed causing major disruption to traffic on this main access route.</li> <li>Significant Property damage</li> <li>Additional stress and mental anguish on the community over such an event happening again</li> </ul>

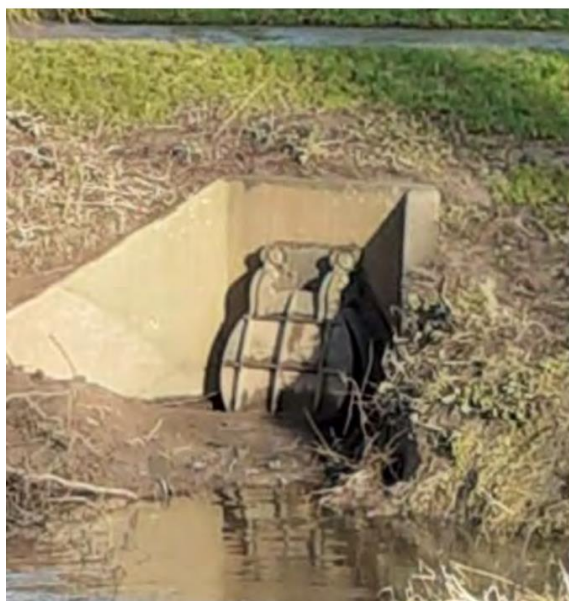
**Figure 13 - Whalley Road Flap Valve**

Figure 13 shows debris and silt build up at the Whalley Road Flap Valve. Figure 14 shows evidence of the flooding that occurred in the school area.

Owner	Action
EA / CWaC	Inspections have been carried out to assess all of the flap valves on outfalls in Northwich to ensure they are in the correct condition which will allow for them to be functional during a flood event. Owners of the flap valves are aware of their role in maintaining their outfall and the importance of their upkeep. This included an Ad-Hoc visual asset inspection of the flood defences in and around Northwich.
CWaC	Gully covers have been replaced on London Road. The original covers were impacting their ability to be cleaned and maintained.
CWaC	The gully network has been surveyed and a cleaning programme was carried out. This included sewers all around Northwich. One package of work, which included Witton Street, has been identified and is the process of being addressed.
Private	Theatre Court have installed property resilience measures to their properties and have completed a drainage survey of the properties and installed non return valves for their outfall to the river network.

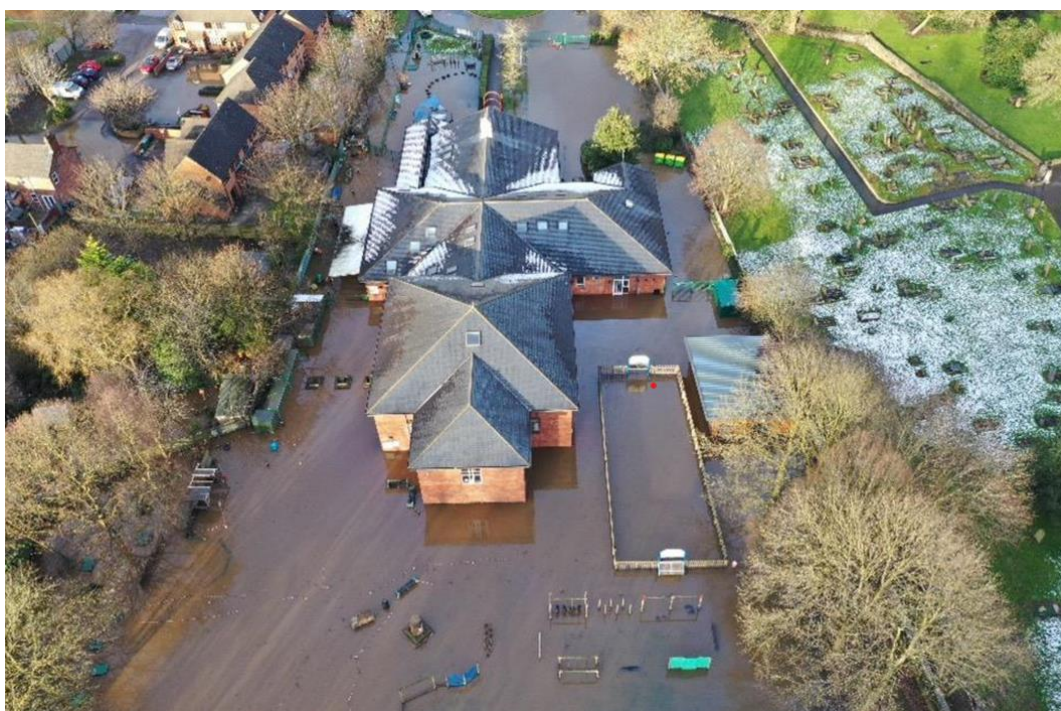
**Figure 14 - Witton School. 21/01/21**

Flooding Incident Information	<ul style="list-style-type: none"> <li>• Witton Church School was flooded via overland flow to a depth of 200-300mm.</li> <li>• Surface water appeared to be running towards the school building from the northwest on School Way, similarly overland flow was coming from the rear of the school in the South and surcharging through the drains (combined system). This was not reported to UU during the event and therefore they did not attend and investigate.</li> <li>• The school has not been internally flooded before, although the Nursery area is sometimes closed during heavy rain.</li> <li>• The School Way Estate, including School Way, Percy Street and Priory Street, was also affected with many front gardens and the car park flooded.</li> </ul>
Flooding Impacts and Observations	<ul style="list-style-type: none"> <li>• Property damage</li> <li>• 282 students and 40 staff had to be placed at other schools during flooding and aftermath until April</li> <li>• Additional stress and mental anguish on the community over such an event happening again</li> </ul>

The school and surrounding area flooded as a direct consequence of the drainage networks, including highways, surface and combined, being collectively surcharged causing overland flow, notably from School Way towards the school, to a depth of between 200-300mm.

The local surface water drainage system on site was surcharged. The location of some of these drainage assets are in such a position that surcharging of these drains contributed directly to water crossing the threshold into school buildings.
