Winsford Main Report Details

Project:	Storm Christoph Section 19 Main Report		
Area:	Winsford		
Date:	10/8/2022	Project No.:	5150735

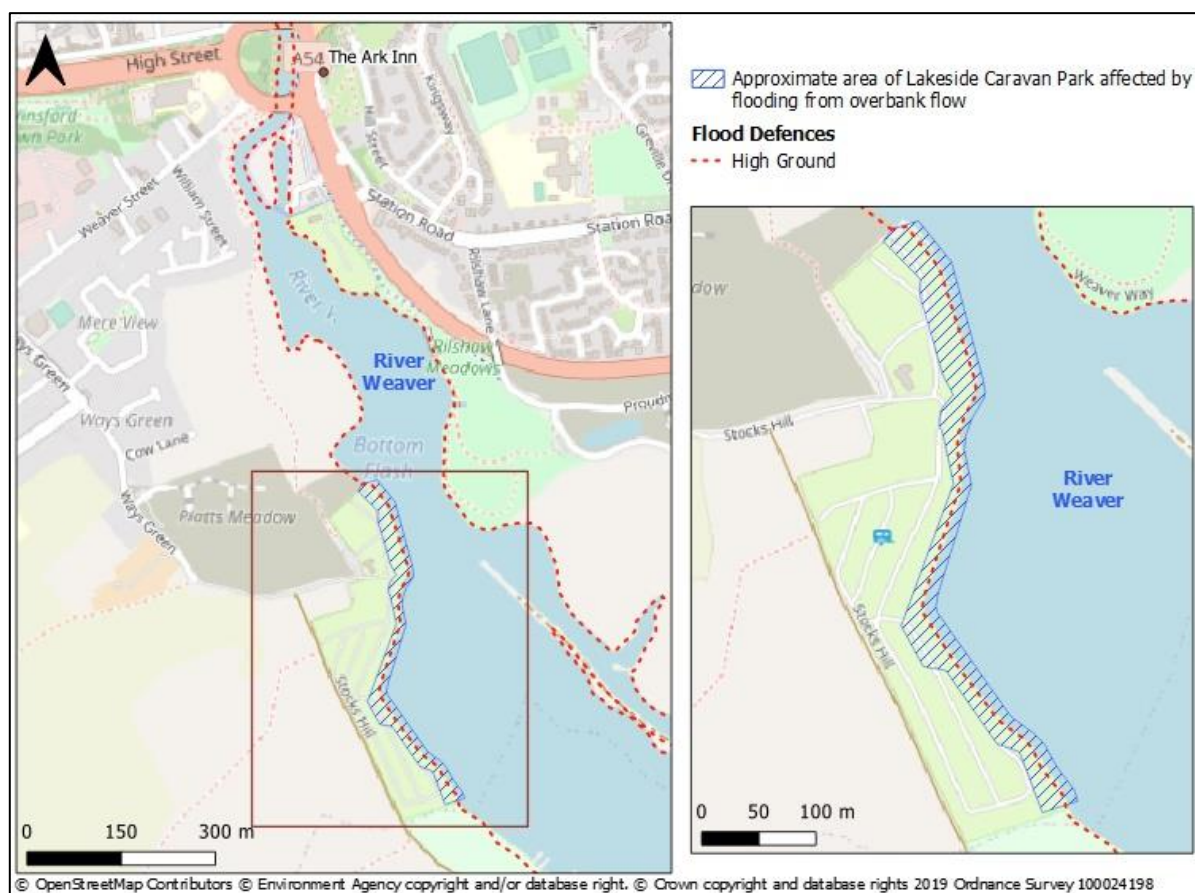
Figure 2 shows details of the flooding, developed in consultation with Cheshire West and Chester Council (CWaC), as Lead Local Flood Authority (LLFA), and affected property owners.

Figure 2 - Flood Overview

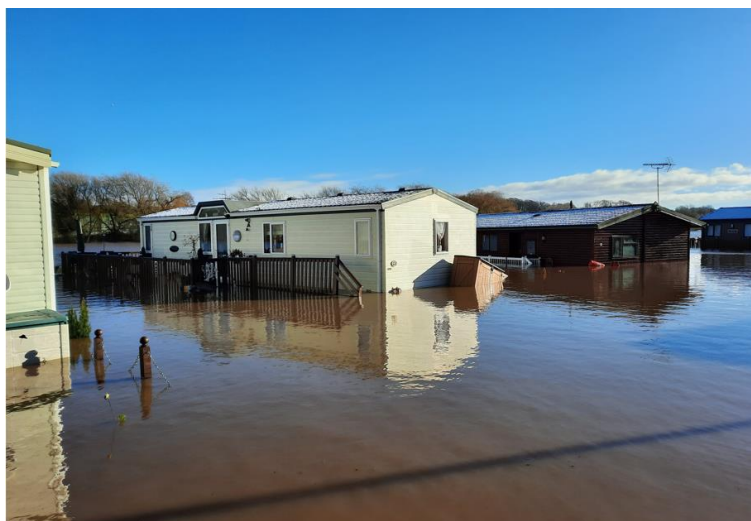
Water in the River Weaver and Bottom Flashes overtopped the banks and flowed through the caravan park causing significant damage. The water was reported to be 1.5m deep, causing damage to static caravans, lodges, electricity boxes and lighting. Figure 3 and Figure 4 provides photographic evidence of the flooding that occurred at Lakeside Caravan Park.

Figure 3 - Lakeside Caravan Park, 21/01/2021

The Environment Agency and CWaC have met with the owner of the Lakeside Caravan Park to explain that caravans affected were located within Flood Zone 3 and the most effective way of reducing this risk, and damage to property, would be to re-locate these to higher ground outside of this high risk area.

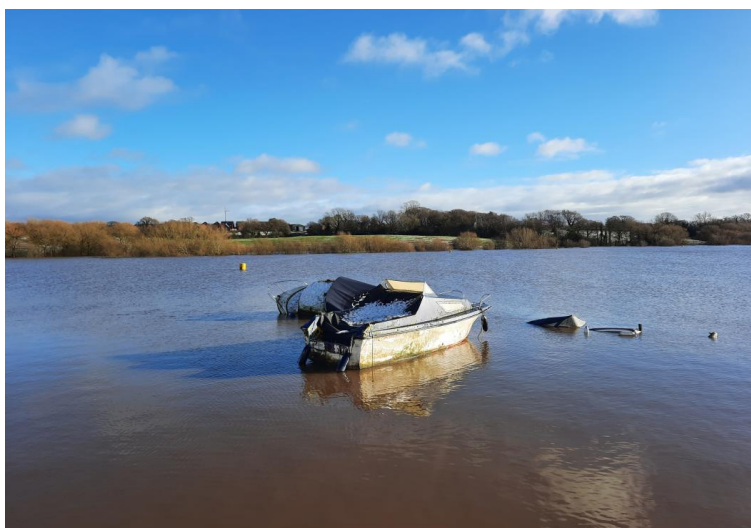
Figure 4 - Lakeside Caravan Park – Boats on the Flash, 21/01/2021
