Winsford Main Report Details

| Project: | Storm Christoph Section 19 Main Report | | |
| Area: | Winsford | | |
| Date: | 10/8/2022 | Project No.: | 5150735 |

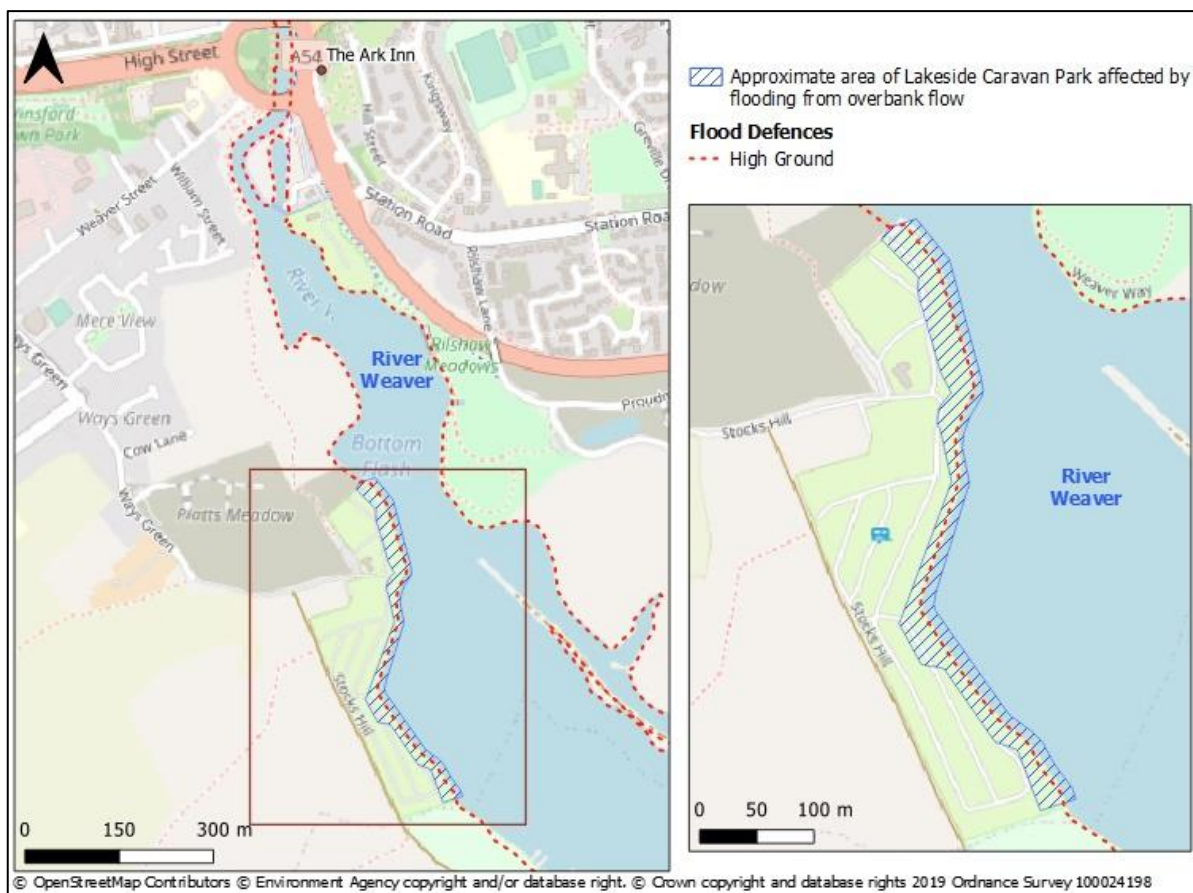
Figure 2 - Flood Overview

Figure 2 shows details of the flooding, developed in consultation with Cheshire West and Chester Council (CWaC), as Lead Local Flood Authority (LLFA), and affected property owners.

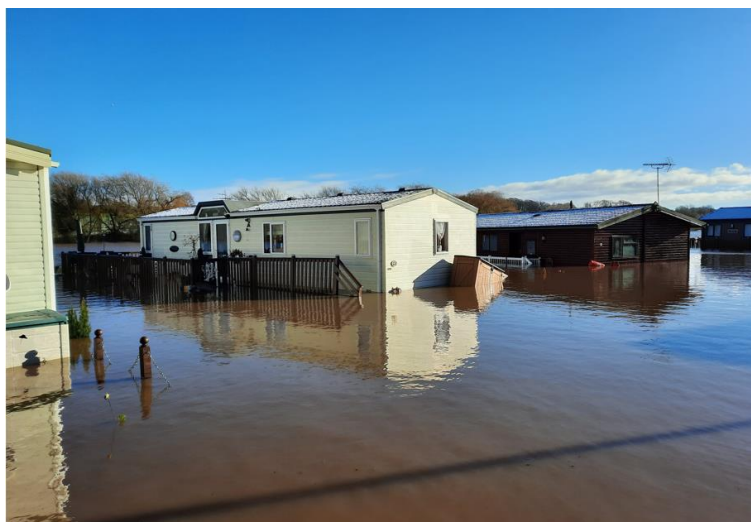
Figure 3 - Lakeside Caravan Park, 21/01/2021

Water in the River Weaver and Bottom Flashes overtopped the banks and flowed through the caravan park causing significant damage. The water was reported to be 1.5m deep, causing damage to static caravans, lodges, electricity boxes and lighting. Figure 3 and Figure 4 provides photographic evidence of the flooding that occurred at Lakeside Caravan Park.

- Flood water was up to 1.5m in depth in some of the caravans.
- Surface water runoff onto the site has increased since the new housing development above and to the side of the caravan park.
- The steep bank to the rear of pitches 21 to 25 and below nos. 8 to 12 slipped and work has been undertaken to stabilise this bank.
- The sandbank within the Flash continues to build up and the manager believes this has contributed to increased flood risk; they have made repeated requests for the flash to be dredged to reduce flood risk and improve navigation and recreation opportunities.

Flooding occurred at Lakeside Caravan Park due to water levels in the interconnected River Weaver and Bottom Flash rising and spilling out of bank. The controlling mechanism for the water levels in Bottom Flashes at the Lakeside Caravan Park is Vale Royal Lock and Sluices on the Weaver approximately 6km downstream. The caravans which flooded are located at the edge of the Flash, at the lowest ground levels. These are inside the Environment Agency Flood Zone 3.

Flooding of the caravans occurred because of high-water levels in the River Weaver and adjacent Bottom Flashes. The water levels at this location are controlled by the downstream Vale Royal Lock and Sluices which were fully open during the peak of the event.

The Environment Agency and CWaC have met with the owner of the Lakeside Caravan Park to explain that caravans affected were located within Flood Zone 3 and the most effective way of reducing this risk, and damage to property, would be to re-locate these to higher ground outside of this high risk area.
