Northwich

Section 19 Flood Investigation Report (October 2019 Flooding Event)

March 2021

5150735-DG-002

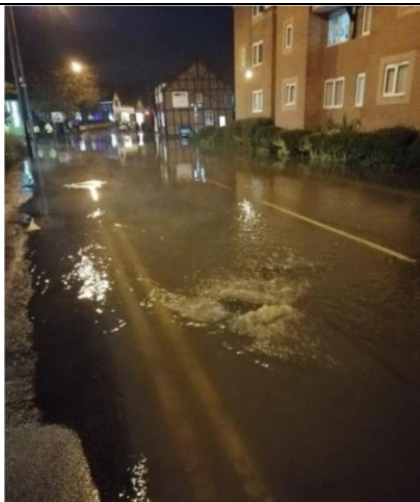
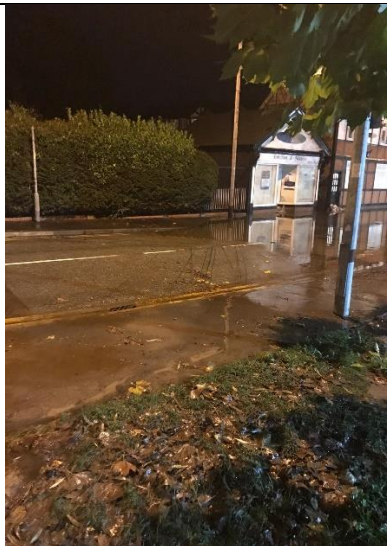
<p>20:15 26/10/2019 London Road Source: EA</p>

<p>20:02 27/10/2019 London Road Source: EA</p>

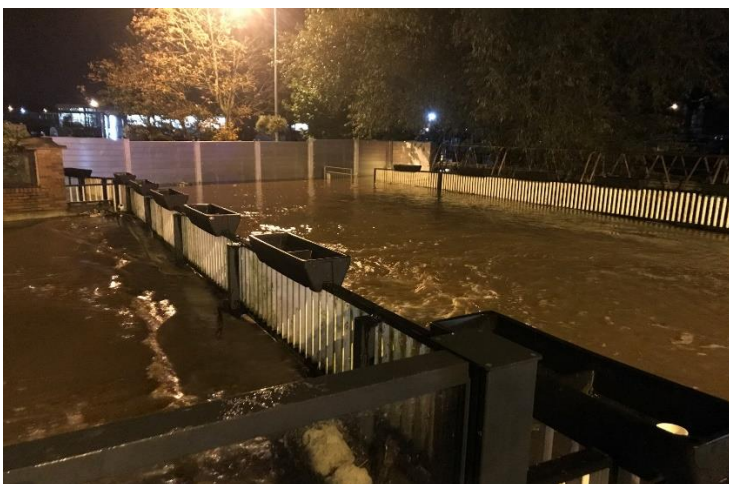
<p>01:53 27/10/2019 Dane Bridge Source: EA</p>

A leak through the EA defences was observed alongside the pipe crossing at Dane Bridge. This would have contributed to water behind the defences; the EA deployed mobile pumps during the event to over pump this water back to the river.

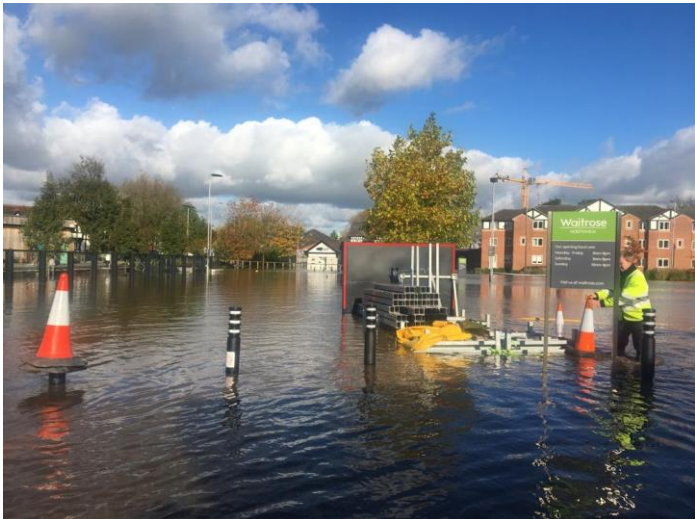
<p>12:53 27/10/2019 Waitrose Source: EA</p>

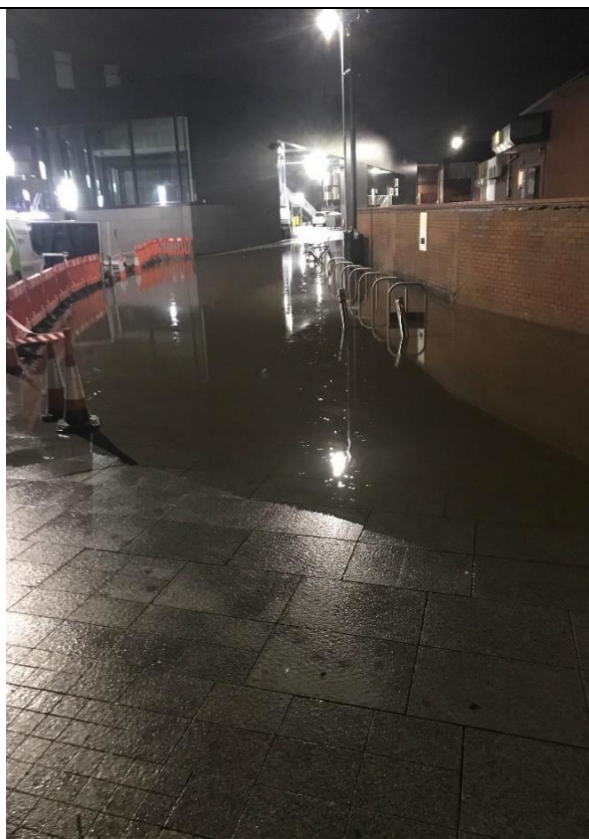
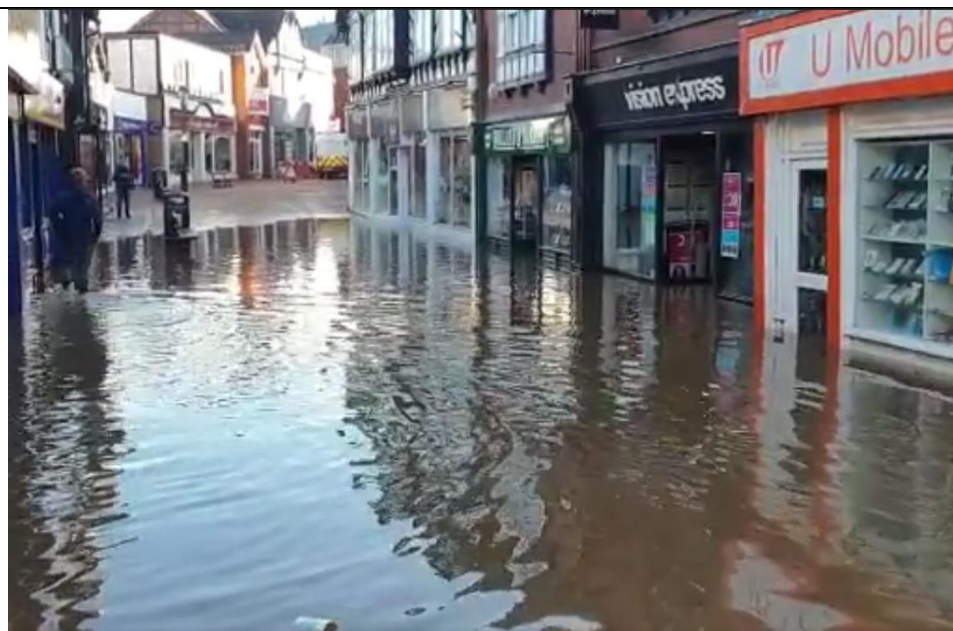
Figure 7-5 - Photograph evidence of flooding at Weaver Way/ High St

Significant fat deposits were present within the drain leading directly eastwards through the narrow alley way to High Street and, although not a complete blockage of the drain, it would have restricted flow and contributed to backing up within the system on High Street. Similarly, localised defects and silt debris would have also contributed to restriction of flow. This would likely have led to surface water flooding alongside the defences on Weaver Way, as this has the lowest ground levels, and likely to have contributed to surface water flooding at the low spots on High Street.
