**CONTAMINATED LAND  
PUBLIC REGISTER**

# Contaminated Land to be Designated a Special Site

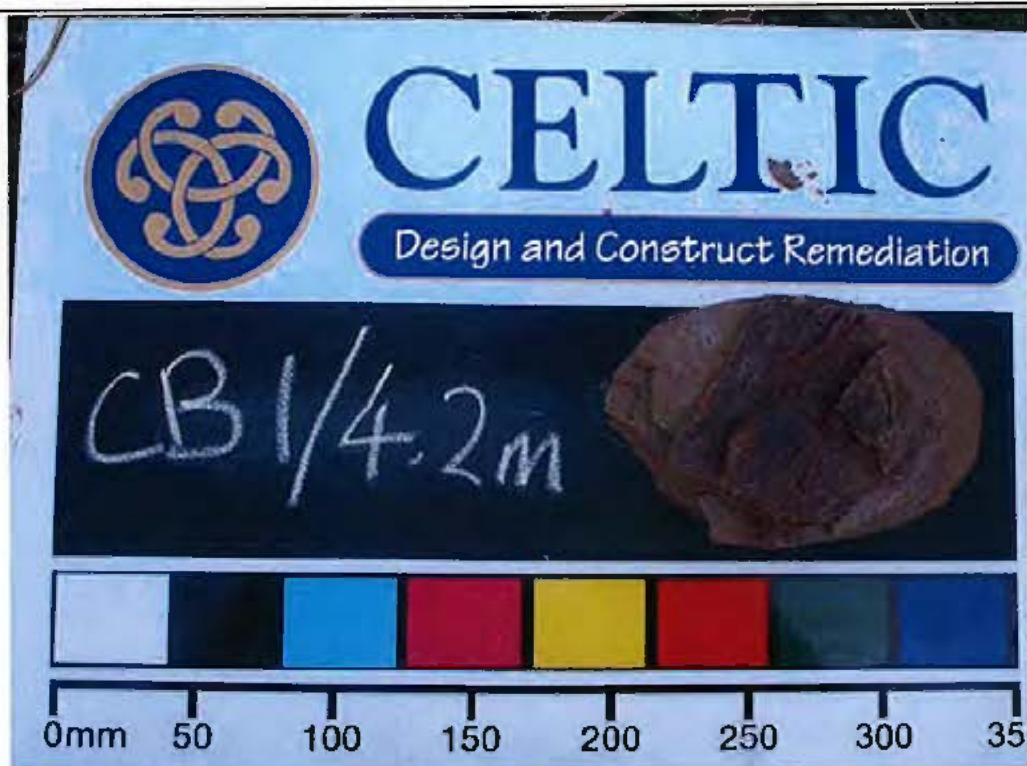
Plate No.: 11

Title: CB1 Core Piece Showing Some Black Staining with Slight Hydrocarbon Odour

The site investigation works have identified oil and organic solvents in the unsaturated and saturated zones. Black staining with an oily sheen and a hydrocarbon odour was observed in the sandstone recovered during the boreholes installation works. Chemical analysis of the Light Non Aqueous Phase Liquid (LNAPL) recovered in December 2006 shows that the LNAPL was predominately in the medium to heavier fractions of the Total Petroleum Hydrocarbons (TPH). The heavier TPH groups make up the bulk of the LNAPL with up to 51.31% of the LNAPL being aliphatic C<sub>10</sub>-C<sub>35</sub> and aromatic C<sub>12</sub>-C<sub>35</sub>, whilst 48.57% of the LNAPL contained greater than 35 carbons. A number of volatile organic compounds (VOCs) were also detected, which included various breakdown compounds of chlorinated solvent such as vinyl chloride and cis-1,2 dichloroethene.

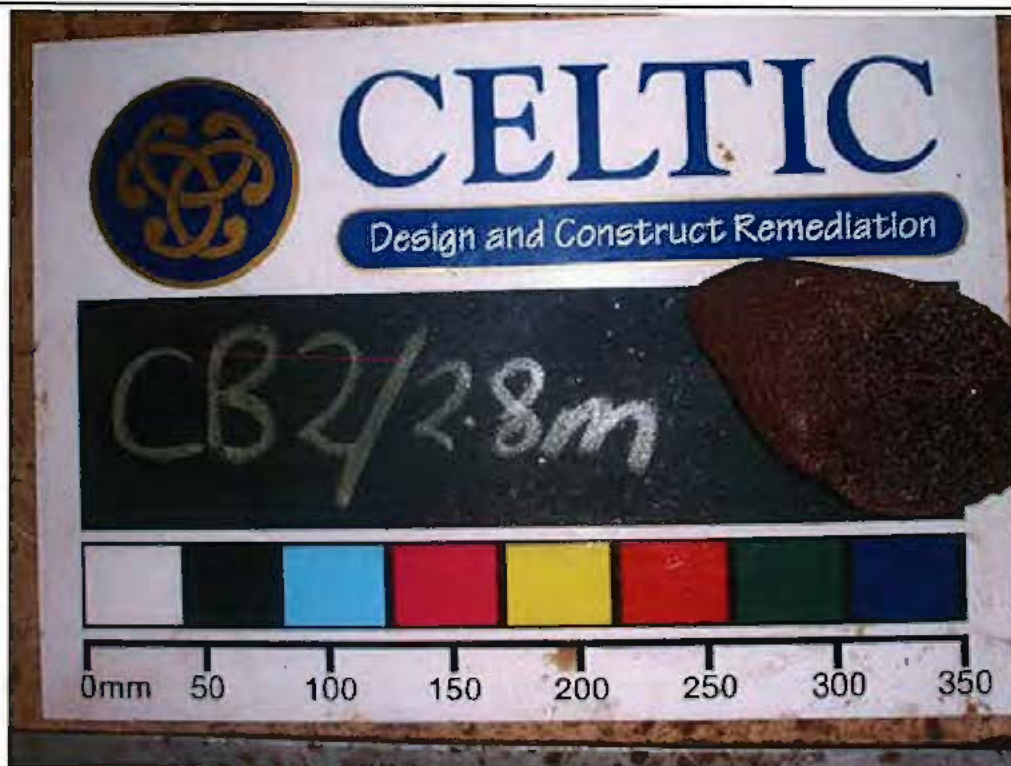
Plate No.: 13

Title: CB2 Core Sample Showing Some Black Staining with Slight Hydrocarbon Odour

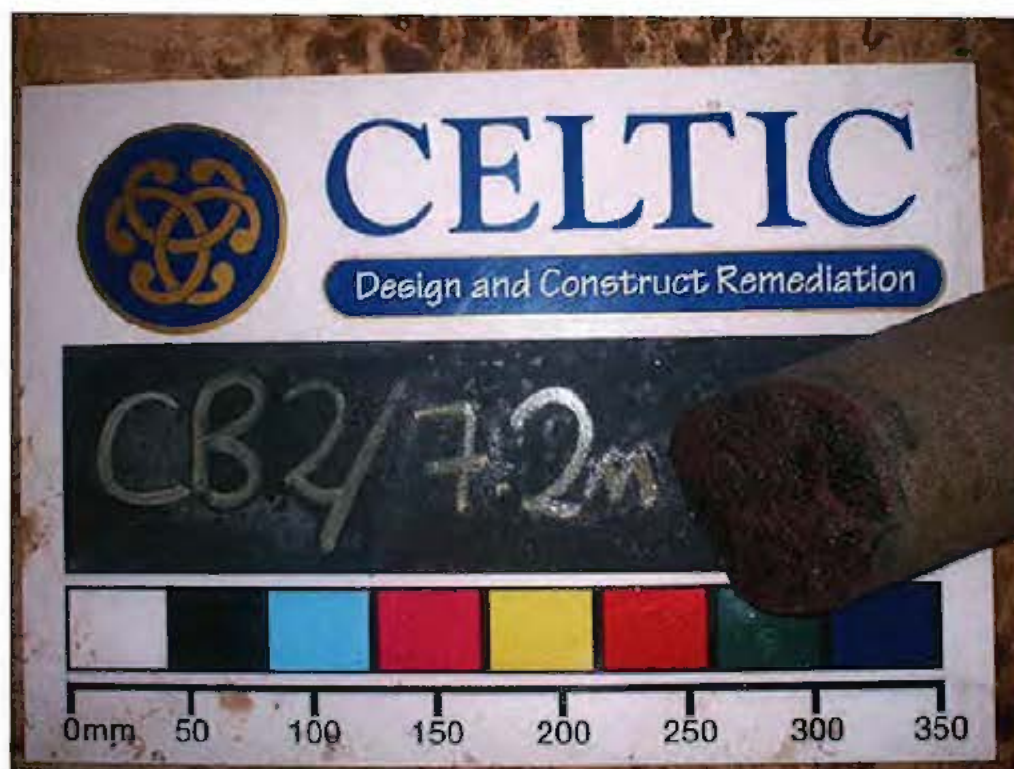
Plate No.: 14

Title: Title: CB2 Core Sample Showing Some Black Staining with Slight Hydrocarbon Odour

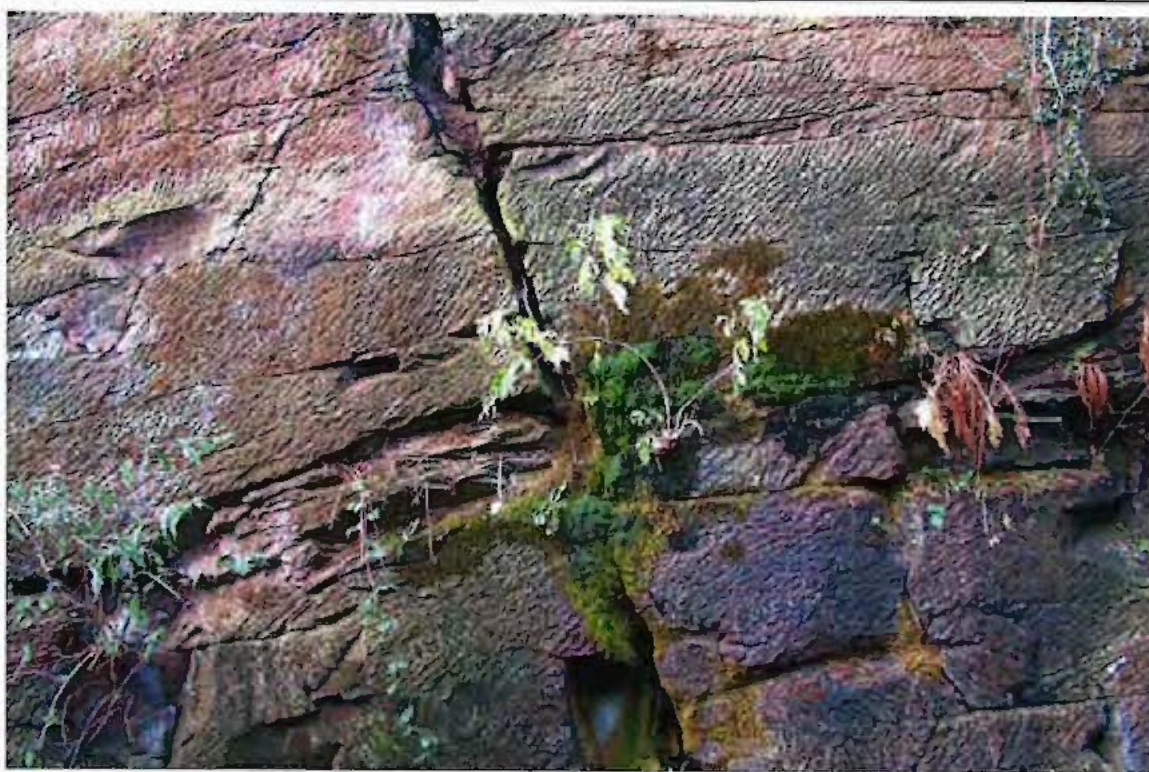
Plate No.: 22

Title: Type 1 Fracture – Crush Zone with no Clear Vertical Offset

- viii) **Understanding of Fracture Network** – Three main types of fracture were seen in outcrops approximately 1 km from the site. Type 1 is the twin fractures bounding a zone of fragmented sandstone typically 50mm to 100mm wide. Type 2: is a single steeply dipping fracture in a variety of orientations, mostly developed in response to geological compressive, strike-slip and extensional stresses. Type 3 is fractures that are approximately parallel to the land surface. These 3 types of fractures at outcrop are interpreted to be equivalent to the features seen in the deviated cores.

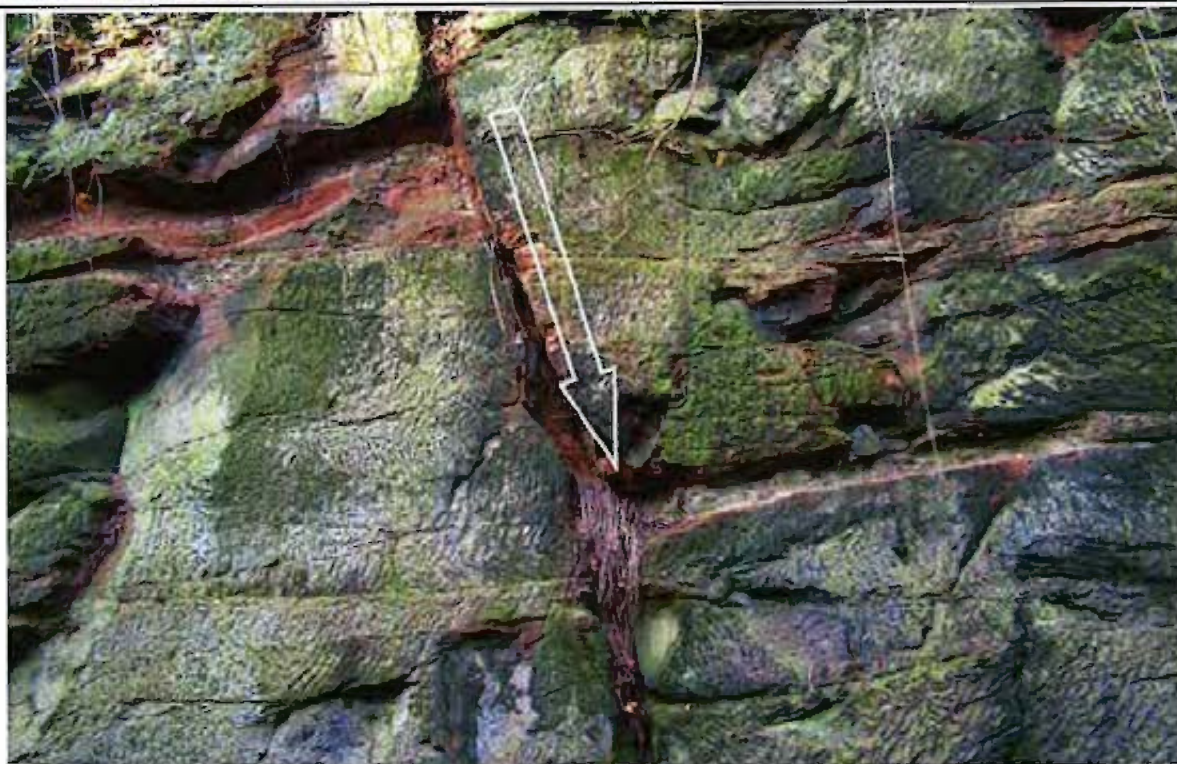
Plate No.: 23

Title: Normal Fault with about 1.5 m of Displacement

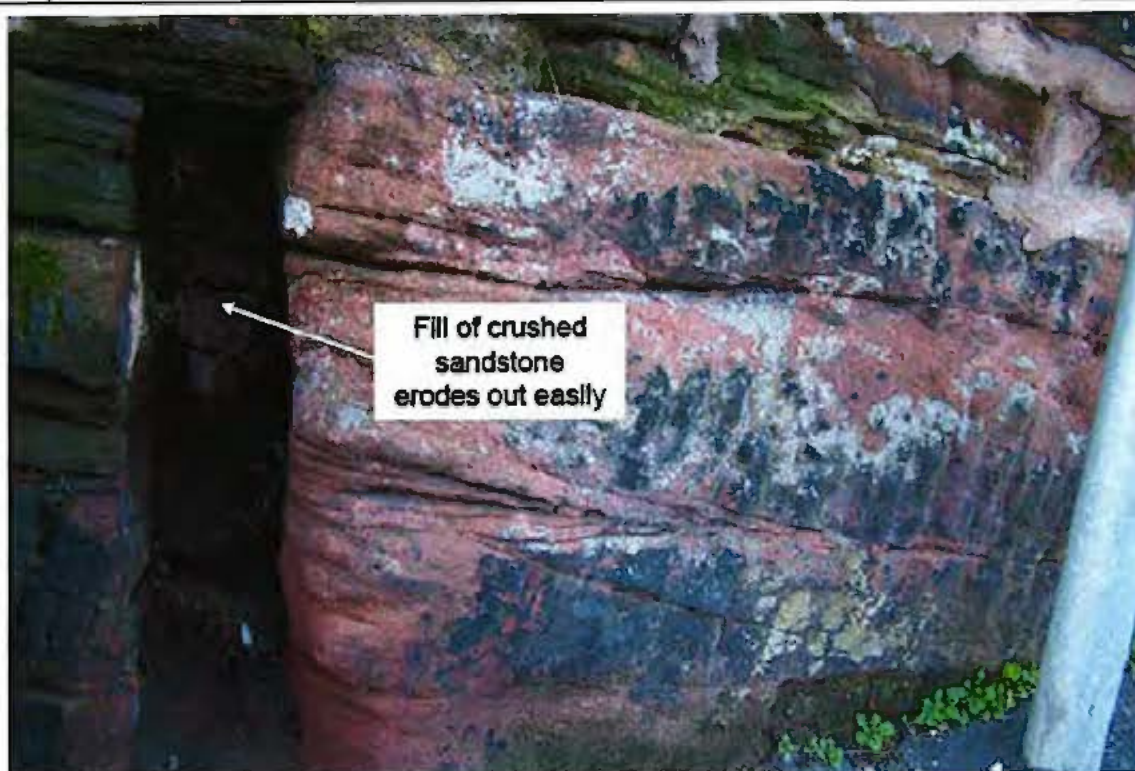
Plate No.: 24

Title: Type 1 Fracture Observed at Junction of Park Street and Ruby Road

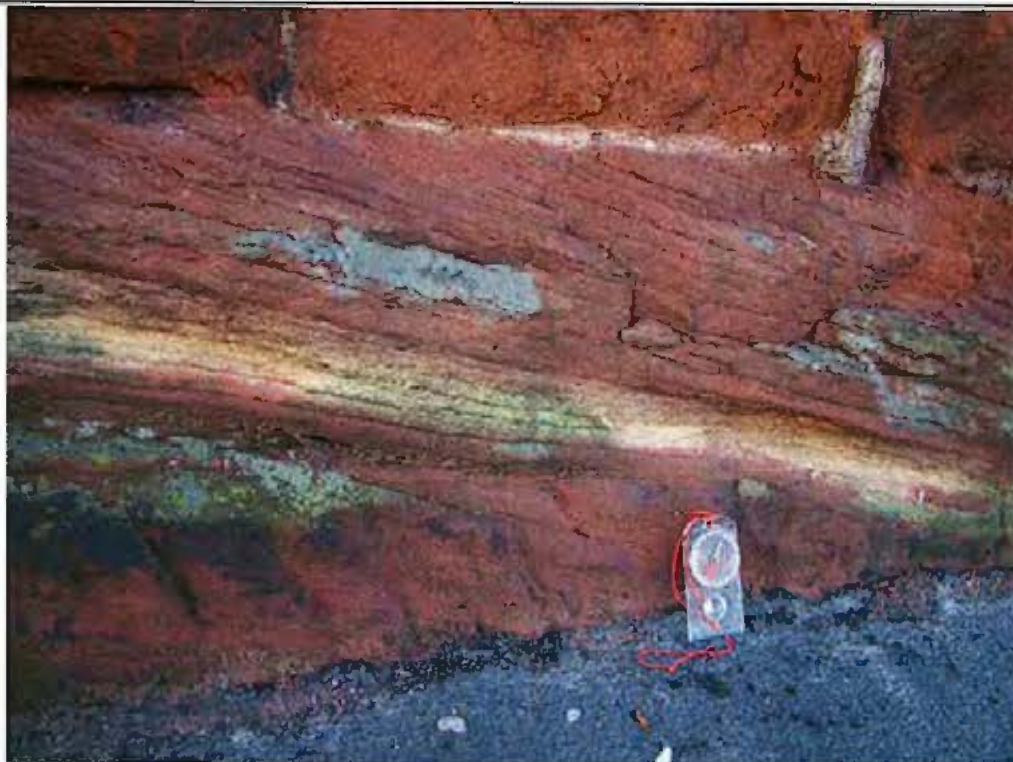
Plate No.: 25

Title: Pale (Reduced) Laminae in Cross Bed Laminae Observed at Junction of Park Street and Ruby Street

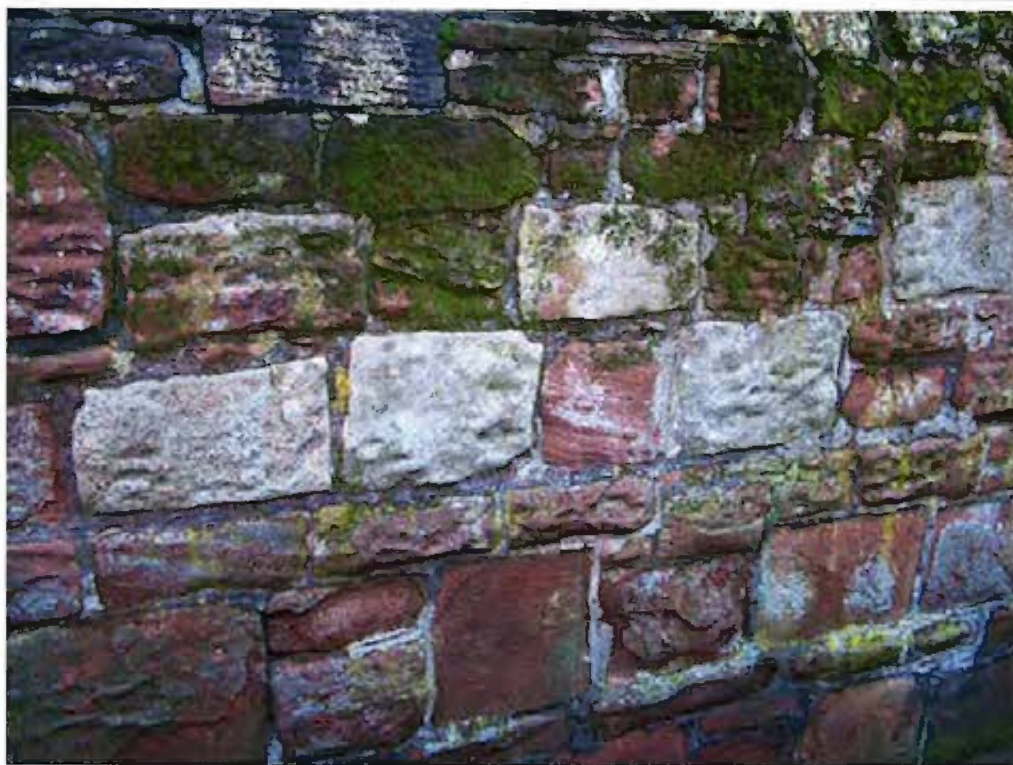
Plate No.: 26

Title: Pale (Reduced) Sandstone Blocks in Old Boundary Wall, North Side of Poplar Weint

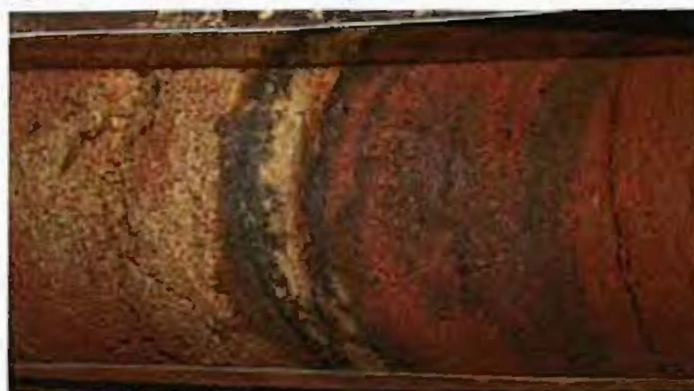
Plate No.: 27

Dark NAPL stain

UV fluorescence  
and strong  
hydrocarbon odours  
suggest that NAPL  
is also present in  
much of the  
unstained sandstone

Title: CB3 Core Piece Showing Dark NAPL Stain Along Sedimentary Lamination

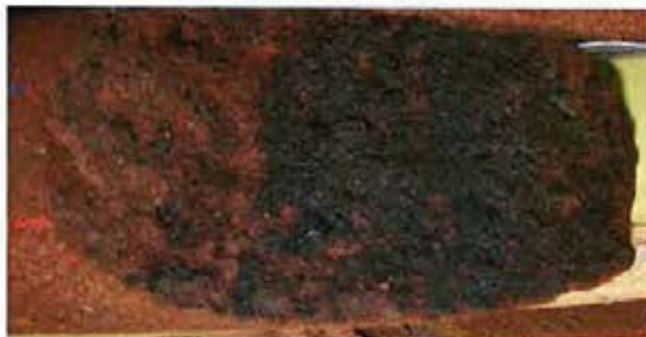
Plate No.: 33

Title: CB4 Core Piece Showing NAPL on a Combined Fracture and Bedding Plane Surface

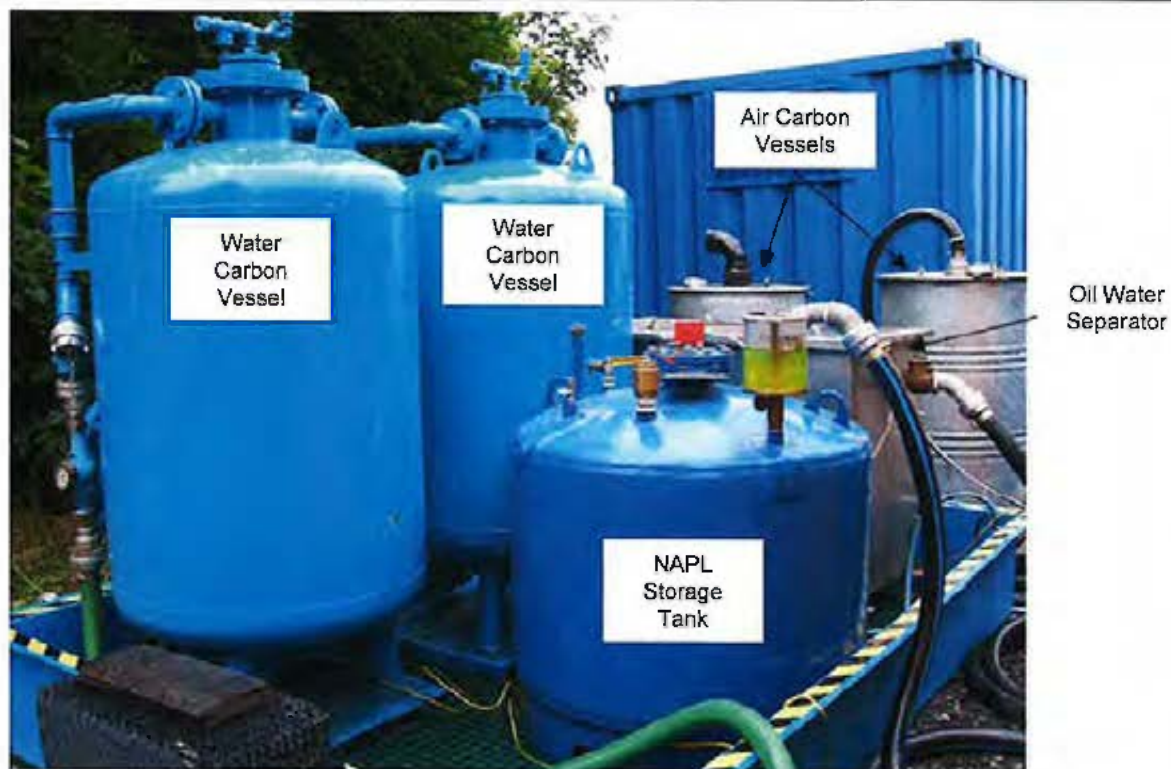
Plate No.: 44

Title: Water treatment system in bunded area

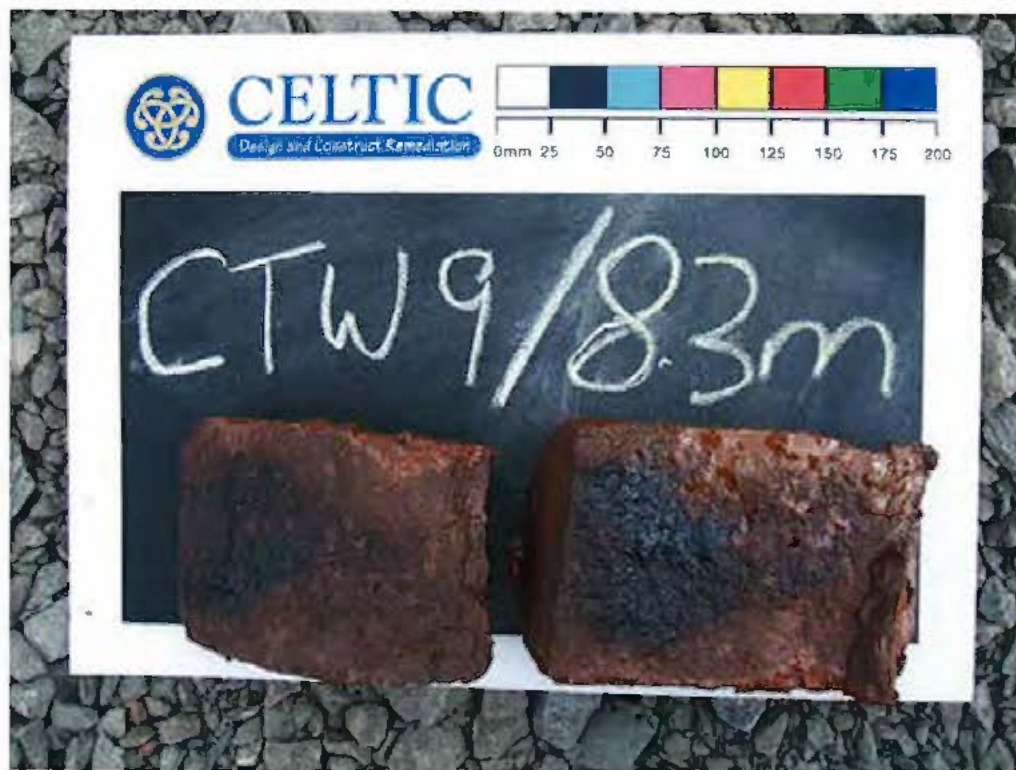
Plate No.: 48

Title: Core Sample Recovered from Treatment Well CTW9 Showing Heavy Black  
Staining with Free NAPL

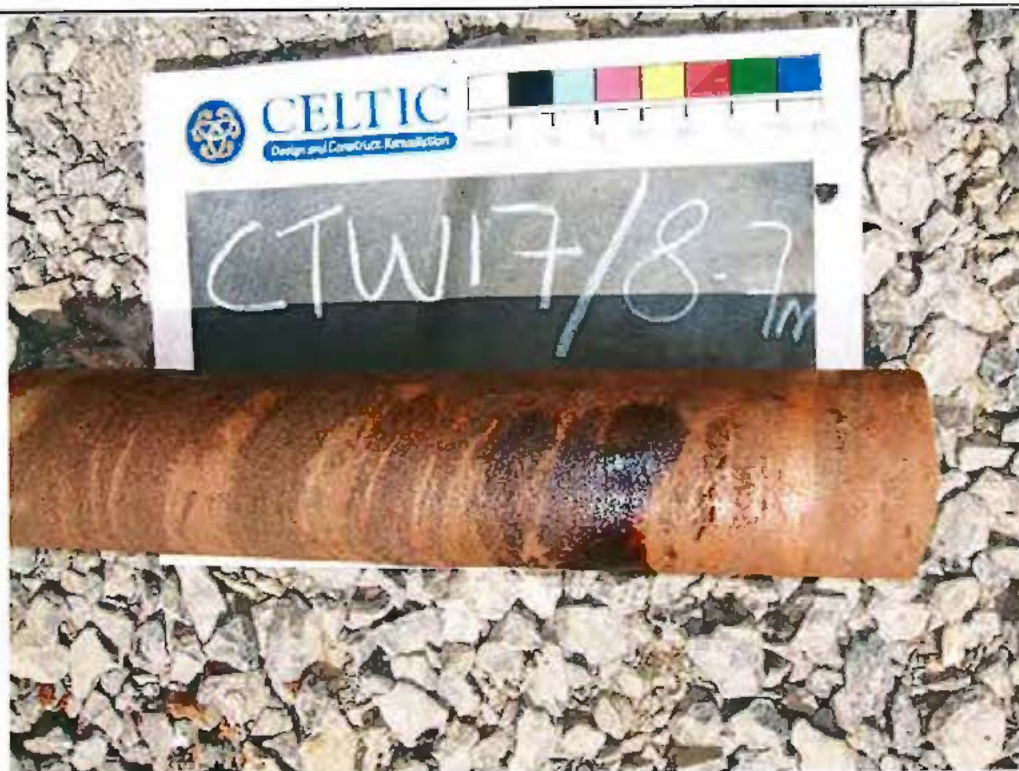
Plate No.: 49

Title: Core Sample Recovered from Treatment Well CTW17 Shows Heavy NAPL Staining

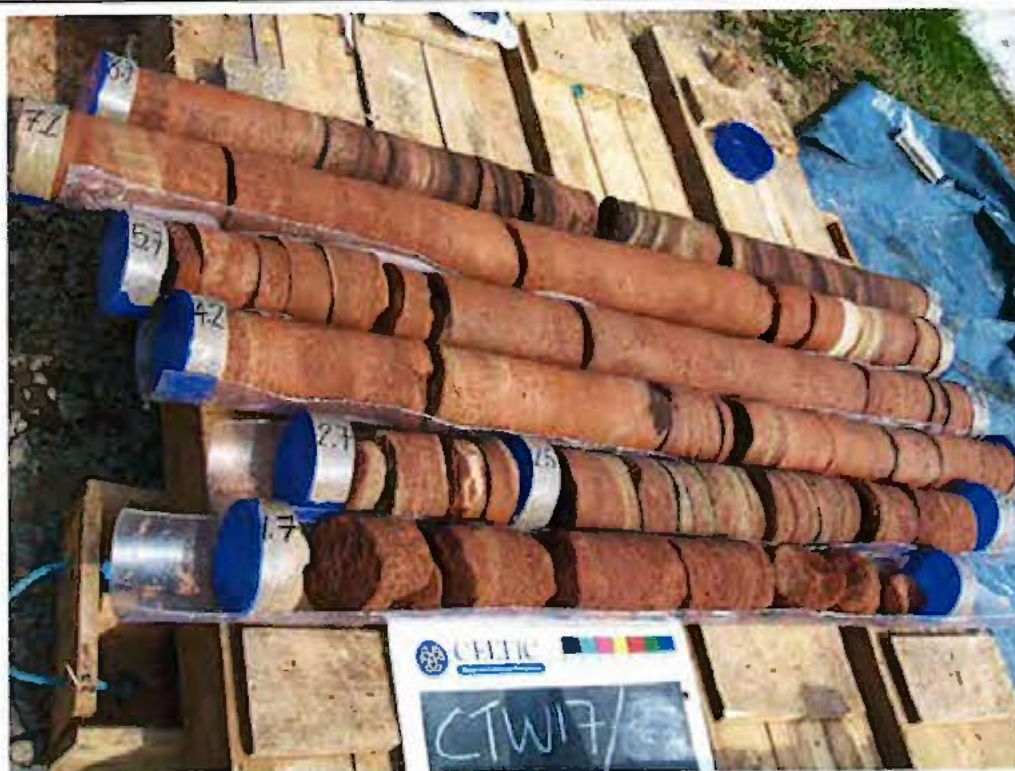
Plate No.: 50

Title: Core Samples Recovered from Treatment Well CTW17

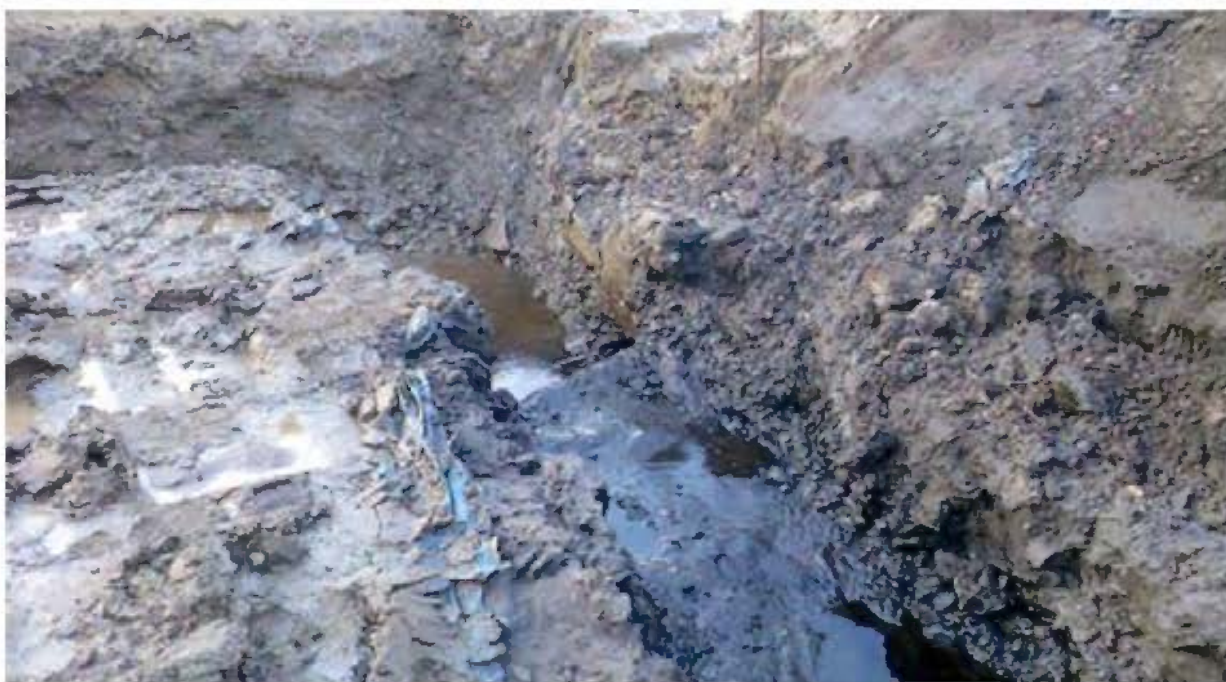
Photograph 5: Hydrocarbon impacted soils and water within foundation excavation.

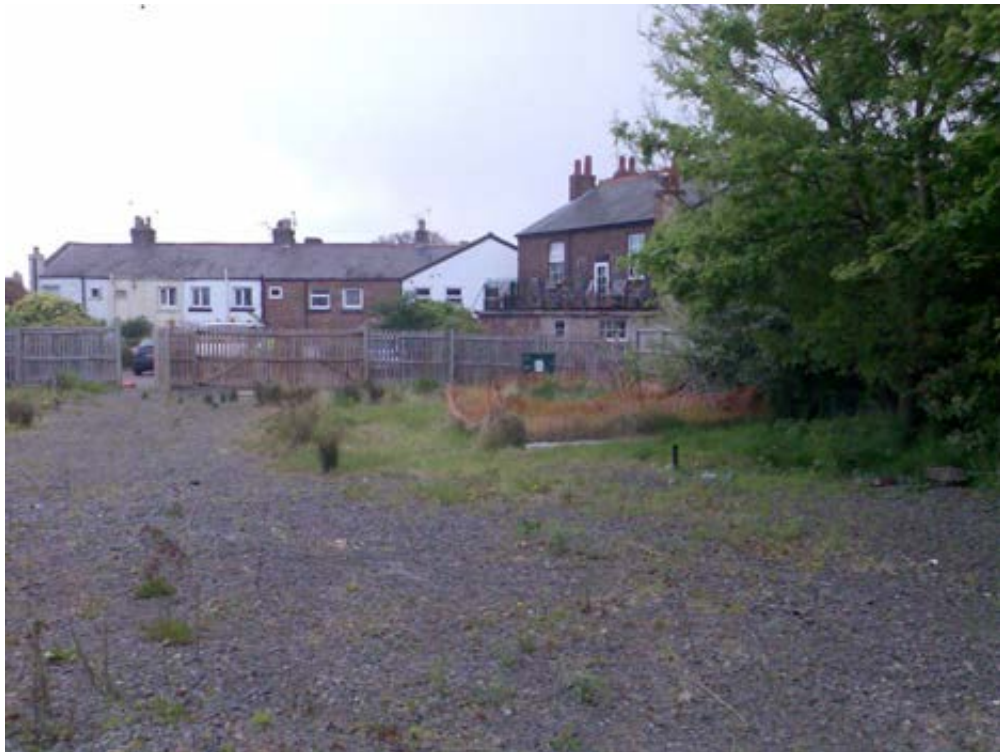
Fig 1: Fenced off area of knotweed

**Area 1** The area of knotweed was originally located on the southern boundary of the site to the rear of properties on Cross St. The infestation originally covered a visible area of approx 2m X 2m though it didn't appear to be particularly well established. Ground conditions on the site show bedrock close to the surface which may explain the lack of growth. At the time of this inspection the knotweed had already been excavated and removed to licensed landfill facility by the client (see attached waste transfer tickets and validation letter from Watkin Jones Homes dated 1<sup>st</sup> April 2011)
