Antrobus Main Report Details

Project:	Storm Christoph Section 19 Main Report		
Area:	Antrobus		
Date:	10/08/2022	Project No.:	5150735

This Antrobus specific Main Report should be read in conjunction with the Section 19 Flood Investigation – Main Report (January 2021 Storm Christoph Flooding Event).

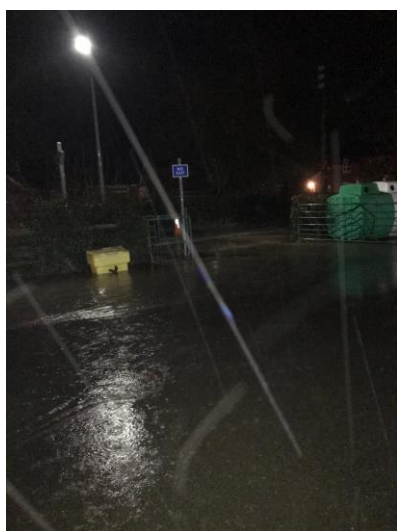
Figure 2 - Knutsford Road. 19:58 20/01/2021

During Storm Christoph, surface water collected in the village hall field, then flowed through the carpark onto Knutsford Road and into the property opposite. Gardens of properties on Knutsford Road and the Old Orchard were affected, as was the village school.
