Hooton Main Report Details

Project:	Storm Christoph Section 19 Main Report		
Area:	Hooton		
Date:	10/08/2022	Project No.:	5150735

This Hooton specific Main Report should be read in conjunction with the Section 19 Flood Investigation – Main Report (January 2021 Storm Christoph Flooding Event).

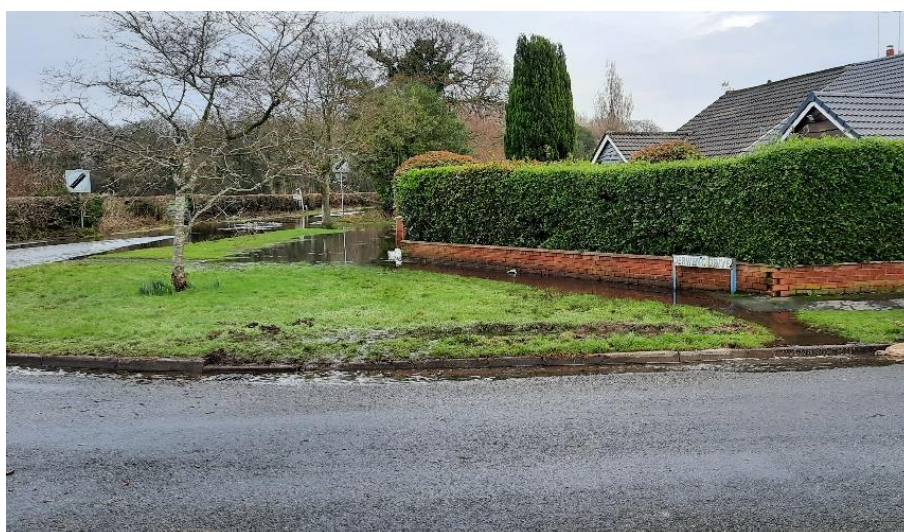
Photographs that illustrate the extents of the flood event in the various areas can be seen in Figure 2 and Figure 3.

Figure 2 – Derwent Drive and Hooton Green Junction. 20/01/2021

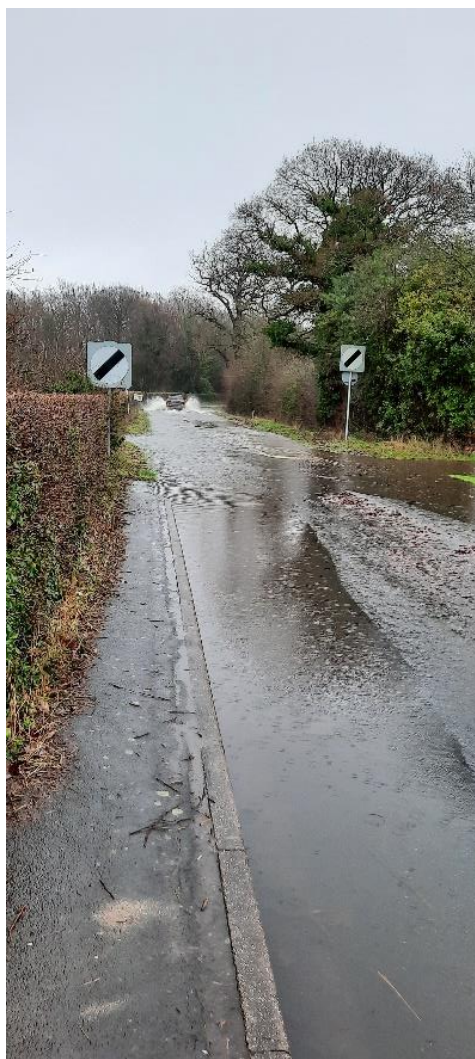
Figure 3 - Hooton Green (point where watercourse is culverted). 20/01/2021

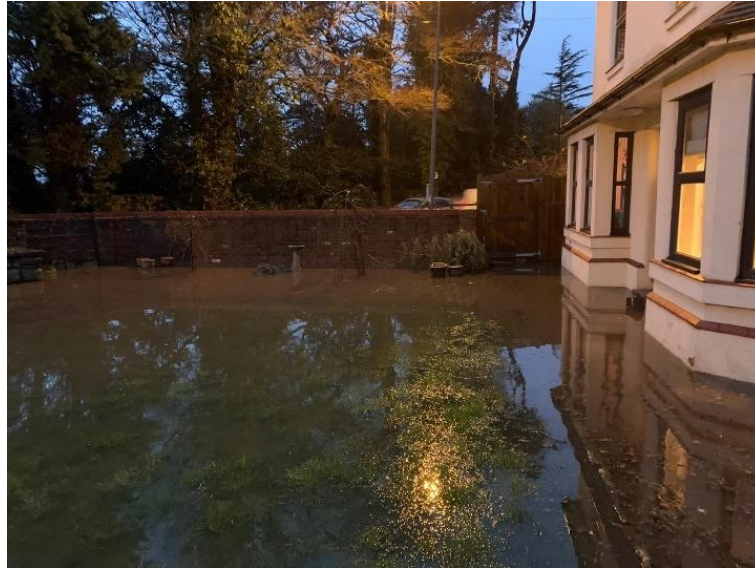
Photographs that illustrate the extents of the flood event in the various areas can be seen in Figures 5 and 6.

Figure 5 - Blackboards Lane. 20/01/2021

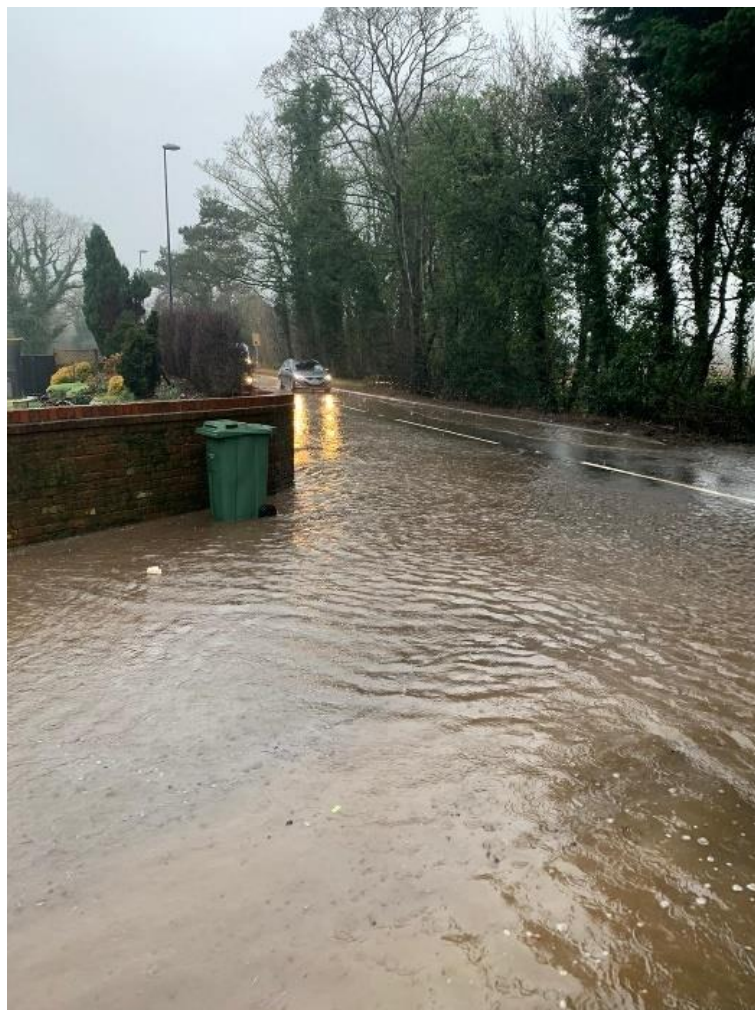
Figure 6 - Welsh Road and Blackboards Lane Junction. 20/01/2021

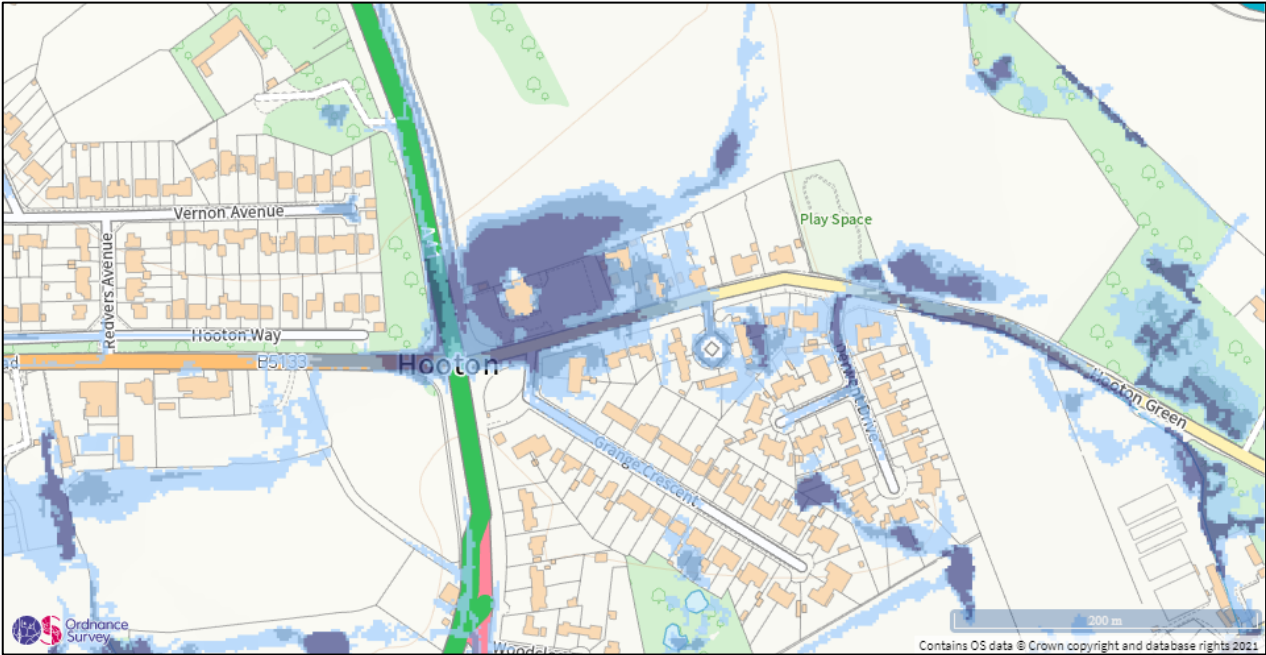
Extent of flooding from surface water
