Kelsall Main Report Details

Project:	Storm Christoph Section 19 Main Report		
Area:	Kelsall		
Date:	10/08/22	Project No.:	5150735

This Kelsall specific Main Report should be read in conjunction with the Section 19 Flood Investigation – Interim Report (January 2021 Storm Christoph Flooding Event).

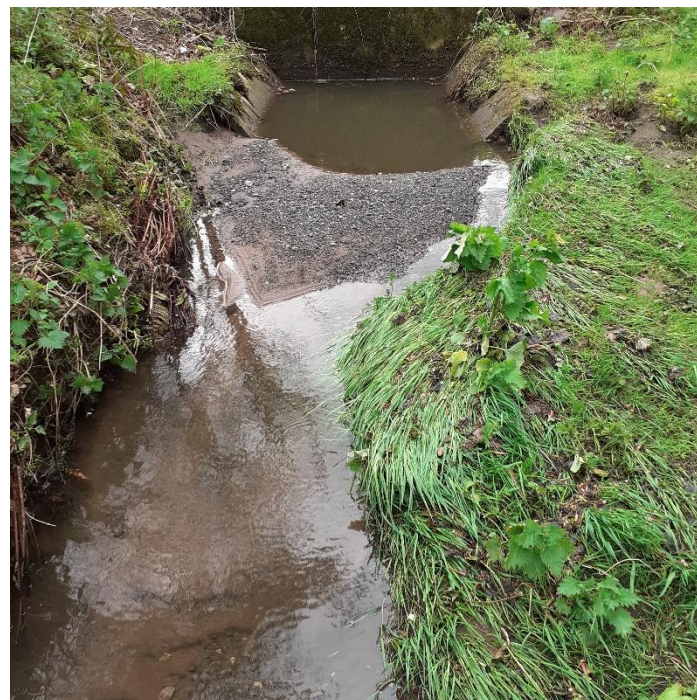
Figure 2 – Partially Blocked Outlet Drain

There are reported issues of water backing up from the culvert beneath the A54 which local residents believe to be as a result of siltation, debris and vegetation at the outlet which is located on private land. However, this is yet to be confirmed by investigation. The culvert beneath the A54 is approximately 100m downstream and below the ground level of Homewood, therefore it is highly unlikely that flooding of the property was a result of water backing up from this culvert.

Figure 2 below shows the extent of the blocked outfall and the build up of silts and gravels reportedly restricting flow. Whilst there is a build-up of material the image does suggest flow occurred around the left hand side of this material.

- The Forestry Commission has confirmed that they will be carrying out ditch clearance works. CWaC will undertake a cleanse of the catchpits upstream of the outfall structure to minimise debris in the highway system being deposited in the open channel.
- Investigations continue to determine if the ditch outfall on the west boundary of Homewood can be diverted into the highway system to avoid the private system.

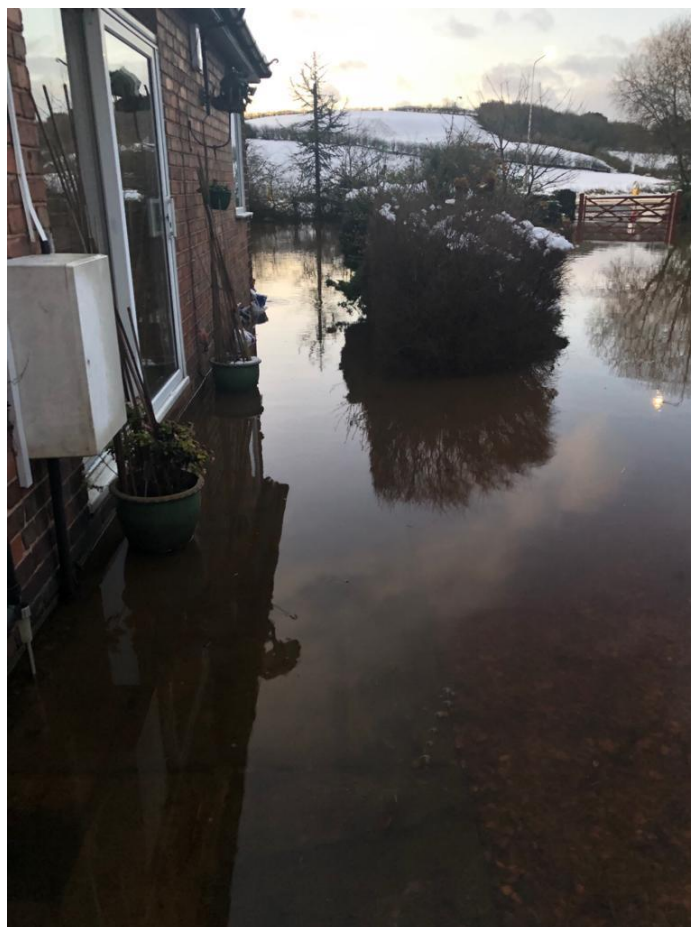
Figure 3 – Flooded Property on the A54

During the Storm Christoph event, flooding in Kelsall was reported at the Morrey’s Lane/ A54 junction, causing internal flooding to one property. There were no further reports of flooding in the village.

Figure 3 below shows the extent of the flooding at the property. The garden of Homewood drains into the adjacent highway drainage through a single 150mm pipe.
