Mickle Trafford Main Report Details

Project:	Storm Christoph Section 19 Main Report		
Area:	Mickle Trafford		
Date:	10/08/22	Project No.:	5150735

Mickle Trafford

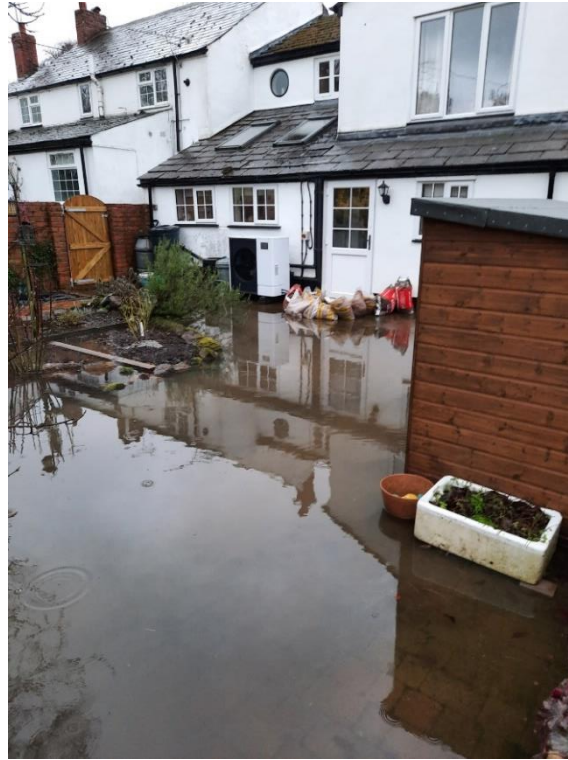
Figure 2 - Warrington Road. Afternoon 20/01/2021

Photographs that illustrate the extents of the flood event in Mickle Trafford can be seen in Figure 2 and Figure 3.
