Northwich Main Report Details

Project:	Storm Christoph Section 19 Main Report		
Area:	Northwich		
Date:	31/08/2022	Project No.:	5150735

This Northwich specific Main Report should be read in conjunction with the Section 19 Flood Investigation – Main Report (January 2021 Storm Christoph Flooding Event).

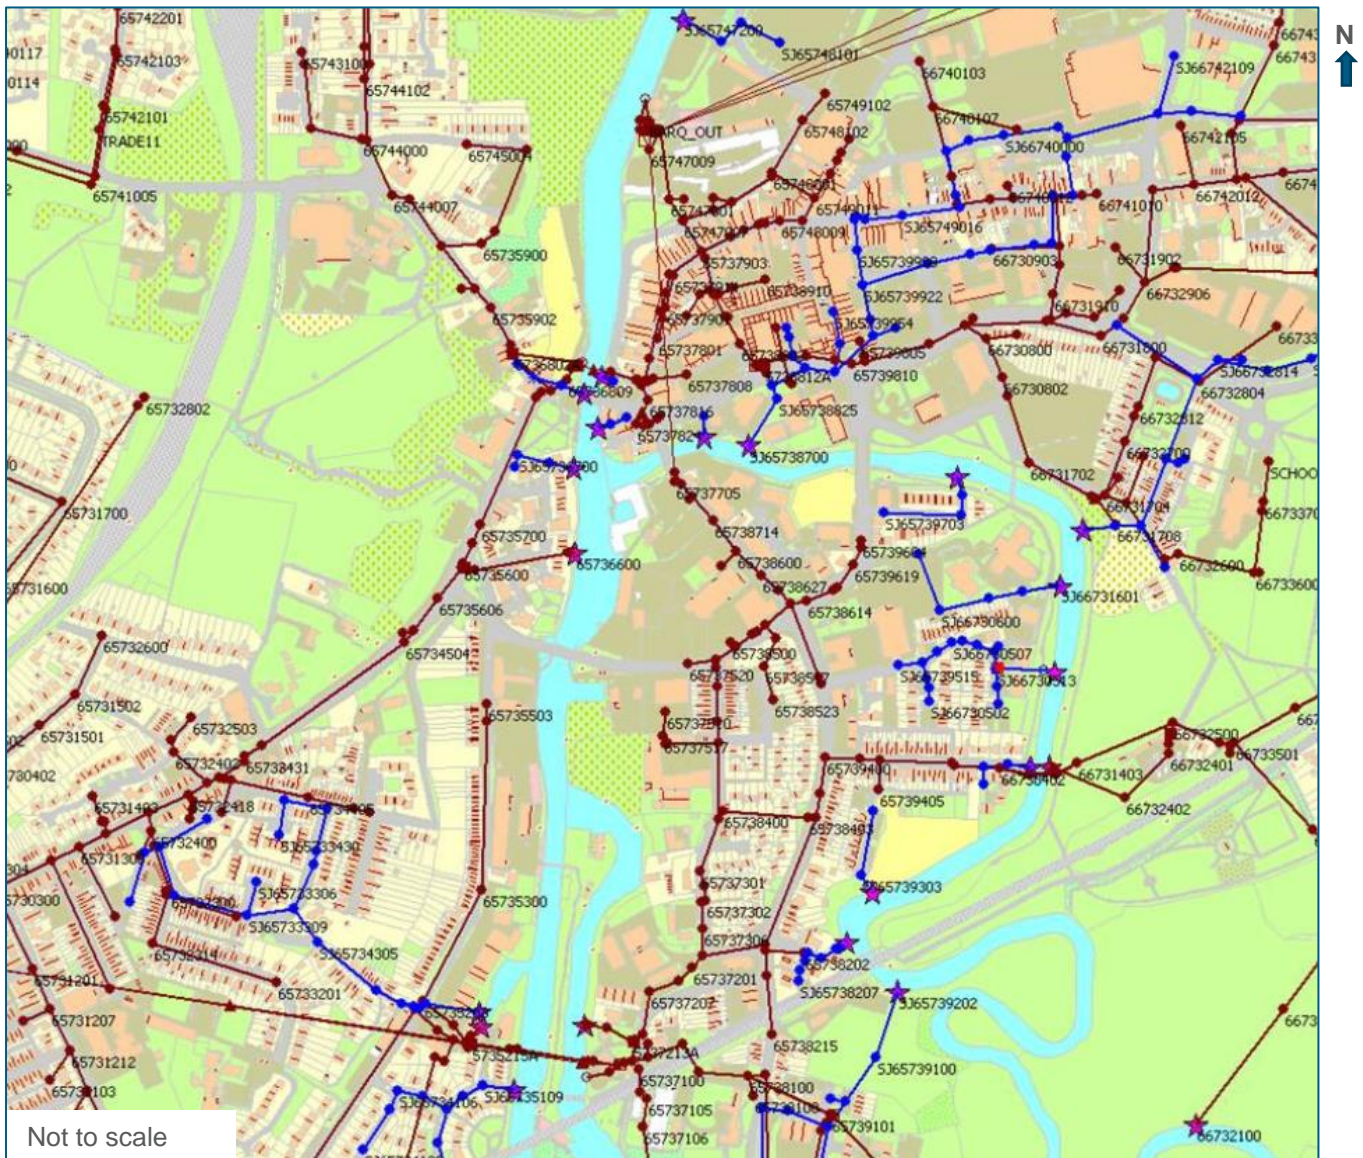
Figure 2 - UU Network and Outfalls– Northwich Town Centre

A schematic drawing of the UU network is presented in Figure 2 and details of their outfall assets, and associated flap valve arrangements, are shown in Figure 3. The catchment descriptions that follow are as described by UU.

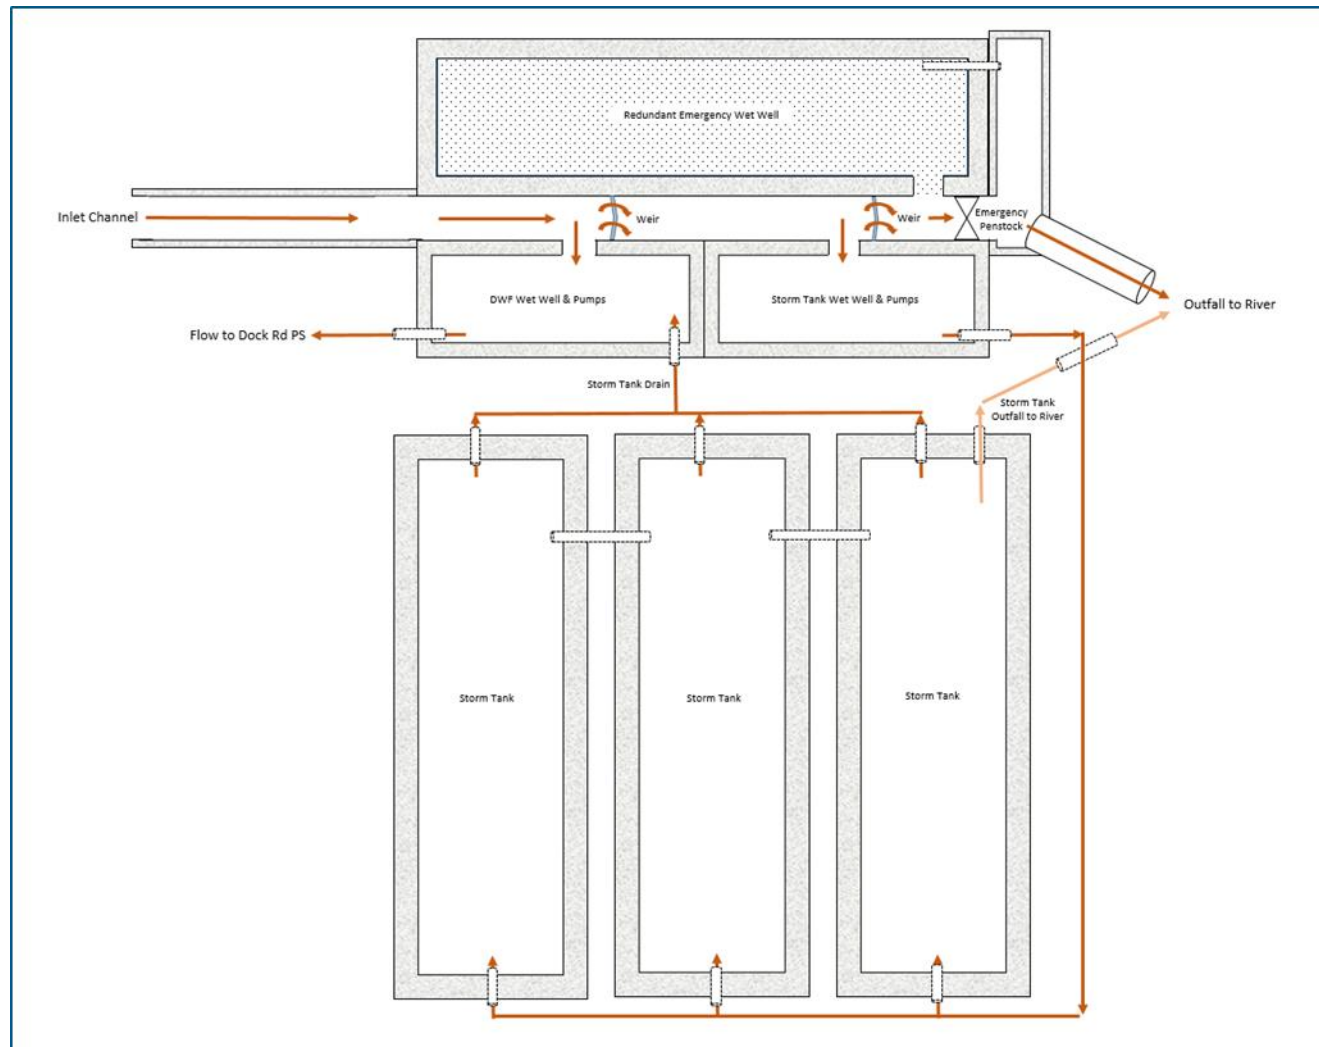
Figure 4 - Baron's Quay Pumping Station Arrangement

Barons Quay pumping station includes:

- Five dry weather pumps that operate on a Duty, Assist, Assist, Assist, Standby arrangement (if pumping demand exceeds capacity for the Duty pump, then an Assist pump will be enabled to assist with the delivery. If the demand continues to increase, additional assist pumps will start). Flows up to 10 times dry weather flow are pumped to Dock Road Pumping Station.
- There are four storm pumps which pump flows in excess of the 10 times dry weather flow to storm tanks located on site.

Barons Quay pumping station's emergency systems:

- There is an emergency penstock which is automatically opened in a storm event to allow excess flow to the river, when the outfall is not 'river locked' or blocked by water in the river at a higher level.
- This outfall is at 9.69 metres above ordnance datum (mAOD).

Figure 4 shows a schematic plan of the arrangement at Baron's Quay pumping station.

UU have confirmed that the Barons Quay and Dock Road pumping stations operated as designed throughout the flood event, there were no reported pump or telemetry failures at these locations. UU deployed an additional 150l/s pump at Dock Road to provide over pumping.

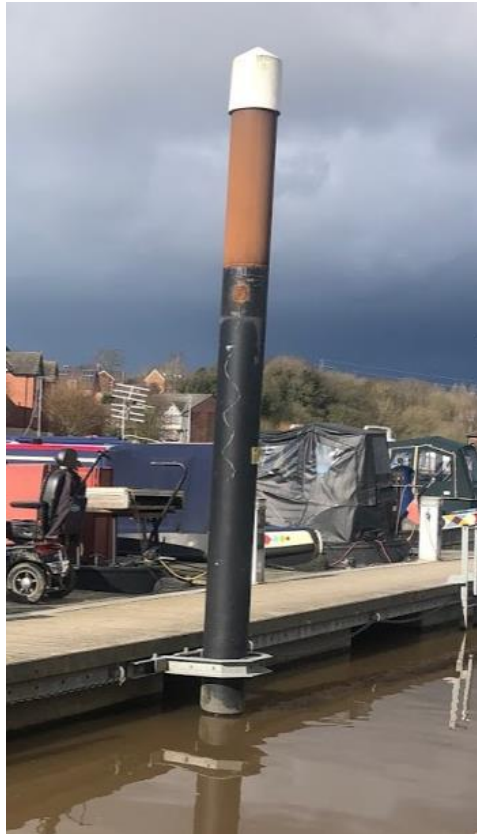
Figure 12 - Northwich Quay Pile. February 2020

Flooding Incident Information	<ul style="list-style-type: none"> River levels were within centimetres metres of overtopping flood defences and the floating dock was reported to be at its highest level (up to the white mark on the pile, Figure 12) Flooding within the Bull Ring due to surface water and the surcharging of the drainage network. The outfalls were river locked. At 23:00 on 20/01/21 a minor leak was observed in the raised defences at the Bull Ring and a small pump deployed. At 01:40 the temporary pump was removed and call made for a CW&C tractor unit pump support At 04:00 the tractor pump became active at Bull Ring UU's pumping station 'Bull Ring' was affected by Scottish Power cutting the power supply to the area for safety.
Flooding Impacts and Observations	<ul style="list-style-type: none"> Highway Flooding (Watling St, Dane St/Weaver Way) Roads were closed causing major disruption to traffic on this main access route. Significant Property damage Additional stress and mental anguish on the community over such an event happening again

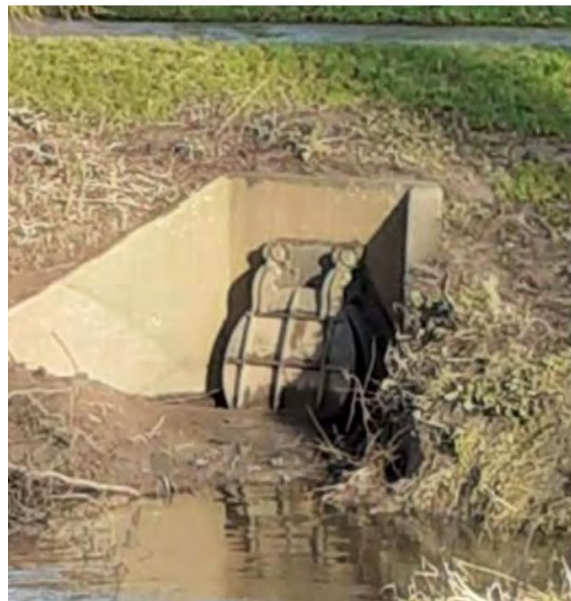
Figure 13 - Whalley Road Flap Valve

Figure 13 shows debris and silt build up at the Whalley Road Flap Valve. Figure 14 shows evidence of the flooding that occurred in the school area.

Owner	Action
EA / CWaC	Inspections have been carried out to assess all of the flap valves on outfalls in Northwich to ensure they are in the correct condition which will allows for them to be functionable during a flood event. Owners of the flap valves are aware of their role in maintaining their outfall and the importance of their upkeep. This included an Ad-Hoc visual asset inspection of the flood defences in and around Northwich.
CWaC	Gully covers have been replaced on London Road. The original covers were impacting their ability to be cleaned and maintained.
CWaC	The gully network has been surveyed and a cleaning programme was carried out. This included sewers all around Northwich. One package of work, which included Witton Street, has been identified and is the process of being addressed.
Private	Theatre Court have installed property resilience measures to their properties and have completed a drainage survey of the properties and installed non return valves for their outfall to the river network.

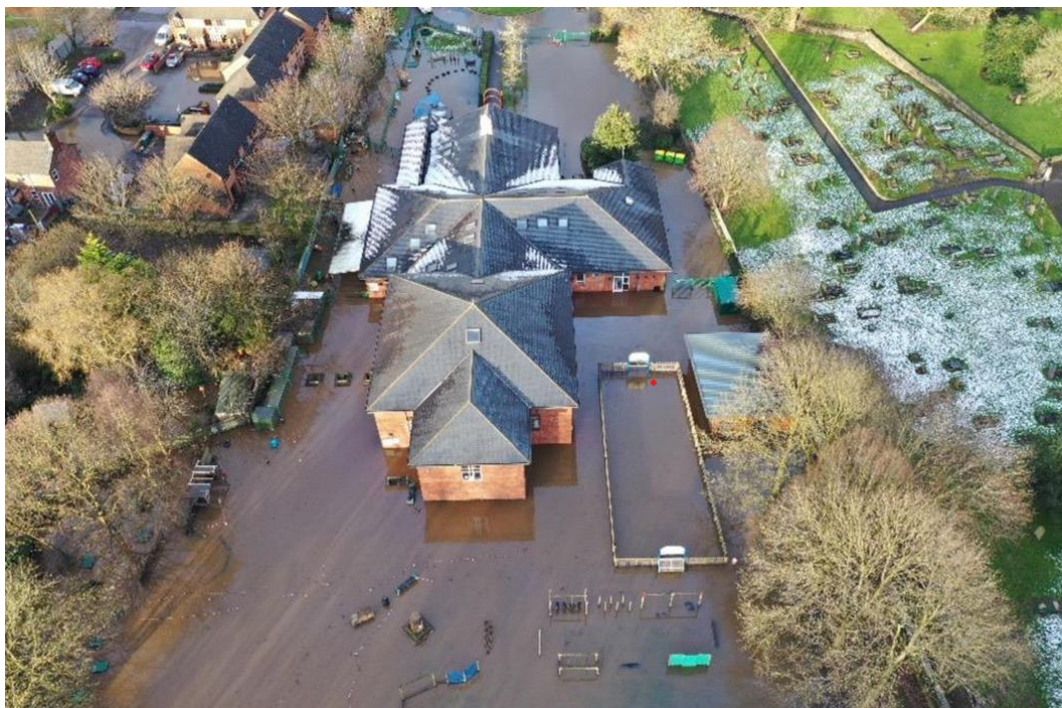
Figure 14 - Witton School. 21/01/21

Flooding Incident Information	<ul style="list-style-type: none"> • Witton Church School was flooded via overland flow to a depth of 200-300mm. • Surface water appeared to be running towards the school building from the northwest on School Way, similarly overland flow was coming from the rear of the school in the South and surcharging through the drains (combined system). This was not reported to UU during the event and therefore they did not attend and investigate. • The school has not been internally flooded before, although the Nursery area is sometimes closed during heavy rain. • The School Way Estate, including School Way, Percy Street and Priory Street, was also affected with many front gardens and the car park flooded.
Flooding Impacts and Observations	<ul style="list-style-type: none"> • Property damage • 282 students and 40 staff had to be placed at other schools during flooding and aftermath until April • Additional stress and mental anguish on the community over such an event happening again

The school and surrounding area flooded as a direct consequence of the drainage networks, including highways, surface and combined, being collectively surcharged causing overland flow, notably from School Way towards the school, to a depth of between 200-300mm.
