Tattenhall Main Report Details

Project:	Storm Christoph Section 19 Main Report		
Area:	Tattenhall		
Date:	08/08/22	Project No.:	5150735

Tattenhall Main Report

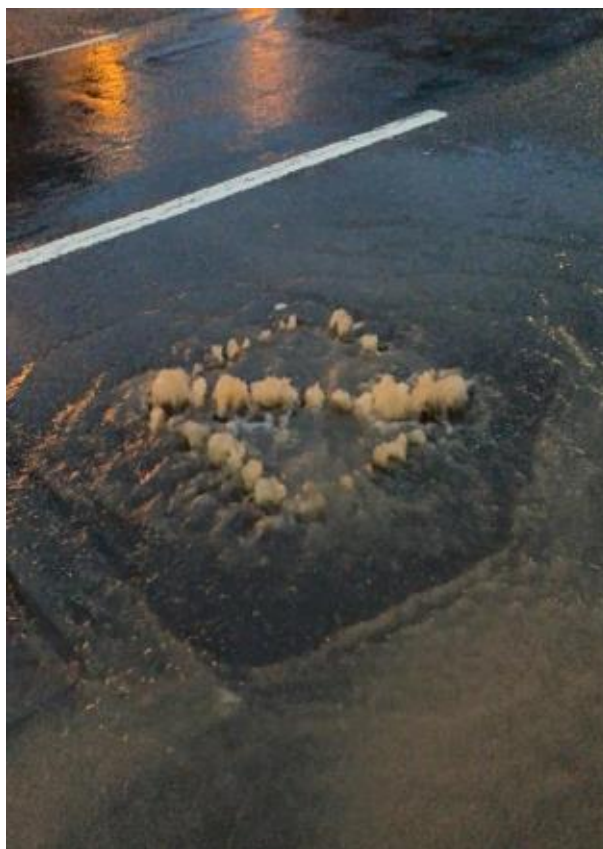
Figure 2 - High Street manhole cover opposite Old Mill Place. 20/01/21

- High Street manhole covers for surface water drainage were lifted indicating the capacity of the culvert had been surcharged.
- The car park at Old Mill Place currently has a layer of mossy sludge that has been there for several weeks, it is thought that this is related to high groundwater. Similarly, there are concerns regarding the borehole being capped which may again lead to increased groundwater levels.

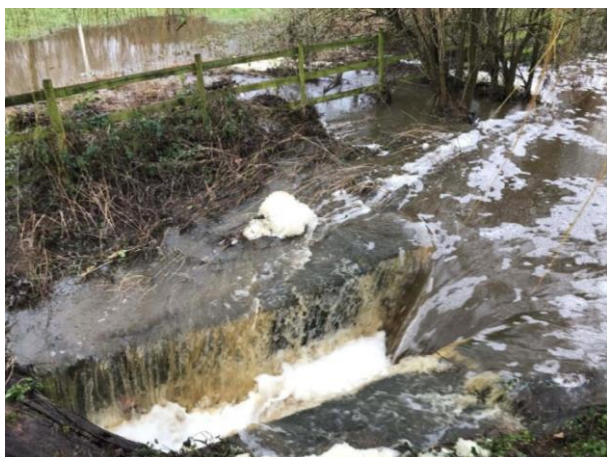
Figure 3 - Mill Brook at the High Street Bridge. 28/01/21 (note that this was taken a week after the event when water levels had subsided)

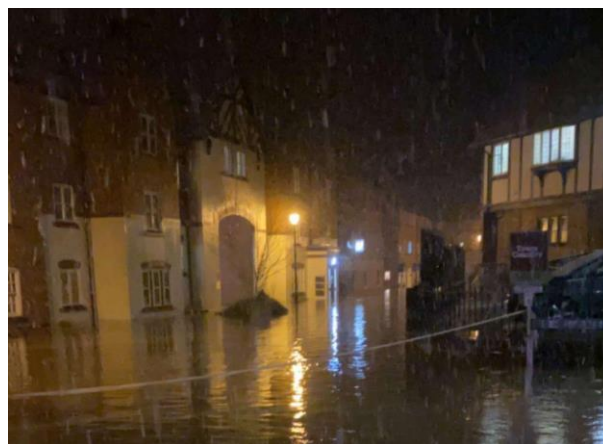
Figure 4 - Old Mill Place. 20/01/21

The High Street at the entrance to Old Mill Place is a low point for the road as well as for the surface and foul water drainage systems. During Storm Christoph, large volumes of water entered from both directions along the High Street into this low area. It was also reported that water overtopped the Mill Pond and ran into Old Mill Place in the south east corner of Old Mill Place. Residents reported water surcharging from the drainage network and coming up from the ground.
