Tilston Main Report Details

Project:	Storm Christoph Section 19 Main Report		
Area:	Tilston		
Date:	10/08/22	Project No.:	5150735

Client	Cheshire West and Chester Council
Project	Storm Christoph Section 19 Main Report
Project No.	5150735
Client signature / date

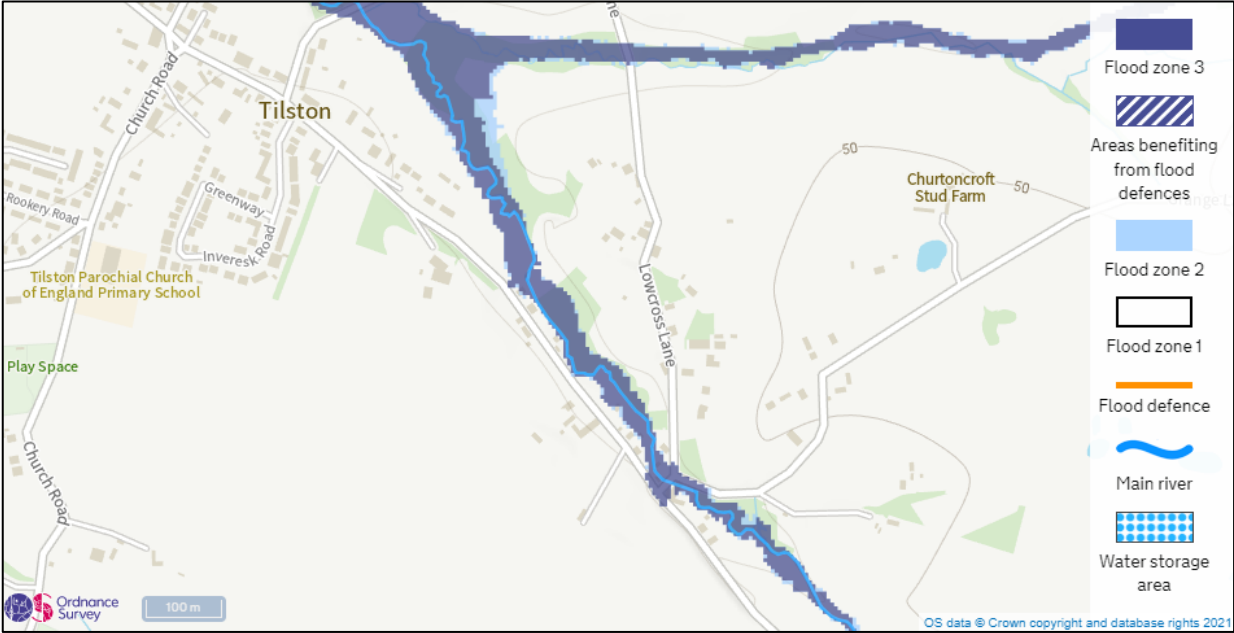
Localised areas of Tilston are within the Environment Agency (EA) Flood Zone 3 and 2 and at high and medium risk of surface water flooding, these areas are predominantly in the Wet Lane area to the east of the main village, refer to Appendix I to view these maps.

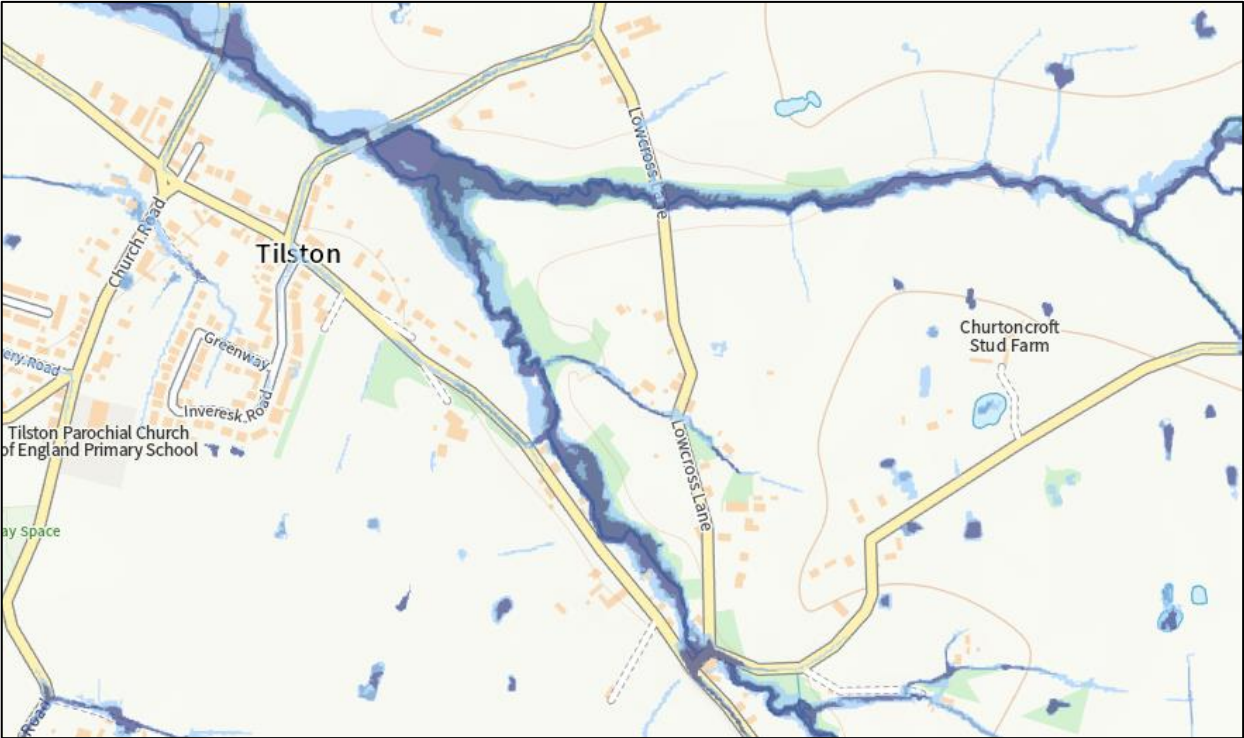
Extent of flooding from surface water
