Preliminary Risk Assessment

Commonside Tip, Alvanley, Cheshire

Cheshire West and Chester Council

Project number: 60747912
60747912_ACM_EN_REP_001

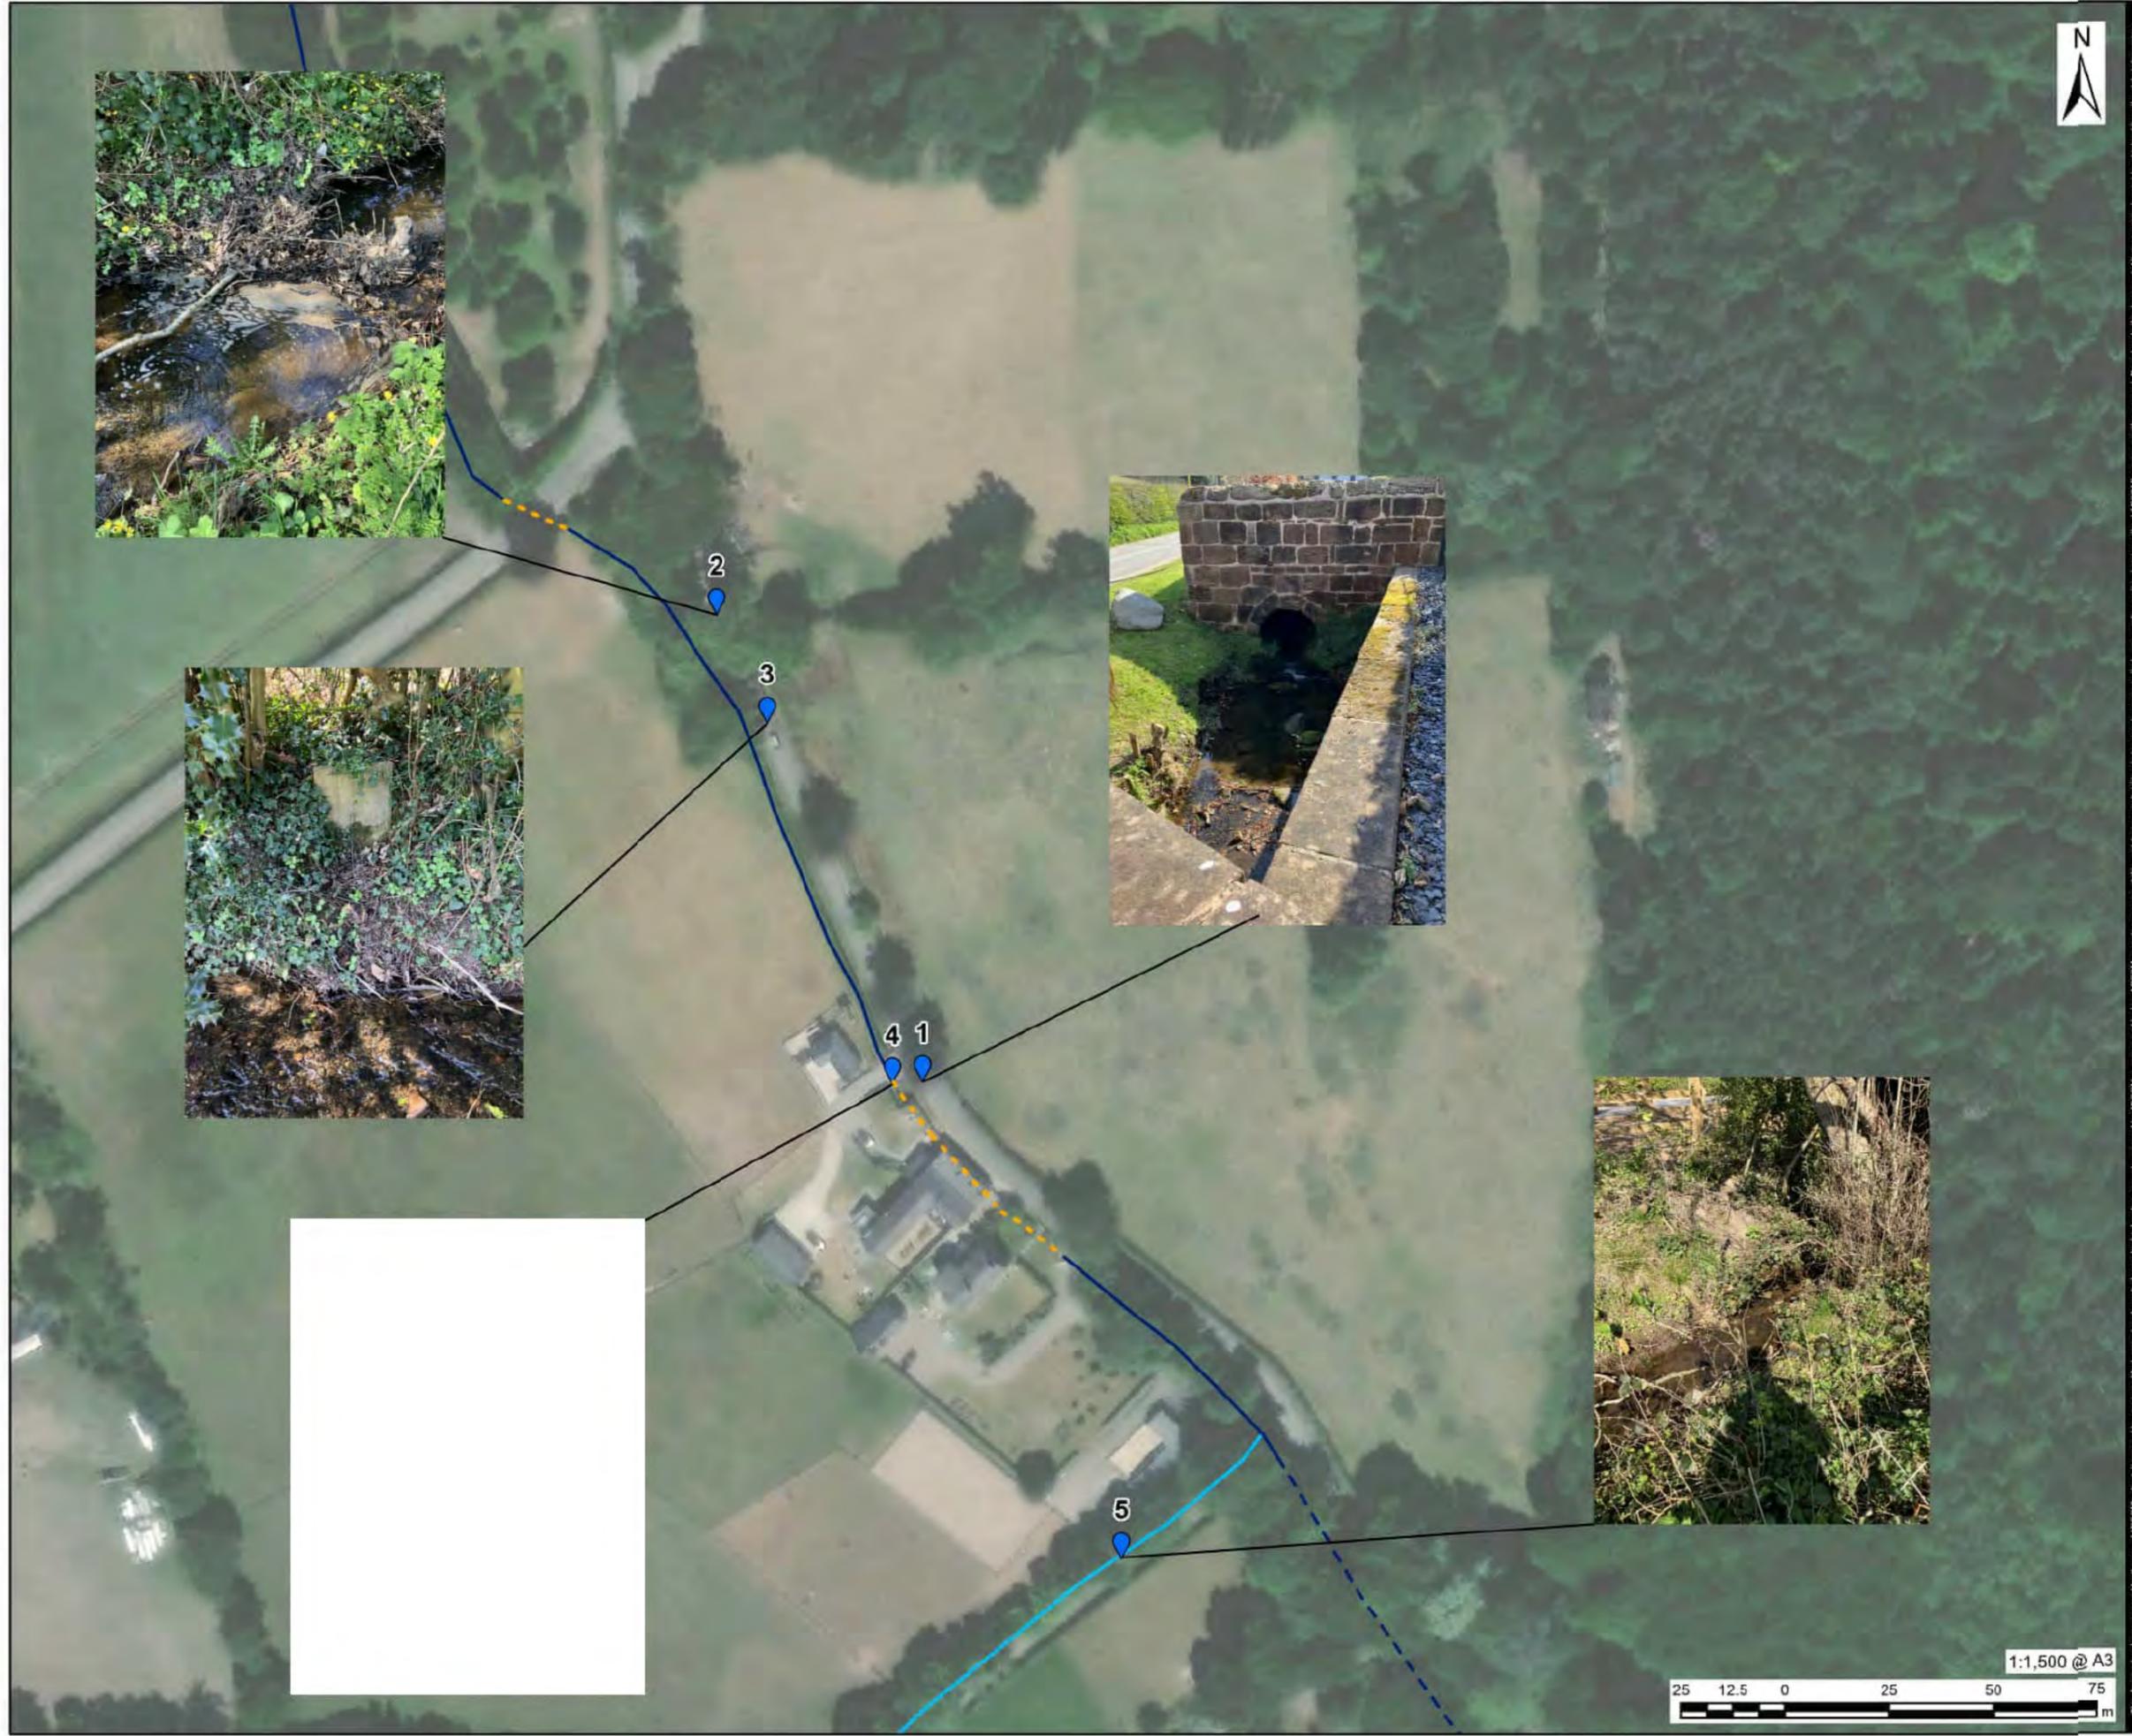
Figure 2: Site Walkover Features Plan

An outfall from the drainage pipe (thought to be connected to the sump) drains into the drainage ditch (west-east flowing) at the northern end of the field boundary. It was noted that there is a public right of way adjacent to this ditch. It was reported that the drain previously used to run beneath the east-west ditch and beneath fields further north to outfall in Foxhill Brook near road junction (as annotated on Figure 2), but this is thought to have been either severed, damaged or is blocked up.

There is a secondary ditch (running south-north) which feeds into the ditch east-west ditch. This is located to the east of the pipe route between the sump area and the east-west ditch and is marked on Figure 2. There has been no previous report of contamination here,

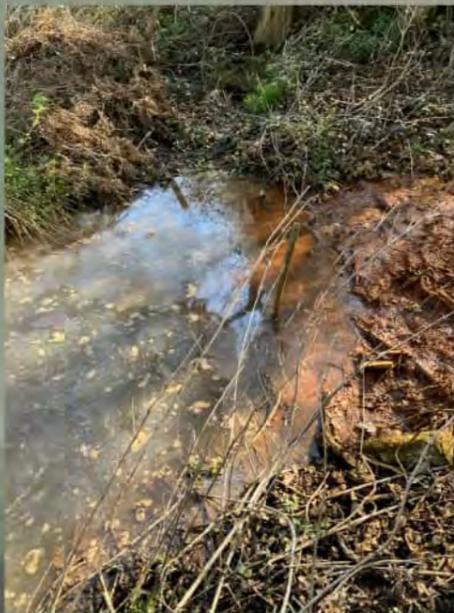
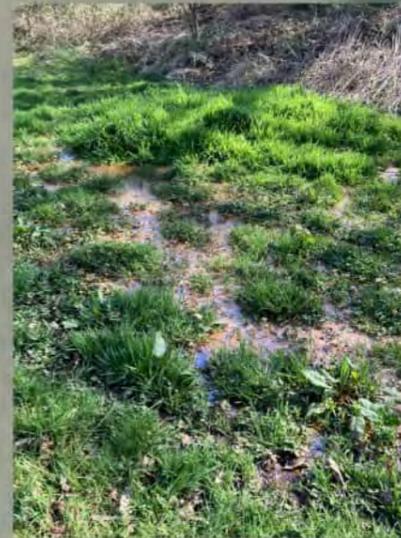
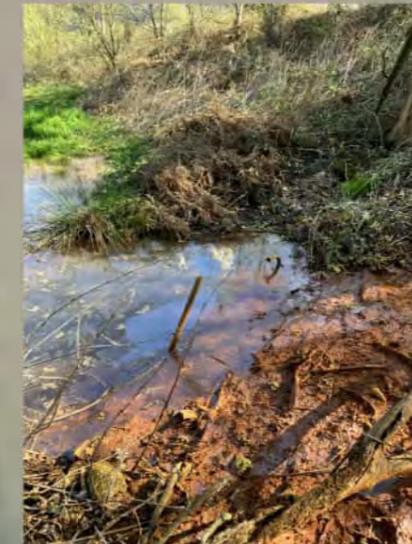
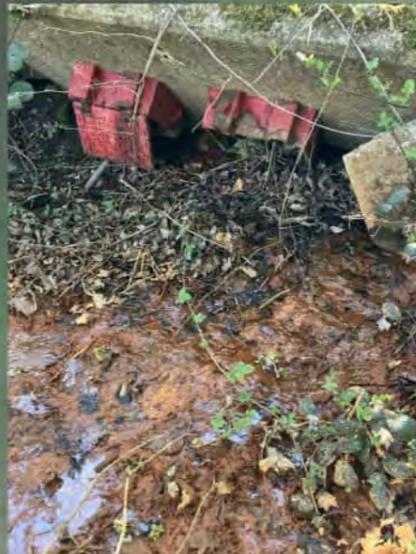
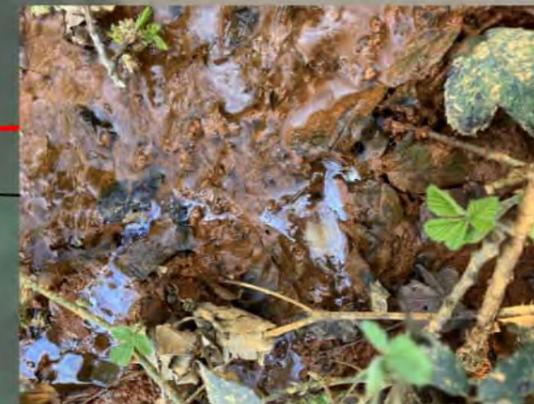
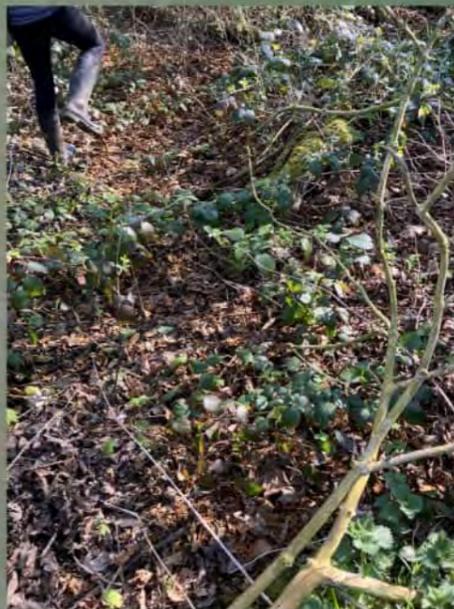
Figure 3: Site Walkover Photographic Plan

Entry to Commonsides Tip was in the southwest corner of the site, through a gate off Commonsides Road. Parts of the southern end of the site had been de-vegetated by a local tree surgeon. It was reported by the client that the tree surgeon does not have ownership rights to the site, but controls access and has informal use of the site. Stockpiles of logs and tree cuttings were seen close to the eastern boundary in the south of the site (see Figure 3, Photograph 27). The ground was slightly undulating underfoot but generally flat, raised centrally.
