Vale Royal Borough Council

# **FRODSHAM (CASTLE PARK LOCALITY) CONSERVATION AREA APPRAISAL**

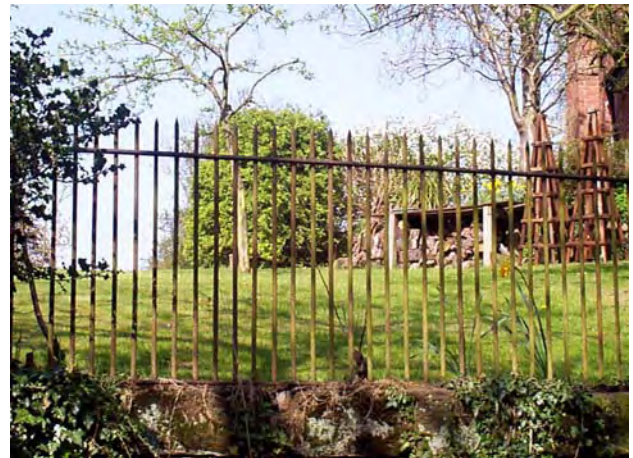
- Traditional original metal spike topped railings - found along Conservation Area boundary - close to watercourse in East

**Original spike topped railings by Synagogue Well**

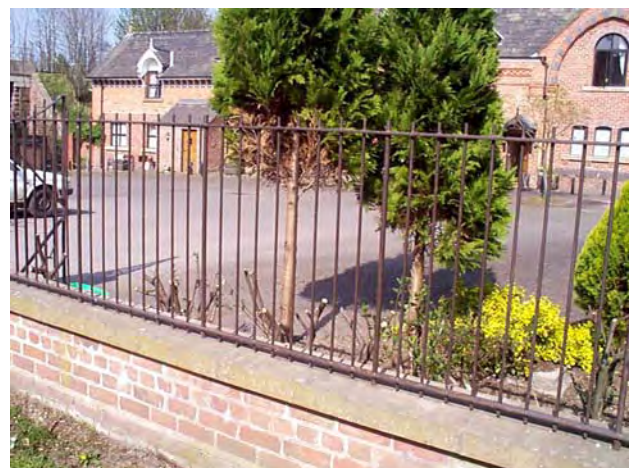
**Modern railings enclosing Park Court**

- Similar railings - with blunt tops - over low brick wall - found along boundary of Park Court - former Fire Station - converted to residential properties

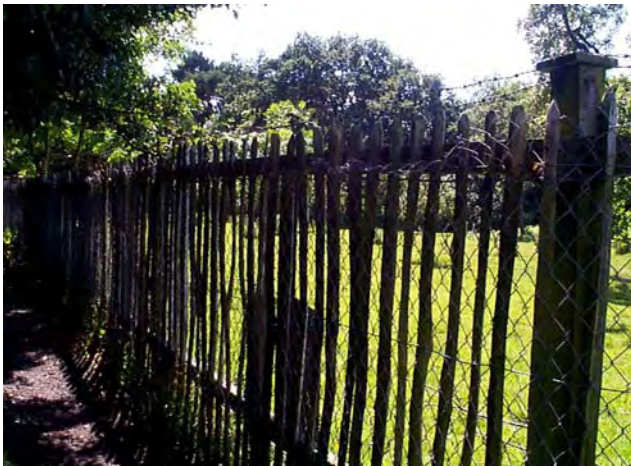
- In South-East of Conservation Area
  - Recent tall, solid, timber fence along Western boundary of Pinmill Croft
  - Pinmill Croft on Park Lane - untidy tall hedge - reinforced by poor quality chicken and sheep wire mesh netting
  - Adjacent to public footpath between Kingsway and Howey Lane - fencing is timber post and rail supporting Chestnut pales reinforced by chain link and topped by barbed wire

**Footpath fencing to field by Pinmill Croft**

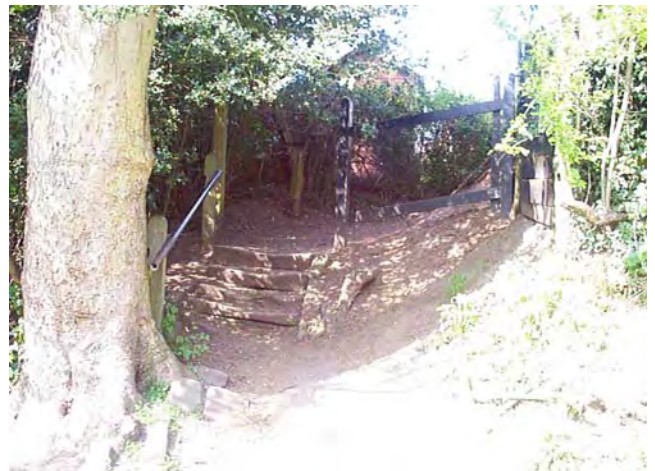
**Footpath steps close to Synagogue Well**

- Fountain Lane runs briefly through North-East of Conservation Area - then becomes Park Lane which was only a footpath track in 1870
- Three vehicular access points to park
  - Principal entrance from Chester Road in North-West
  - From Fountain Lane in North-East
  - From Howey Lane in South-East (service access)
- Five pedestrian access points to park
  - From a public footpath leading from Park Lane in South-East

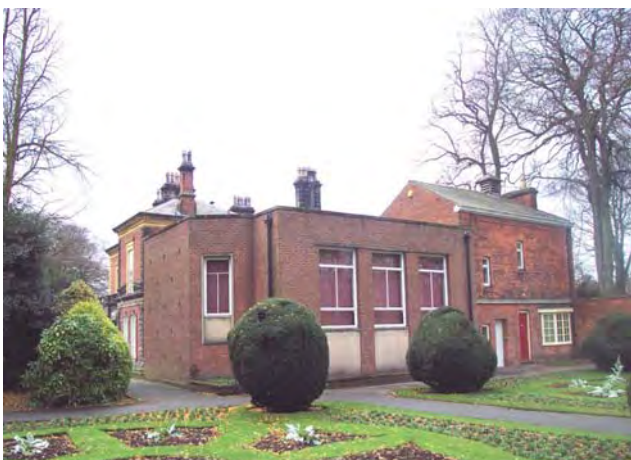
**Council Chamber**

- Castle Park House
  - Cellar walls - formed from parts of foundation walls of earlier (possibly C13<sup>th</sup>) Castle/Manor House
  - Doubtful claim of Roman origin
  - Park Place constructed late C18<sup>th</sup>
  - Reconstructed and extended - 1851
  - Extended to East by mid C20<sup>th</sup> flat roofed Council Chamber - on site of original kitchen yard

- Ugly Council Chamber extension -
  - Flat roof with concrete parapet coping
  - Pale red/brown slop moulded bricks - some special angles - in lime mortar
  - Yellow cast concrete window reveals and aprons below glazing
  - Bland metal window frames
- Glazed conservatory
  - Poor timber facade - profiled stone plinth - brick back and flank walls
  - Glazed roof - broken panes - mechanical venting system
  - Decorated tiled floor
- Simple, glazed, timber-framed, slate roofed, single-storey, lean-to extension to East side and elevation of Arts Centre

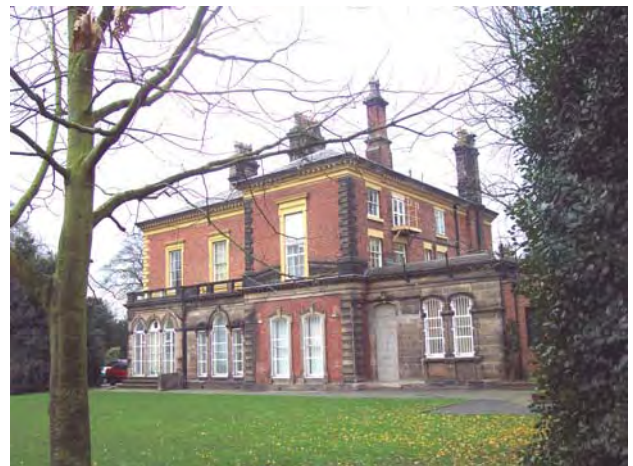
**Main House from parkland**

- Neo-classical Victorian reconstruction and extension of Georgian House

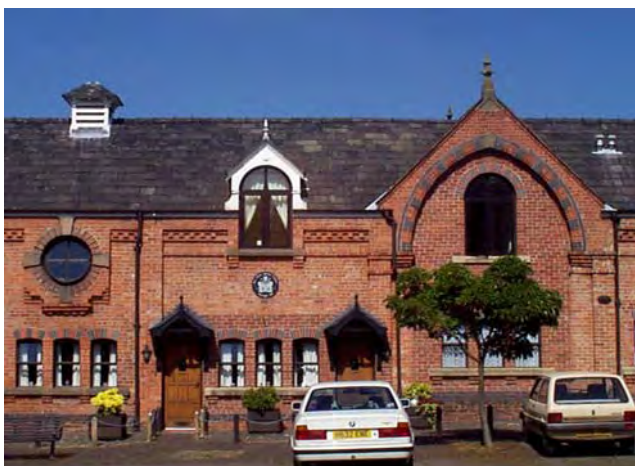
**Slate, timber, brick and stone on Park Court**

- Blue/grey Welsh slate - usually hipped - roofs with plain ridge tiles generally
  - Timber eaves brackets to hooded porch roofs and North bay eaves of West elevation of Park Court
  - Timber louvred tower roof vents on some outbuildings

- Plain red tiles - including ridge - on bowling green pavilion and Pinmill Croft
- Warm - Cheshire red/buff brickwork
  - Flemish bond to main house
  - Garden bond common elsewhere
  - But - poor re-pointing on Arts Centre
  - Alternating red and blue rubbed brick sections to oculii and arches on Park Court

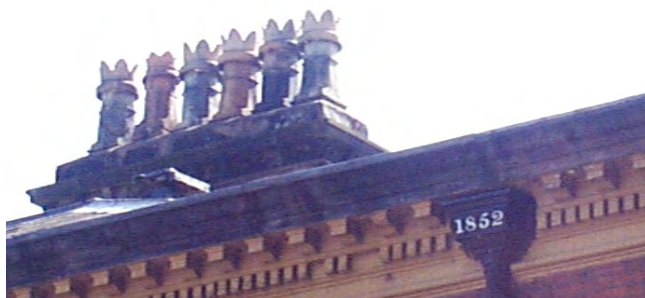
- White painted metal on Pinmill Croft
- Rainwater goods
  - Cast iron on majority of properties
    - main house - hopper dated 1852
- Plastic on bowling green pavilion and new Arts Centre courtyard units

**Main house chimneys and dated hopper-head**

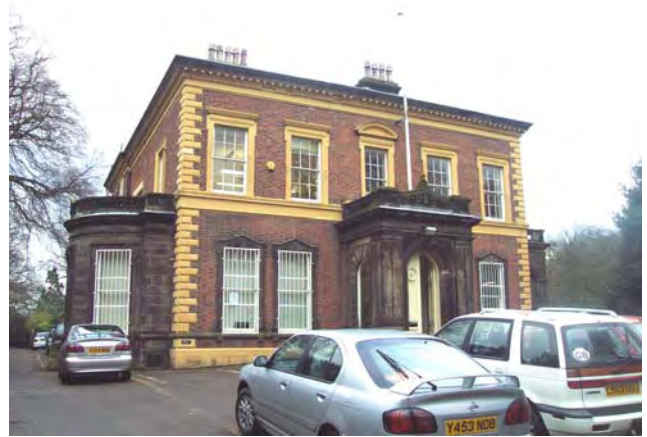
**Front entrance porch of Main house**

- On main house
  - In stone
    - Carved tympanium with acroterion on porch - another tympanium to South elevation (unfortunately cut into to facilitate lowered window sill above)
    - Carved porch doorway spandrels
    - Banded rustication to porch openings
  - In stone and stucco
    - Quoins
    - Window eared architraves

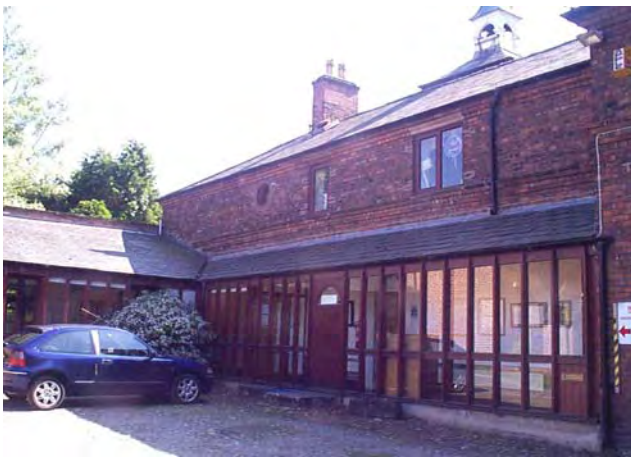
**Glazed lean-to Arts Centre extensions**

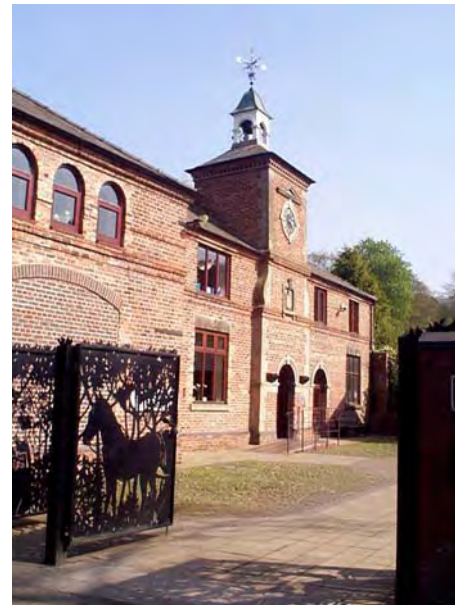
**Former coach house – now Arts Centre**

- Arts Centre - formerly coach house -with prominent central clock tower bay

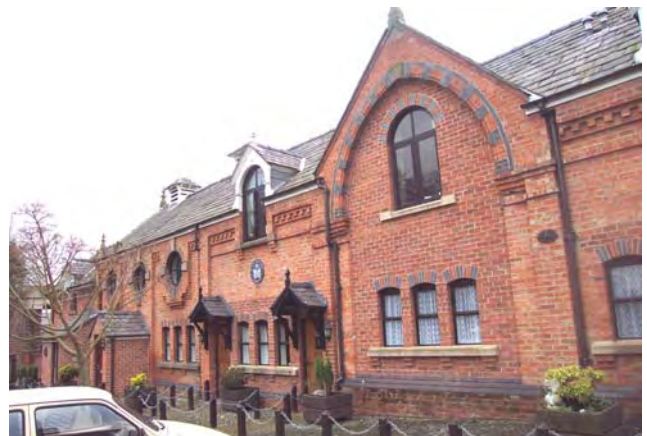
**Park Court complex**

- Park Court - housing since 1984 - former C19<sup>th</sup> farm buildings - later Fire Station - feature of Fountain Lane area

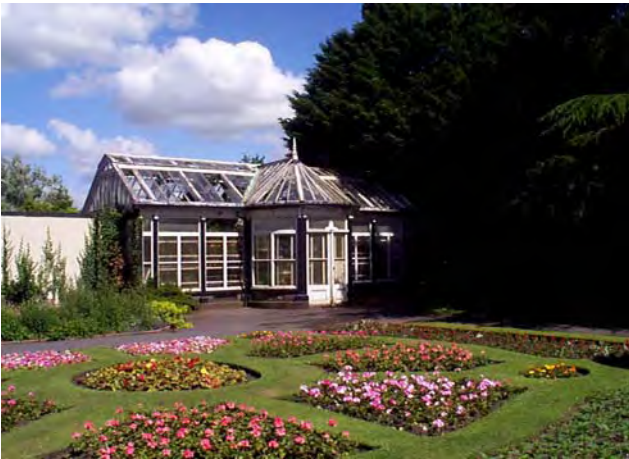
- Glazed conservatory - focus within formal garden despite disrepair

**Semi-derelict conservatory**

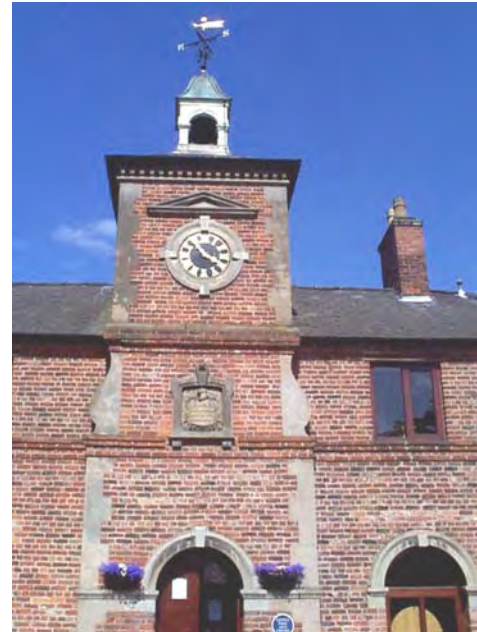
- Cupola with weather-vane
- In sandstone
  - Wright family crest
  - Keyed oculus enclosing clock face
    - Stone pediment above
  - Quoins
  - Semi-circular door head arches

**Arts Centre clock tower**

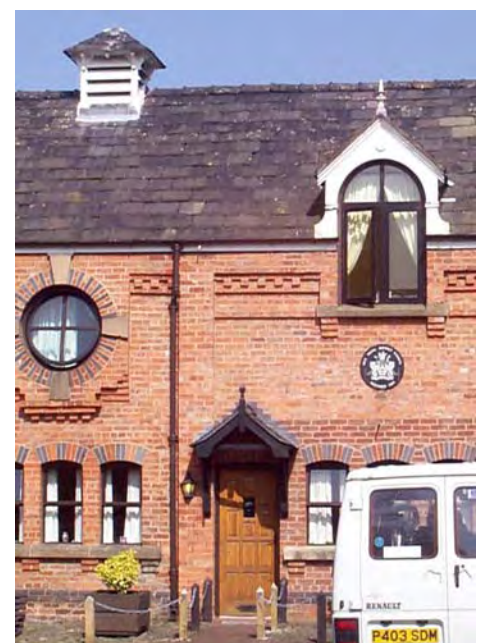
- On Park Court
  - Alternating red and blue rubbed bricks and sandstone keys to oculi and arches
  - Brick corbels below window sills

**Park Court detailing**

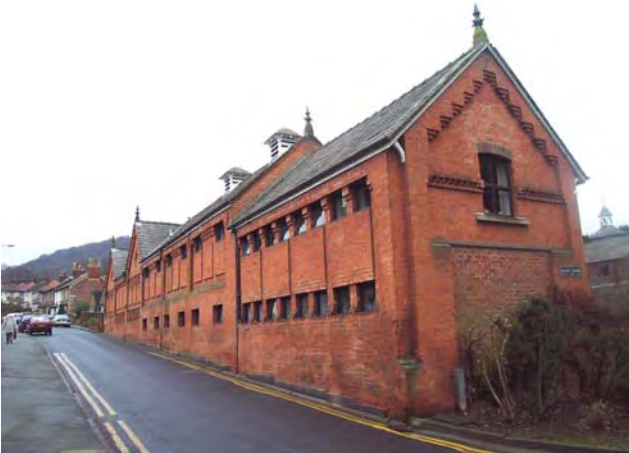
- Timber eaves brackets to hooded porch roofs and North bay eaves of West elevation
- Brutal brick detailing - Fountain Lane elevation - mini-buttress piers at low level - corbelled out above - inverted stepped corbelled eaves to gables

**Park Court – brutal elevation to Fountain Lane**

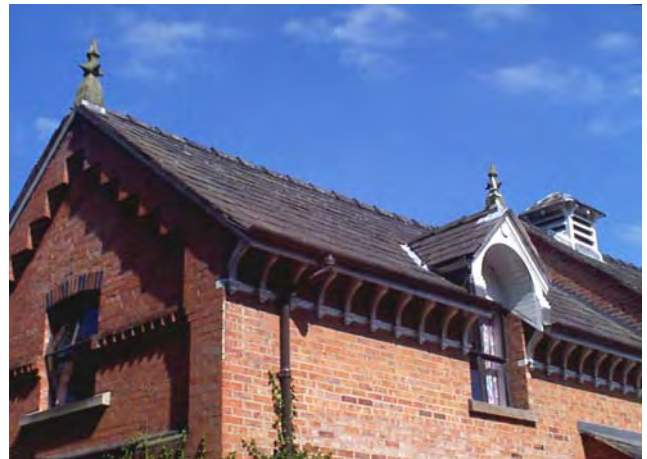
**Interesting Victorian detailing - Park Court gable**

- String courses
  - Stucco - on main house
  - Brick-work - multiple courses on Arts Centre
  - Brick-work - multiple courses with special moulded dentils to Nos 8 and 10 Fountain Lane
- Dentil courses
  - Timber - below eaves to main house
  - Stone - to porch and ground floor extensions on main house
  - Brick-work to
    - Oculii and below eaves on Park Court
    - Arts Centre clock tower
  - Brick-work - saw-tooth pattern to
    - Top of walls to derelict building in Upper Courtyard
    - Tops of chimneys to Nos 8 and 10 Fountain Lane
    - Sections of eaves to Fountain Lane elevation of Park Court
- Timber louvred ridge tower vents above roof-lines of Park Court and gardeners cottage (formerly laundry)
  - Latter held high level water tanks fed from Synagogue Well
- Timber eaves brackets to West elevation of North bay of Park Court

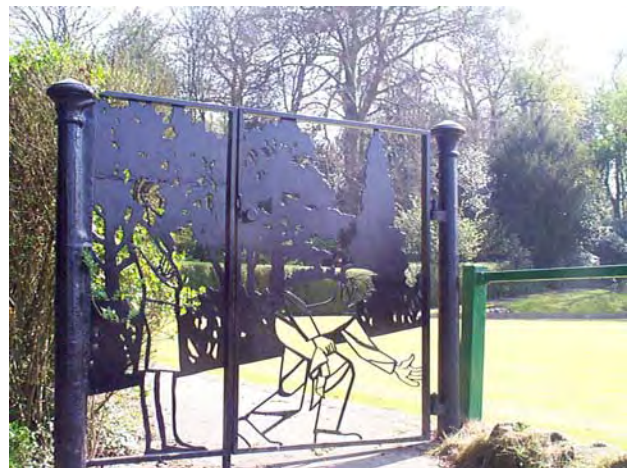
**Modern artistic gates to the bowling green**

- White gables with black geometric timber detailing to Nos 8 and 10 Fountain Lane
- Interesting modern black painted metal gates at Art Centre, garden for disabled and bowling green

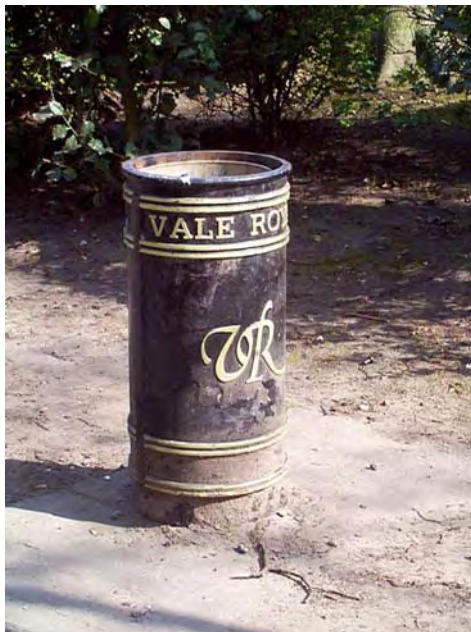
Cast iron Vale Royal litter-bin

- Galvanised tall lamp posts in main car park and on driveway to main house
- Aluminium replica Victorian lampposts along North-Eastern section of main driveway - easily damaged
- Various styles of litterbins throughout Conservation Area
  - Many in poor condition
  - Occasionally found overflowing
  - Some of more recent cast iron bins incorporate Vale Royal insignia

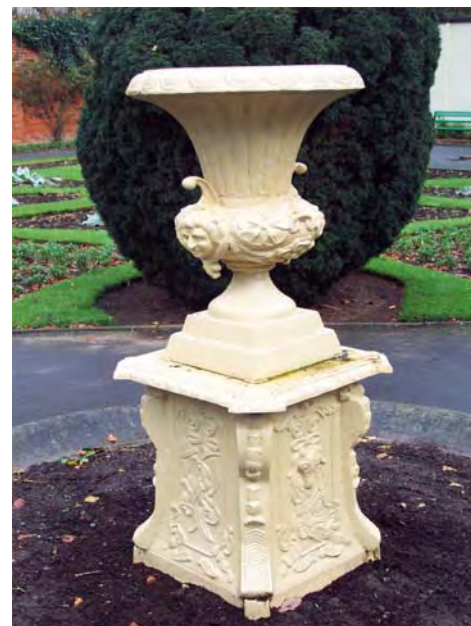
- Linear linked series from formal garden
  - Brick arch at entrance
  - Reproduction moulded, painted cast iron urn and plinth in centre

Reproduction urn – site of former fountain

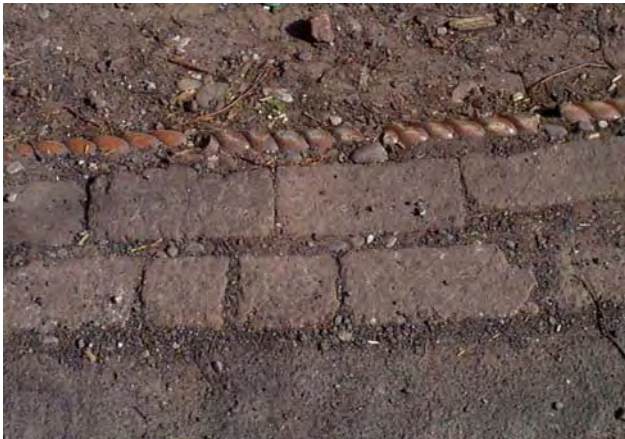
- Fountain Lane and Park Lane have macadamised roads and footpaths
- Main park driveway - heavily potholed
  - Reinstated macadam - poor condition
  - Some stone raised edging remains - most is in pre-cast concrete
- Alongside access road off Fountain Lane
  - Stone housing to road drainage gully with cast iron top
  - Rope effect brown glazed tile edging and two rows of paving brick adjacent
    - Much of this detail missing or simply ignored and overlaid

Rope tile edging on access from Fountain Lane

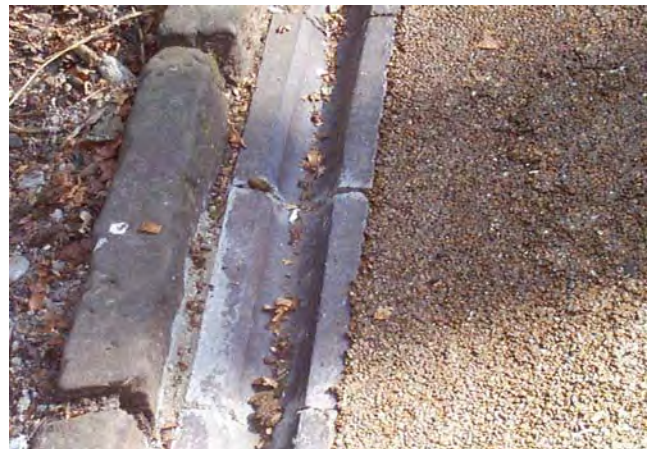
- Bound limestone has been used in areas to repair eroded sections
- Macadam paths within park generally have pre-cast concrete edging
  - Those close to Howey Lane service road access have stone edgings
  - That to West of American Garden has rows of cobblestones - mostly covered by macadam
- Gravel paths are generally stone edged
  - Short flights of stone steps common
  - Public footpaths off Park Lane have soil residue from run-off from adjacent higher land
    - That South of orchard to Pinmill Croft has large smooth sandstone blocks at Park Lane end
- American Garden paths
  - Small brown gravel - resin-bound
  - Sandstone edges with adjacent drainage channels - usually in clay tile - sometimes stone or concrete
  - Issue of leaf-mould build-up on paths

Drainage channel along path sides

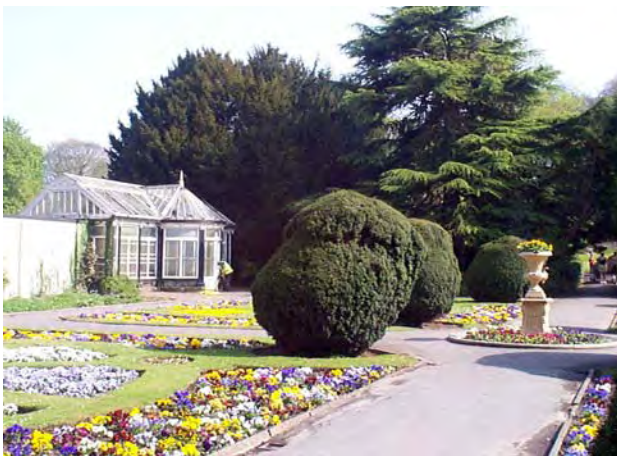
- Castle Park – planted and landscaped - now mature 'registered' historic garden
  - Has four distinct areas - three green spaces - one wooded
- Gardens and pleasure grounds around main house
  - Flat grassland area used for informal play especially ball games - close to main house
  - Formal garden - East of main house - geometric pattern of bedding plants - conservatory

Formal garden to East of house

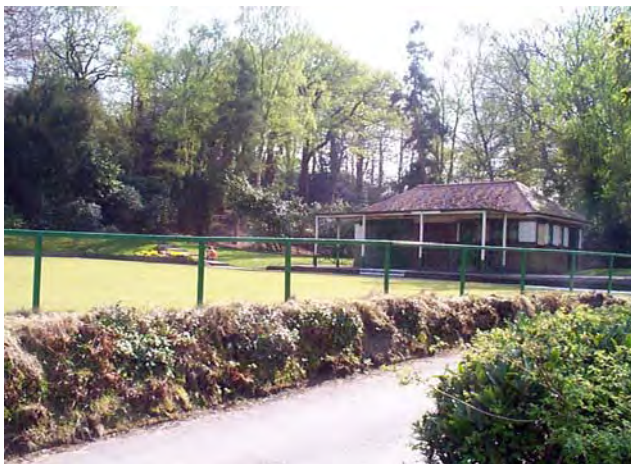
- Formal games area - on land formerly occupied by kitchen garden and orchard - to North-East of park
  - Tennis courts constructed in former kitchen garden area
  - Bowling Green constructed on parts of a former adjacent orchard

Bowling green and pavilion

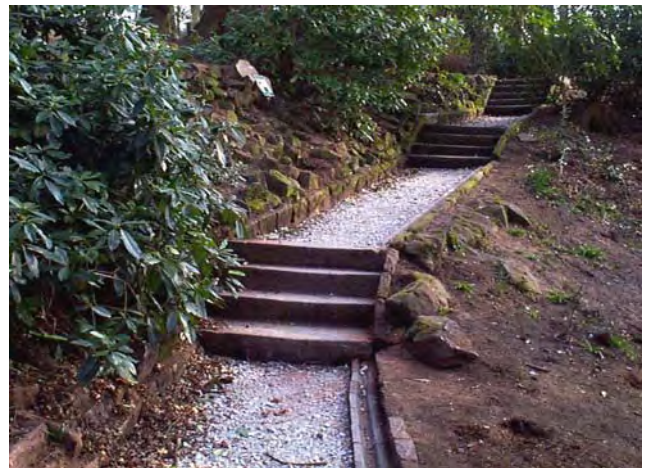
- Open area of former pasture - later parkland - to South of park
  - Also used as sports field and football pitch
  - Tree covered mound to South - metal railings surround manhole cover to underground reservoir
  - 'Flagpole hill' - no longer obvious
- Wooded American Garden to South-East
  - Wooded area - informally planted with trees and rhododendrons
    - Irregular ground levels - laid out with winding intersecting stone edged paths - with side drainage channels - short flights of stone steps connect varying levels

Restoration of steps in American Garden

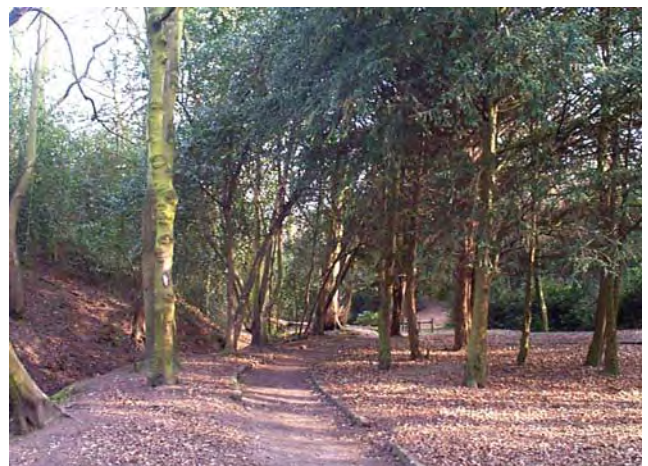
- In West of area - paths and drainage lead to sunken area - recently restored stone lined pond or small reservoir
- Whole of Eastern part includes linear feature water-course

Path adjacent to linear water-course

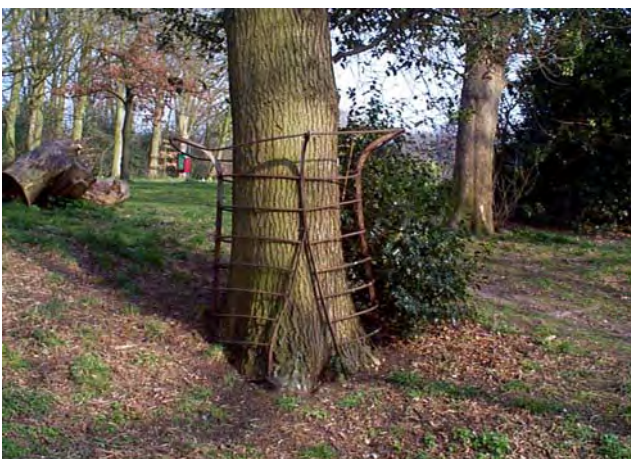
**Obsolete tree guard**

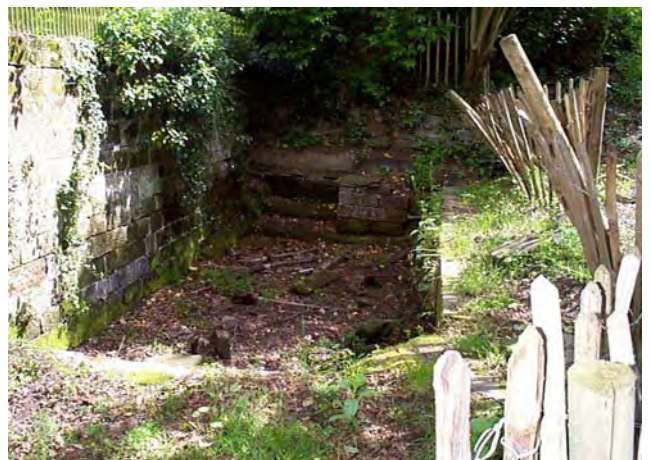
- “Gushing water” from land springs was originally used for water features
  - System of buried pipes (now lost) fed water features and fountains
- Drainage in marshes to North-West of Frodsham reduced the water table in the area of Castle Park
- Significant watercourse through East of parkland – littered and untidy
  - Flows from pipe below Howey Lane – upper reaches are wild, overgrown and badly littered – some stone blocks may be evidence of previous watercourse management
  - Stone walled Synagogue Well (reservoir) no longer operational

**Synagogue Well - disused cistern**

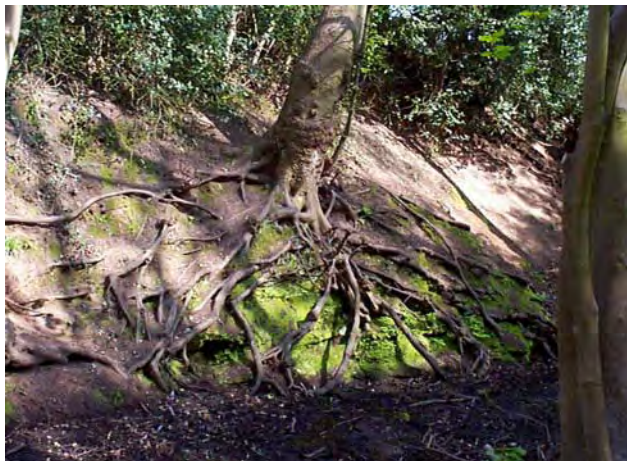
- Generally lined with coursed and dressed stone - topped with irregular smooth edged stones to give a more natural effect
- Heavy erosion with exposed tree root presence along its length

**Tree roots along Eastern watercourse**

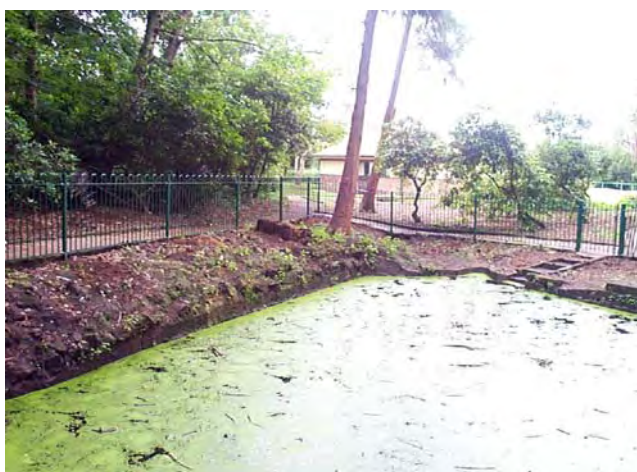
**Recently restored pond in American Garden**

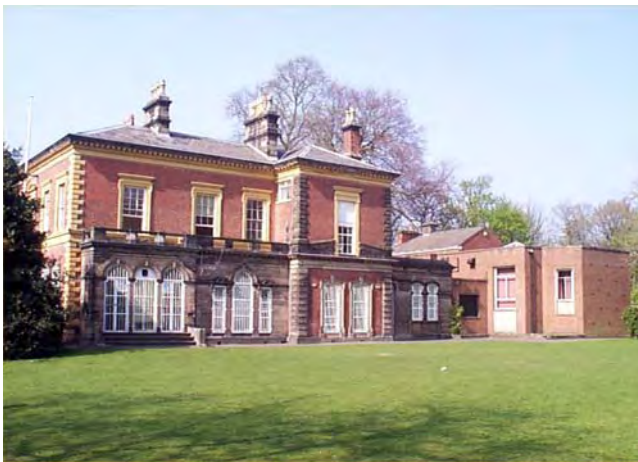
- Inconsiderate treatment of main house - has left its appearance untidy
  - Ugly fire escape to North-West elevation
  - Razor wire along flat roof edges
  - Lack of consideration when applying cables to main building walls - untidy assortments visible externally
  - Overbearing security bars on ground floor windows
  - Lost detailing on main house
  - South-West elevation ruined by unsympathetic mid C20<sup>th</sup> Council Chamber extension

**Main house from South**

- Whole site requires sensitive restoration, improvement, management and supervision
- Missing applied stucco quoins, dentil course work, balusters, window canopies and brattishing to main house could be reinstated - with razor wire removed

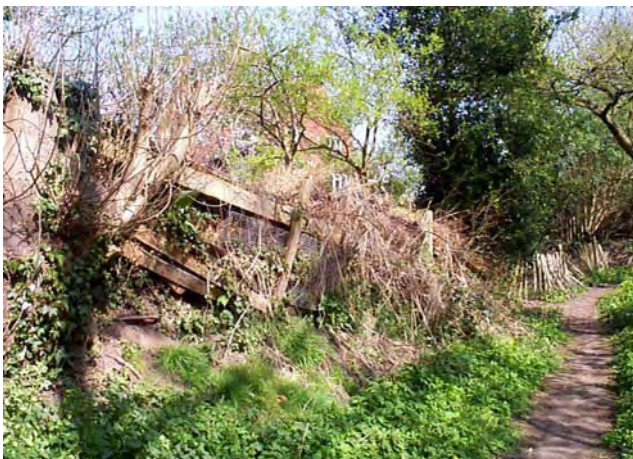
**Compost heap pressure on fence near to Synagogue Well**

- Garden waste - applying pressure to original metal railings along Eastern boundary of Park
- Path at back of Chester Road - worn down considerably
  - Manhole covers now raised creating trip hazards
  - Roots of large old self sewn tree have intruded into body of path
  - Red sandstone edging missing in many places along this path
  - Concrete post and chain-link fence across path at foot of railway embankment - appears to serve no purpose - in an untidy and vandalised condition
- Buildings in Upper Courtyard adjacent to Arts Centre - in poor and dangerous state of disrepair
  - Missing steps leading up to closed gate to Formal Garden - giving access to dangerous unmanaged void underneath higher level

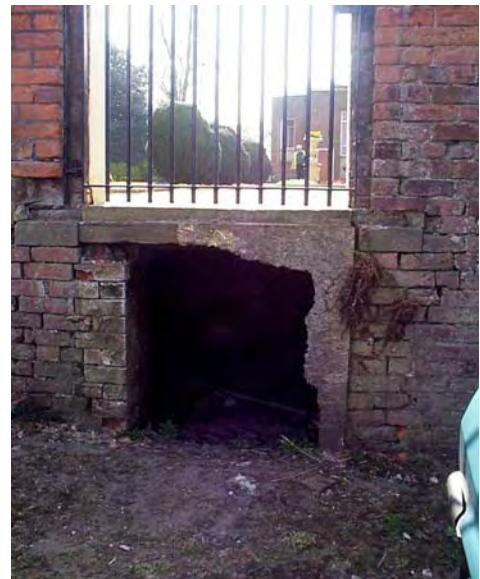
**Upper courtyard void behind former steps**

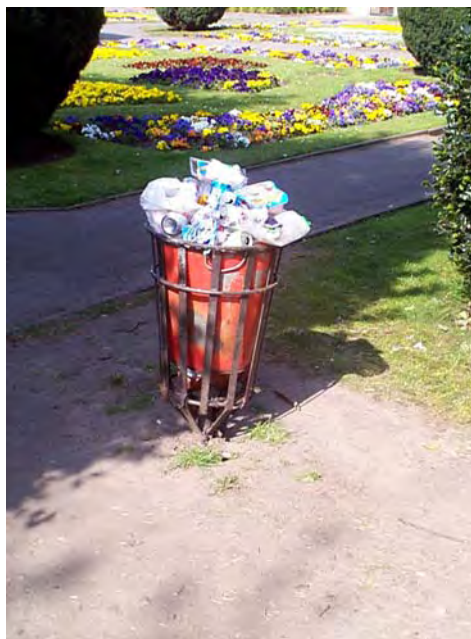
- Small raised bed on South-West corner of Council Chamber - not always part of planting programme
- Overgrown nature of vegetation in Garden for Disabled
- External lights on during daylight
- Overflowing and poor condition of some litter bins

**Overflowing bin in Formal Garden**

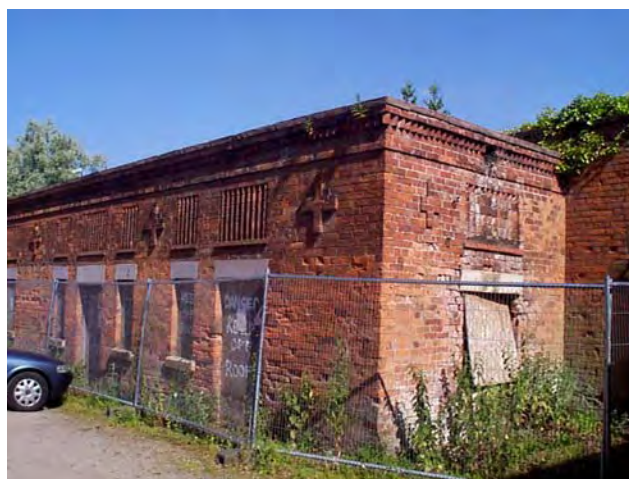
**Upper courtyard buildings with potential**

- Derelict buildings in upper courtyard adjacent to Arts Centre could be restored and brought into an appropriate use
