Vale Royal Borough Council

**MARSTON  
(LION SALT WORKS)  
REVISED  
CONSERVATION AREA  
APPRAISAL**

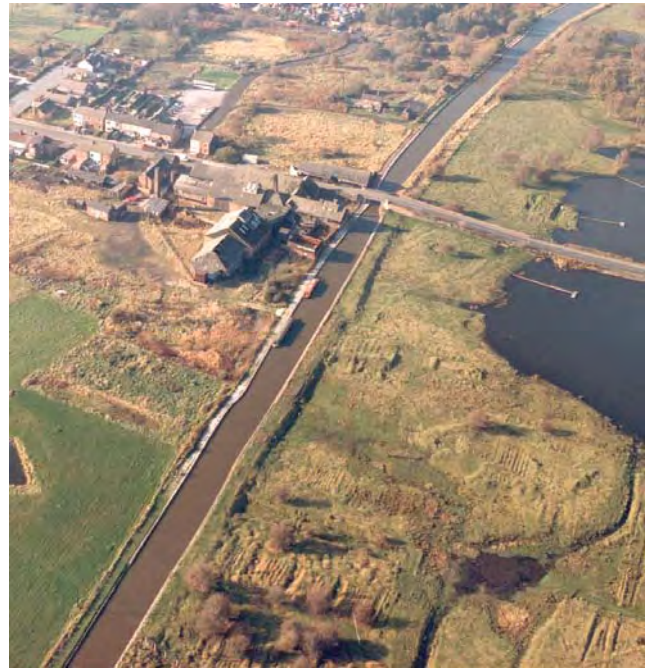
**View west across former Ollershaw Lane Works and Lion Salt Works**  
(Reproduced with the kind permission of The Lion Salt Works Trust)

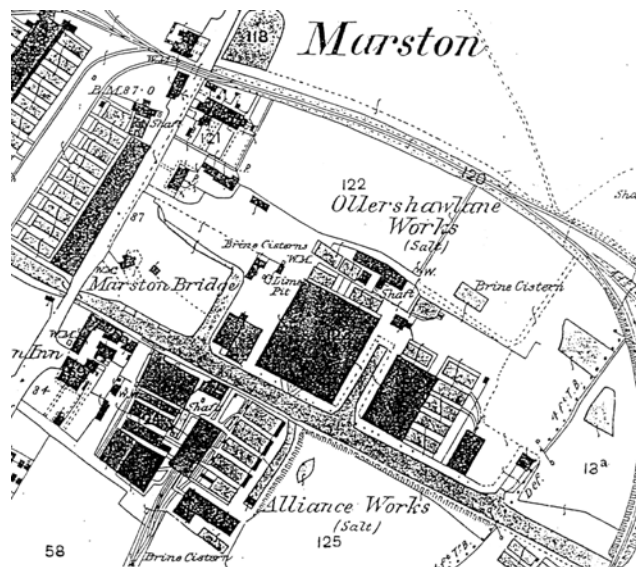
**Extract from 1<sup>st</sup> Edition OS map showing Ollershaw Lane Works (1877). Note also the extent of the Alliance Works to the south**

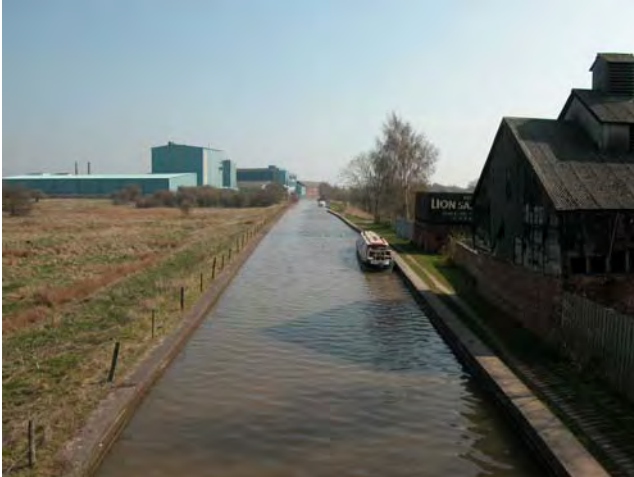
- View to northwest across Adelaide flash pool to copse of trees.
- Linear views available along the canal -
  - To the east a dialogue is set up between old and new – the foreground is dominated by the

characterful small-scale canal-side structures of the Lion Salt Works in traditional materials; this contrasts with the bland bulky modern factories finished in blue cladding, beyond the conservation area.

**View east from canal bridge - Lion Salt Works with the modern salt works in the distance**

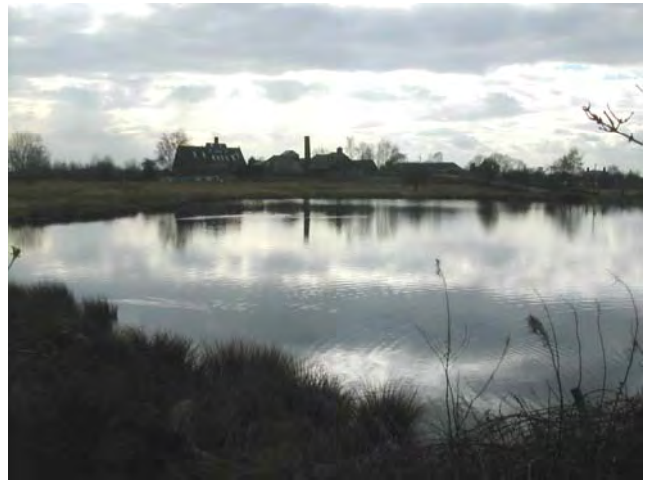
- Looking towards the centre from the perimeter of the area, the view is dominated by the distinctive timber structures and brick chimneys of the Lion Salt Works – slightly elevated above their

surroundings their outline appears in dark silhouette against a bright sky.

**View across Ollershaw flash to Lion Salt Works**

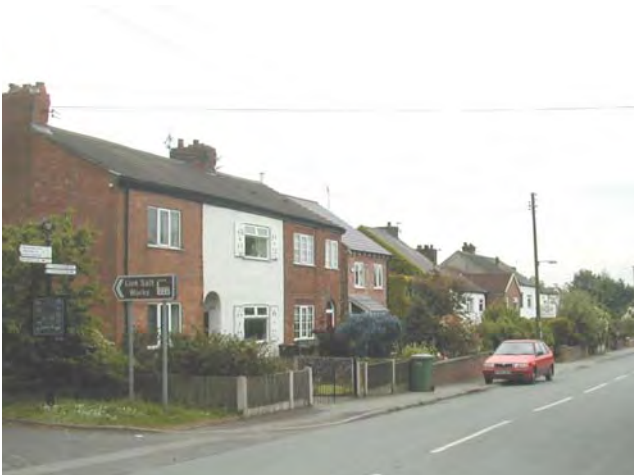
- Property boundaries on Ollershaw Lane are mainly defined by low red brick walls.
  - In summer time vegetation that spills over the red brick walls, softens and enhances the character of the area.
  - In most cases the frontage boundary has been punched through to allow off road parking.
  - There are some less appropriate timber and concrete panel fences.

**Front boundary treatment of gardens of terraces**

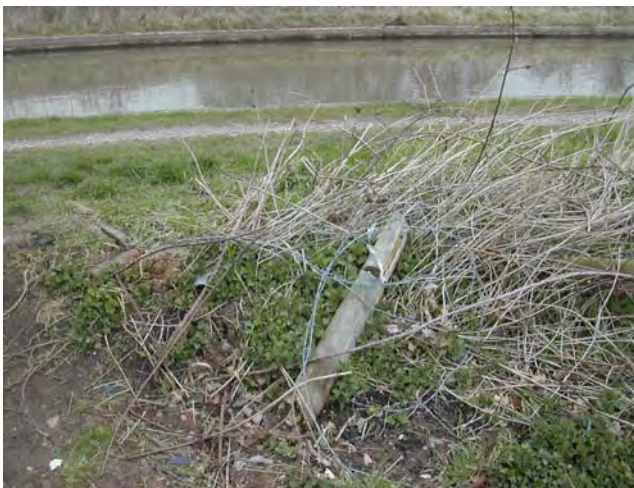
- Along Cross Street boundaries appear more loosely defined – some gardens are open to the road, which interrupts the uniformity of the street.
- Beyond the village centre, poor quality post and wire fencing predominates, often in a poor state of repair – detracts from the quality of the area.

**Collapsed post and wire fencing**

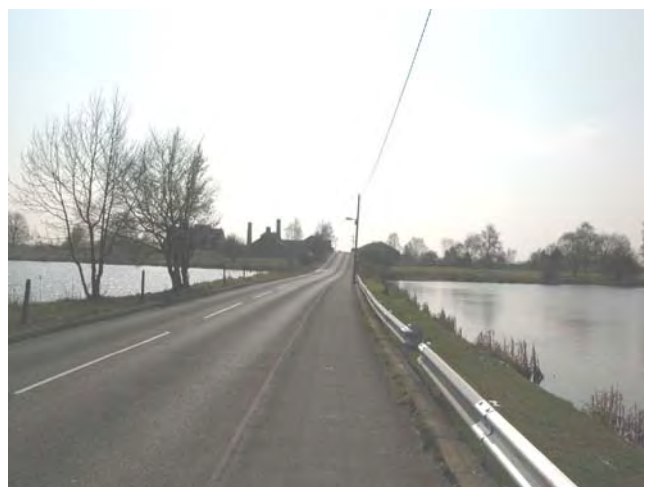
- Recent timber post and rail fencing mark the boundary around Crystal cottage.
- Tall spiked galvanised fencing has been used in recent years to protect open mine shafts and enclose part of the Lion Salt Works – this is appropriate to the area's industrial character.
- The canal edges are strongly defined with wide concrete reinforcement walls, which indicates previous subsidence problems.
- The recently installed standard safety railings on the side of Ollershaw Lane detract from the area's character.

**Safety railings approaching village from north**

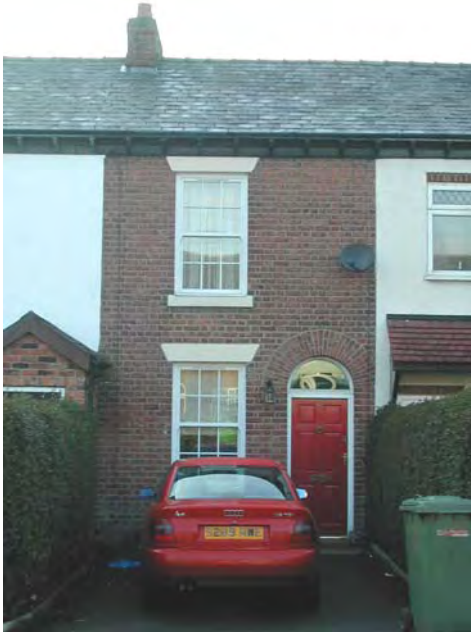
- One recently renovated dwelling serves as good evidence of how attractive the original design of the terrace could be.

**Dwelling on west side of Ollershaw Lane – original design features retained**

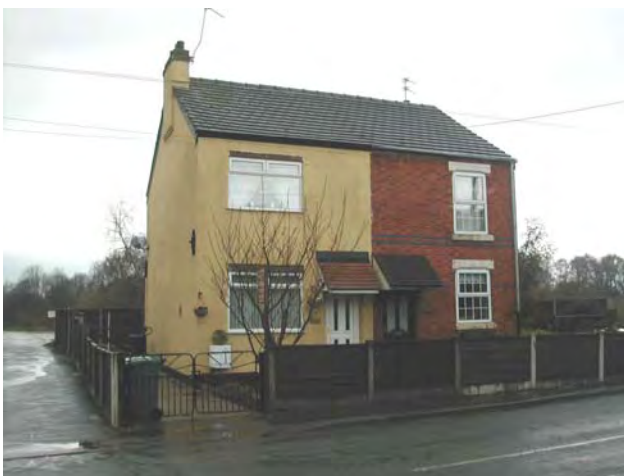
- Due to subsidence, the facades and/or gables of several have had to be rebuilt.
- In some cases this has been carried out in the original style and brick but often with a loss of original architectural details.

**Facade of dwelling to right has PVCu windows added – with rebuilt gable**

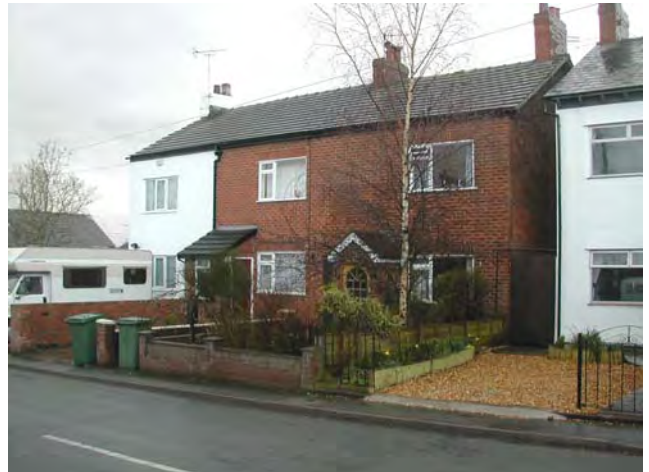
- In others, this has been carried out in new brickwork to a modern style, contemporary with the rebuilding date.
- Probably the original 19<sup>th</sup> century structure remains behind these new facades, with original internal features.

**Facade of terrace rebuilt in modern form**

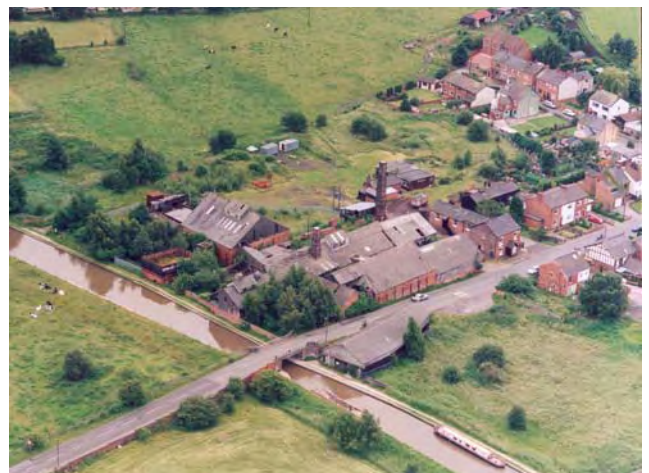
**Marston and The Lion Salt Works  
(Reproduced with the kind permission of The Lion Salt Works Trust)**

- The Lion Salt Works buildings are characterised by:
  - Timber-frame structures.

- Materials were chosen for economy and performance.
  - Brick bases were required to support the heavy saltpans and form fire and flue spaces underneath.
  - The lightweight timber structure above allowed good ventilation, and
    - Was able to accommodate the degree of movement likely due to subsidence.
    - Was resistant to salt.
    - Was easy to repair.
- Majority of the buildings within the village are constructed of red Cheshire brick in Flemish Bond.
  - Some alternative modern red brick has been used in the rebuild of some facades, including brown/red sand faced bricks in Stretcher Bond.
  - Some houses have painted cement render finish.
- Roofs are of Welsh slate with some later replacement concrete tile in a variety of colours and types – these detract from the character of the area.
  - Original ridge tiles are blue clay, but concrete replacements are increasing.

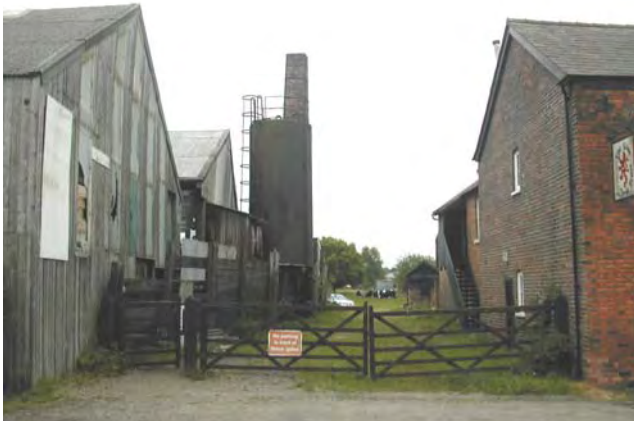
- Horizontally and vertically timber-boarded walls.
- Deep orange/red brick bases.
- Cement fibre corrugated sheet roofs.
- Roof hatches with louvered vents to allow steam to escape.
- Cement fibre rainwater goods.

**The Lion Salt Works - a variety of materials chosen for their flexibility and ready availability**

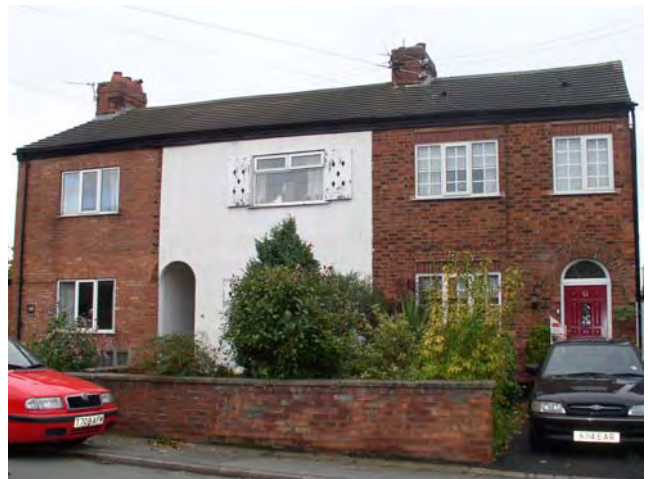
- Chimneystacks are red brick with clay pots of varying designs – some buildings, including the former Red Lion Inn, have lost their stacks.
- Rainwater goods are generally of replacement PVCu.
- Original window frames are portrait format with sliding timber sashes – few survive.
  - Most replacement window frames are timber in random designs to landscape format – some are of PVCu.
- Original heads and sills are stone – most dwellings no longer possess them.
  - Many rebuilt facades have a brick soldier course above windows.
- The Salt Barge has leaded lights set in stone mullioned window surrounds.

**These houses have both original and modern replacement features**

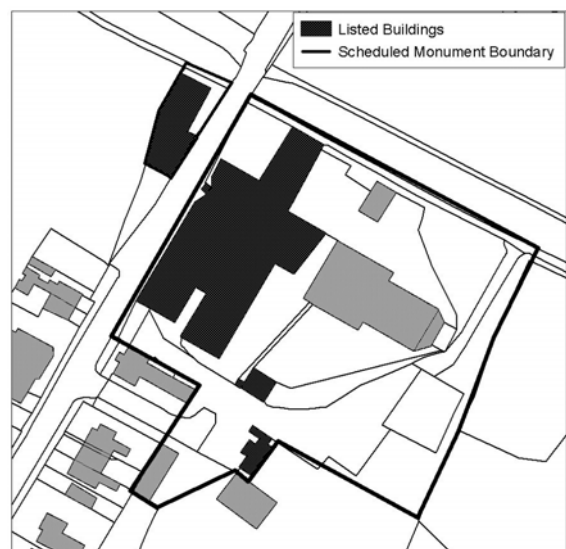
**Scheduled Site and Listed Buildings**

- The Lion Salt Works site is a Scheduled Monument – the designation includes all the upstanding structures on the sites to either side of Ollershaw Lane.
- The Grade II Listed Buildings are:
  - Pan house sheds Nos. 3 and 4 and the stoves and store sheds or warehouses behind.
  - Engine shed and pump house.
  - Manager's office (and attached boiler-house although not in list description).
  - Coronation salt store on the west side of Ollershaw Lane.
- The Lion Salt Works is unique in being the last surviving inland natural brine pumping open pan salt works in England – the existing structures contain evidence of all the various processes involved in the production of salt from natural brine at an open pan works and as such they are all key buildings.

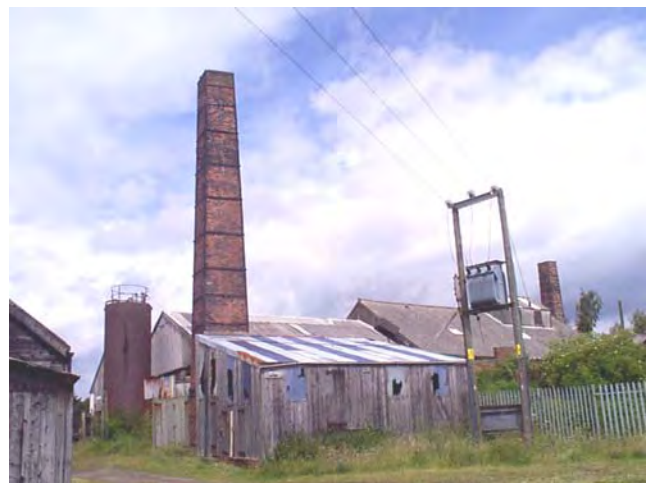
**Engine Shed and Pump House with Chimney**

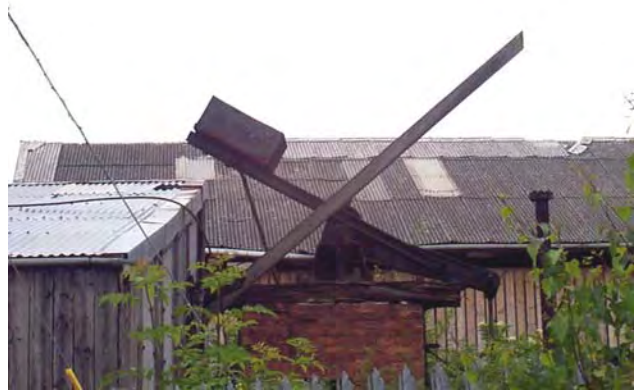
**Remains of the 'nodding-donkey'**

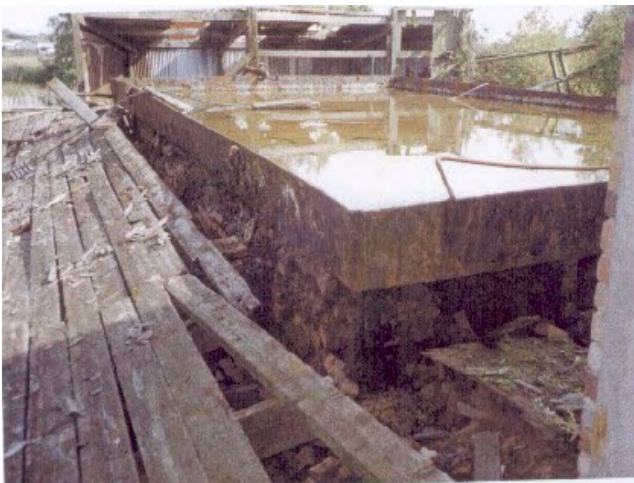
**Salt Pan**

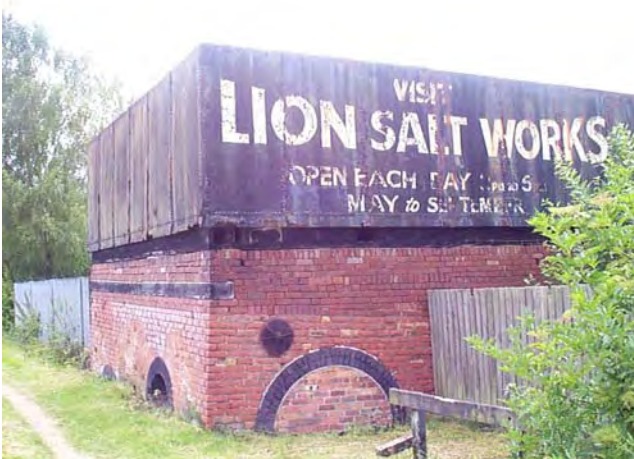
**Brine tank - significant – high profile**

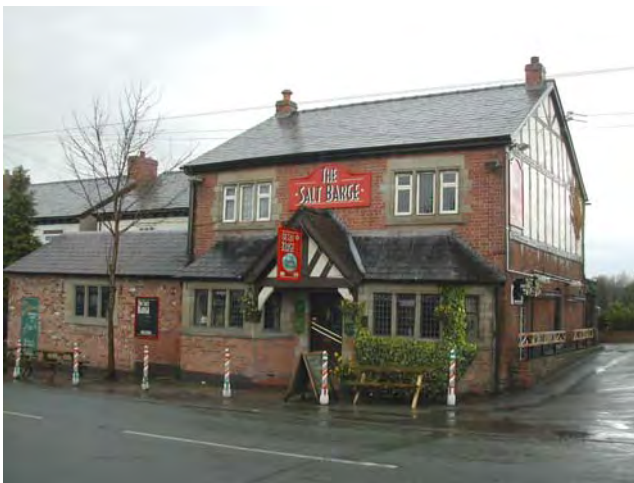
- Opposite is the public house built to replace The Red Lion Inn – once The New Inn known today as The Salt Barge.
  - A red brick building with blue slate roof and stone window surrounds, it has been significantly altered and extended in recent years to the rear and to the left (to also include the adjacent terraced house).
  - Mock timber-frame effect decoration has been applied to the north gable end, which is not in keeping with the character of the original building.

**The Salt Barge**

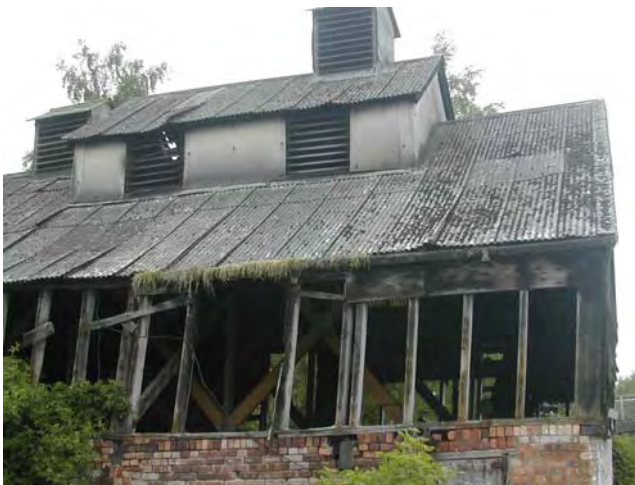
**Roof hatches with ventilation louvers**

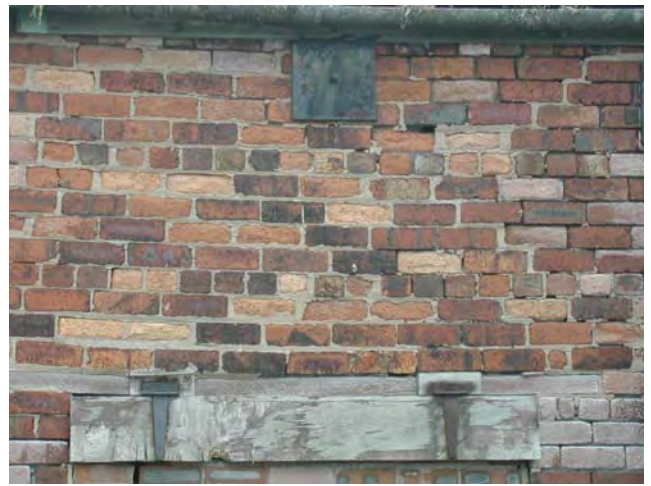
**Timber flap with metal hinges and square wall tie plate**

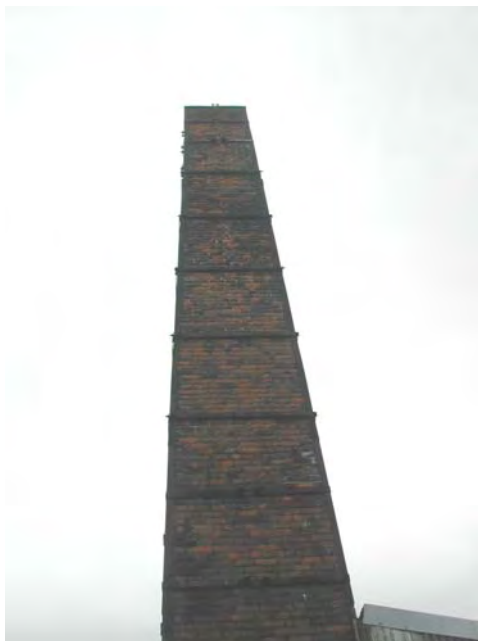
**Tall Pump House chimney with iron strapping**

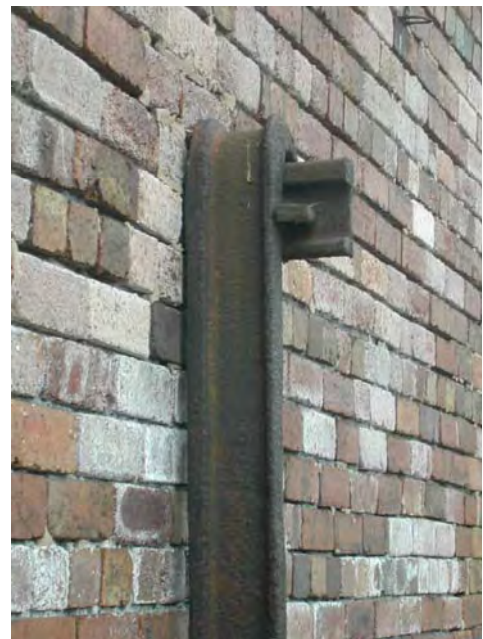
**Iron hangers**

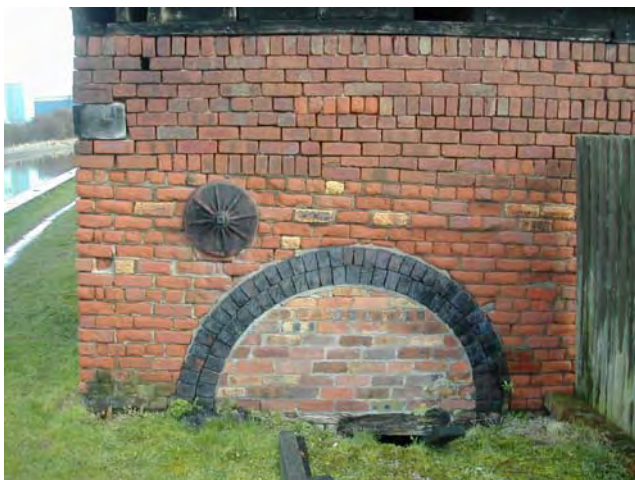
**Ribbed cast iron structural tie plate**

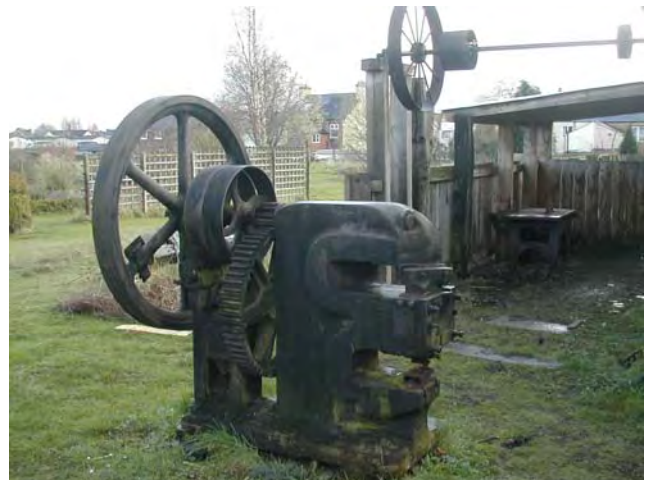
**Permanent cast iron machinery**

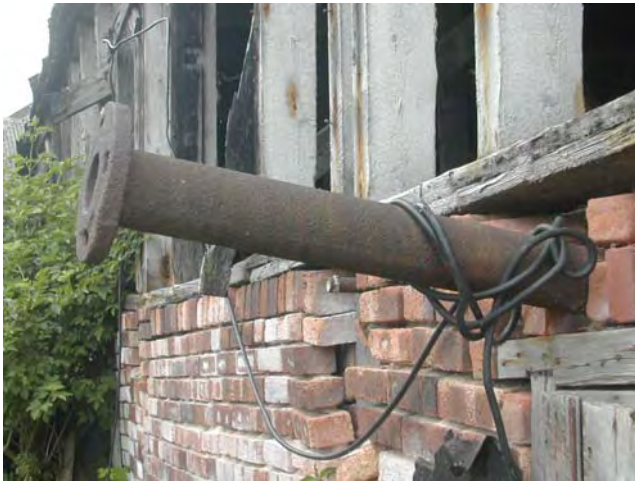
**Corroded iron pipe work**

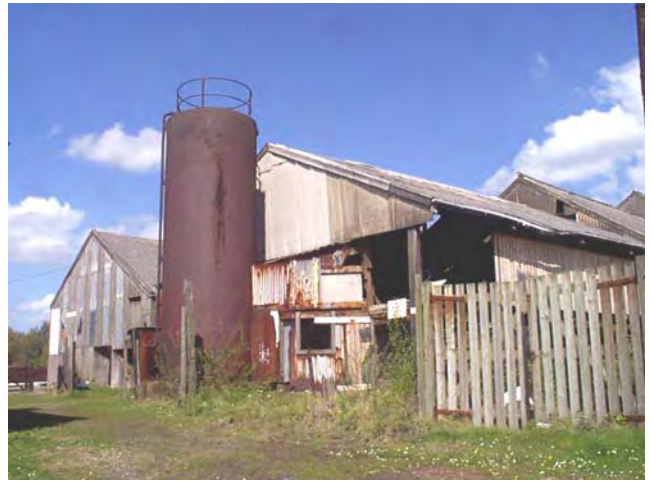
**Silo to rear of Pan House No. 4**

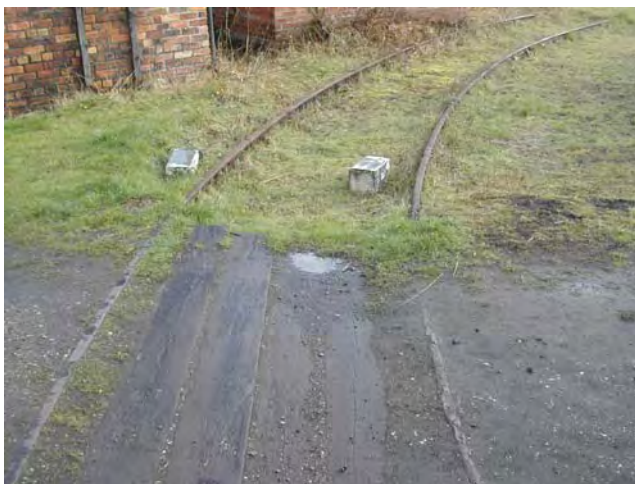
**Railway tracks set in ground**

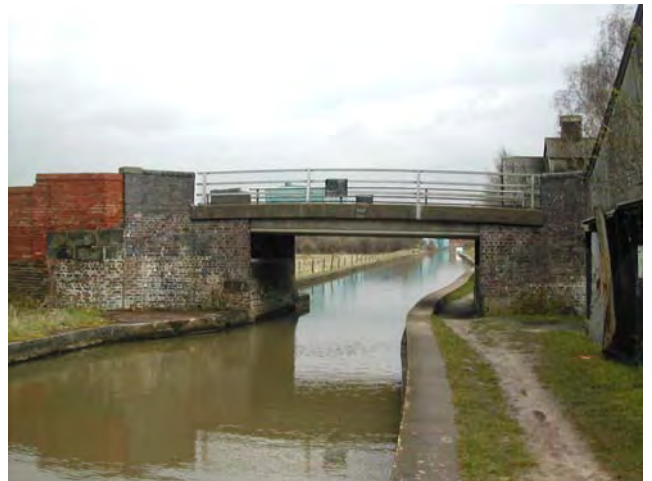
- Canal Bridge No.193 has been unsympathetically altered by removal of the centre portion and replacement with concrete beams and open steel guarding – there are stress cracks in the remaining blue engineering brickwork abutments.

**Canal bridge No.193**

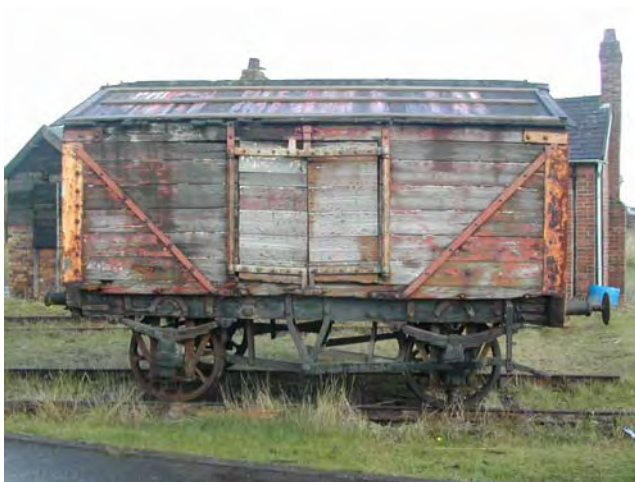
**Railway wagon**

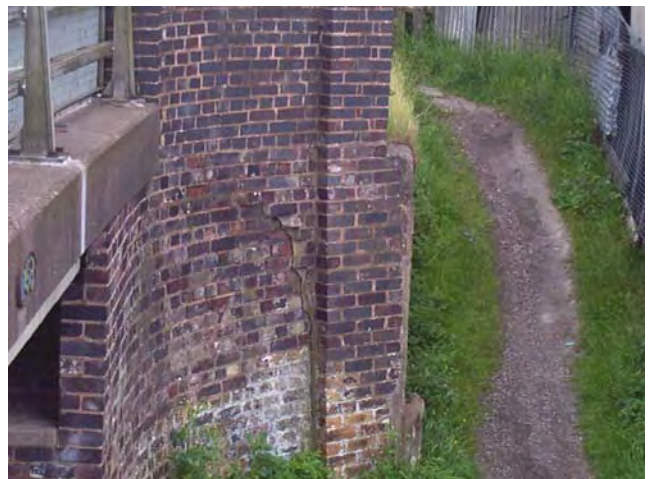
**Stress crack in bridge abutment**

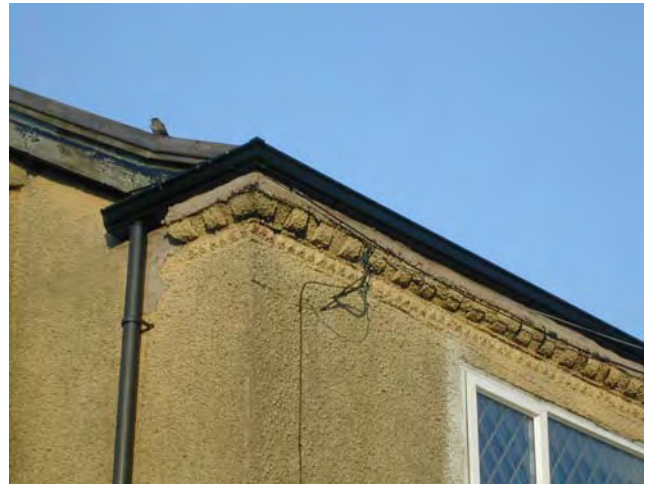
- Other detailing is either lost or covered, for example the cornice detail to Nos. 5 and 7 Cross Street.

Cornice detail on No. 5 Cross Street

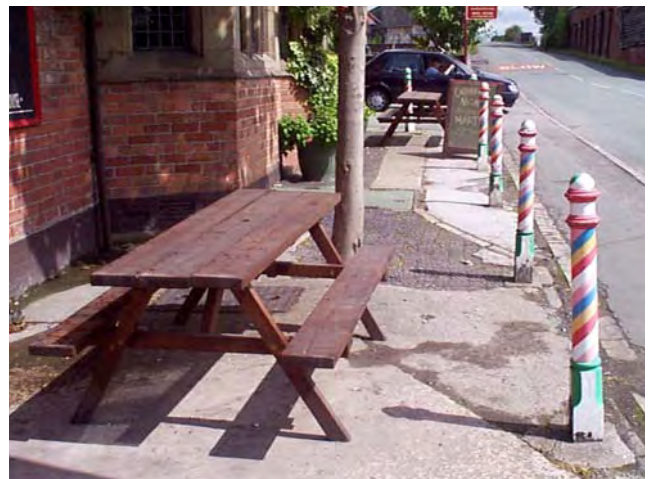
- Street and highway signage is modern aluminium on steel posts.
- Timber telegraph poles are positioned on alternate sides of Ollershaw Lane in the village – simple modern luminaire street lighting is attached to most poles.
- Inappropriate modern concrete street lamps down Cross Street.
- Candy striped bollards in front of The Salt Barge public house add to its character.
- Standard timber picnic style tables also on the forecourt of The Salt Barge.

Candy striped bollards and picnic tables by The Salt Barge public house

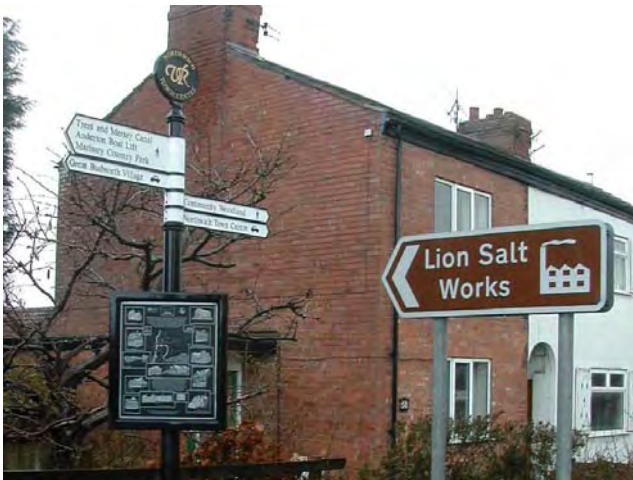
- Adjacent to a standard brown tourism sign, a cast metal fingerpost with an interpretation panel has been recently positioned outside the access to the Lion

Salt Works. It is similar to those found in the nearby Northwich town centre.

**Interpretation board and tourism sign outside The Lion Salt Works**

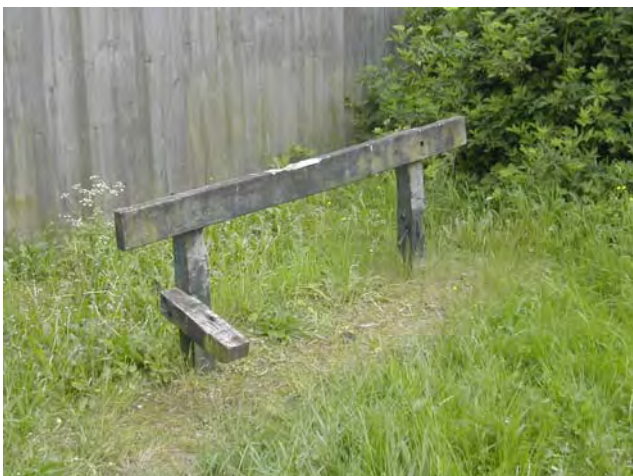
- Derelict broken timber seat and overturned canal stop-plank housing on towpath detract from quality of the area.

**Damaged seat on canal towpath**

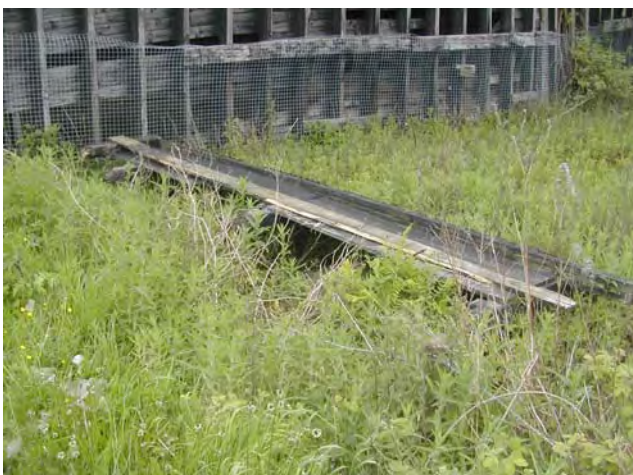
- Derelict canal stop-plank housing toppled down into field adjacent to Coronation Salt Stove – stop-plank slots no longer exist below bridge 193 due to raised concrete edges.
- Eaves bracket detail on Nos. 35-39 Ollershaw Lane.

**Damaged stop-plank housing**

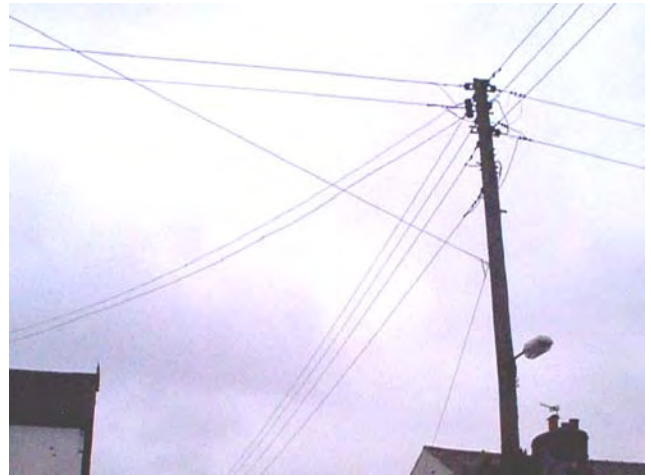
- Within village – random network of both overhead power lines and telephone wires radiating from poles – intrusive and distracting.

**Intrusive wirescape**

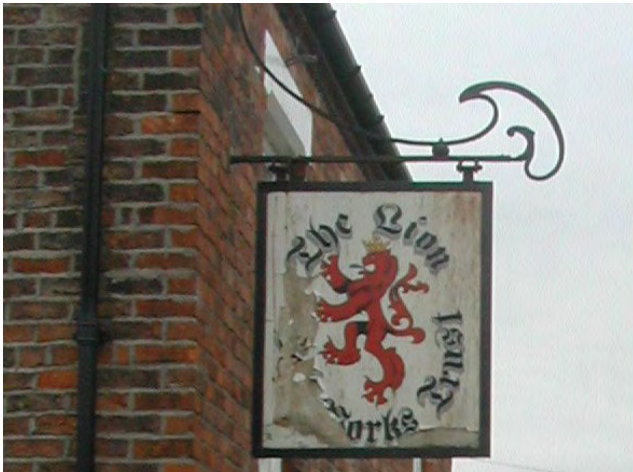
- There are no shop fronts within the conservation area.
- Historic signage connected to the Lion Salt Works includes:
  - The painted hanging sign supported by an ornate wrought iron bracket on the former Red Lion Inn, which although in

need of refurbishment, enhances the building's character.

**Lion Salt Works Office hanging sign**

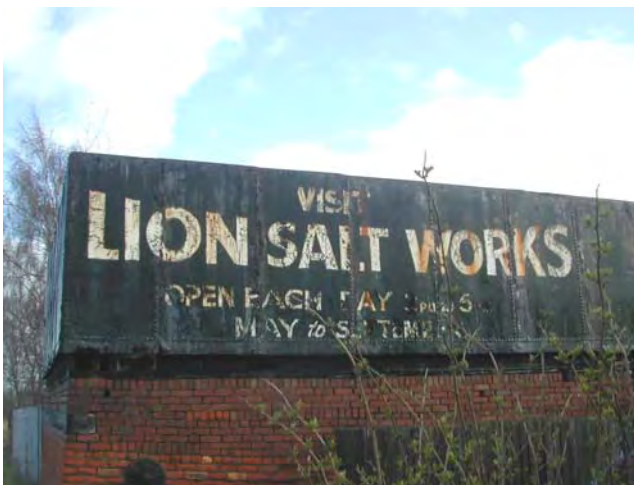
- The distinctive painted white lettering on the black brine tank and the faded large white on black lettering on the gable end of the salt store.

**Brine tank, with painted signage**

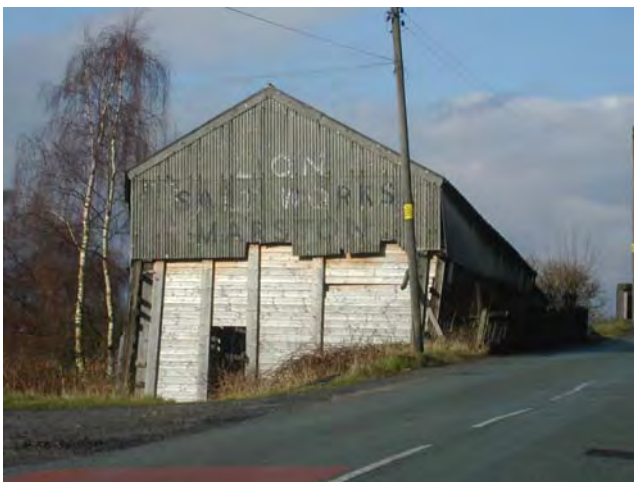
**Signage on Coronation Salt Store**

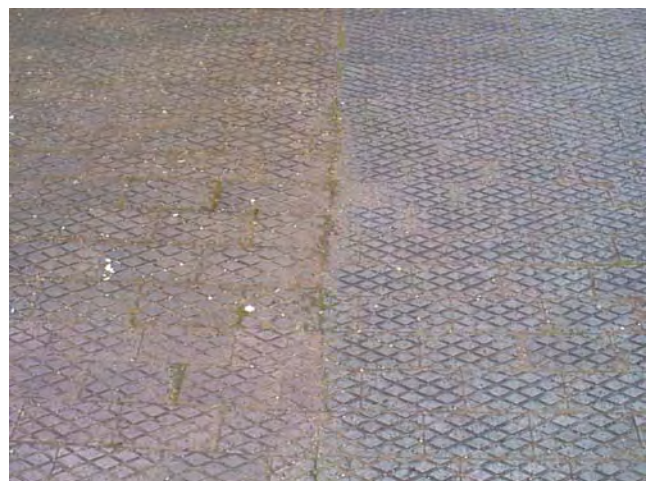
- The public roads are green surfaced dressed tarmac – the footpaths are heavily patched tarmac and the kerbs modern pre-cast concrete.
- New blue diamond chequered clay brick pavers to front and side of The Red Lion office match sunken and partially soil covered originals found along its frontage.

**Original and new diamond pattern pavers**

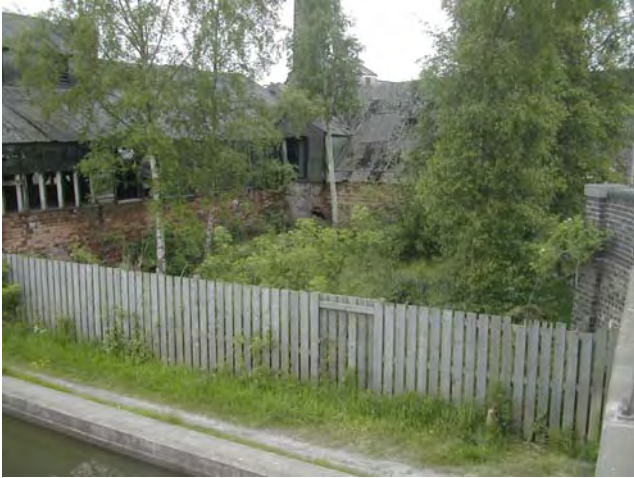
- Site of pan house No. 1 was hard landscaped in the 1982 – now reclaimed by nature due to lack of maintenance.

**Site of pan house No.1, now overgrown**

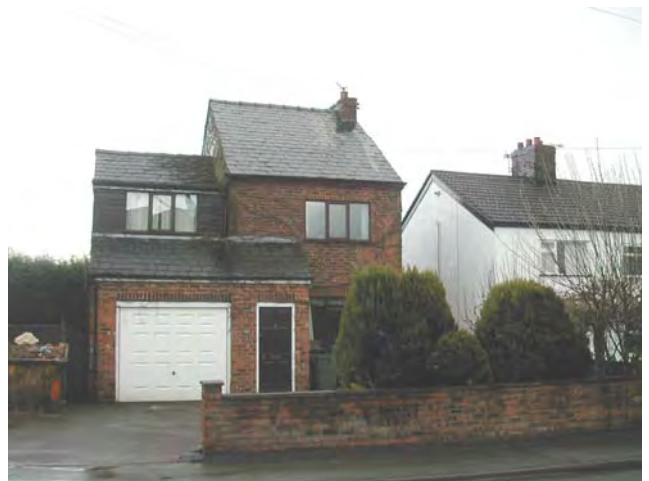
- The principle negative factors affecting the conservation area are:
  - The volume, weight and speed of traffic through the conservation area and in particular over the canal bridge.
  - The views of the dominant industrial buildings to the east.
  - Views of, and noise from, the scrap metal yard to the west – which appears to have been recently extended up to the boundary of the conservation area.
- New housing that does not respect the building line or simple form of the terrace detracts from the character of the area.

**Modern housing in contrast to traditional terrace**

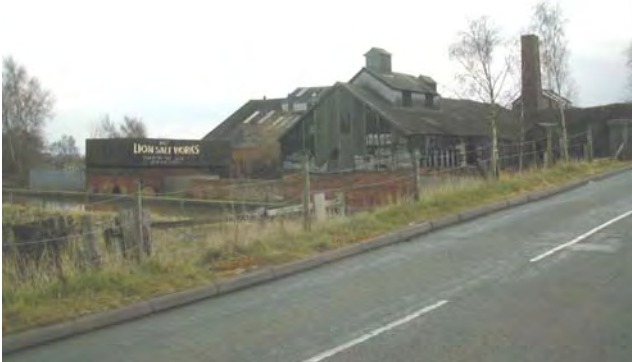
- Lack of public access to the open spaces adjacent to the flash pools limits enjoyment of these areas.
- Poor quality fencing and galvanized tubular steel gates beyond the village centre give an untidy appearance.
- The current dilapidated condition of The Lion Salt Works makes the buildings dangerous and attracts vandalism.

**The Lion Salt Works from canal bridge approach**

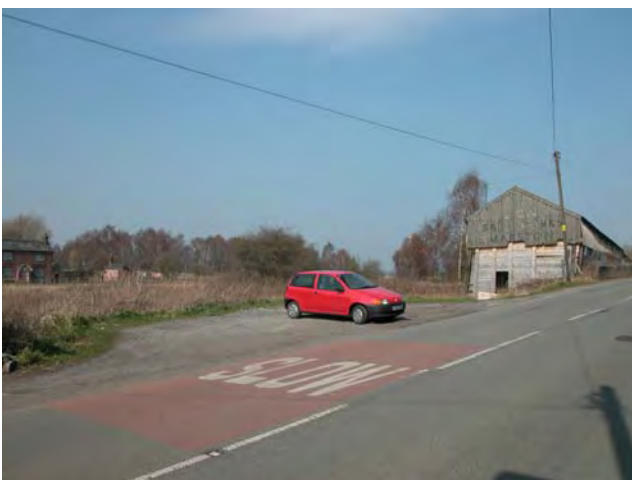
**The lay-by opposite the Lion Salt Works is poorly surfaced, and detracts from its surroundings**

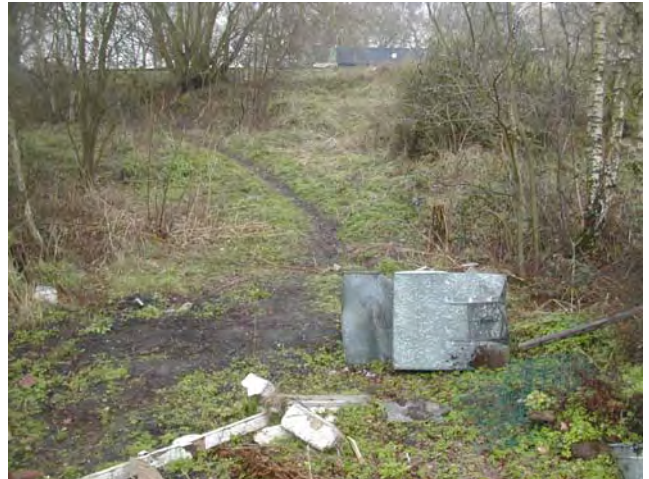
**Fly tipping to the southwest of the canal**
