SNC • LAVALIN

Northwich

Section 19 Flood Investigation - Interim Report

November 2020

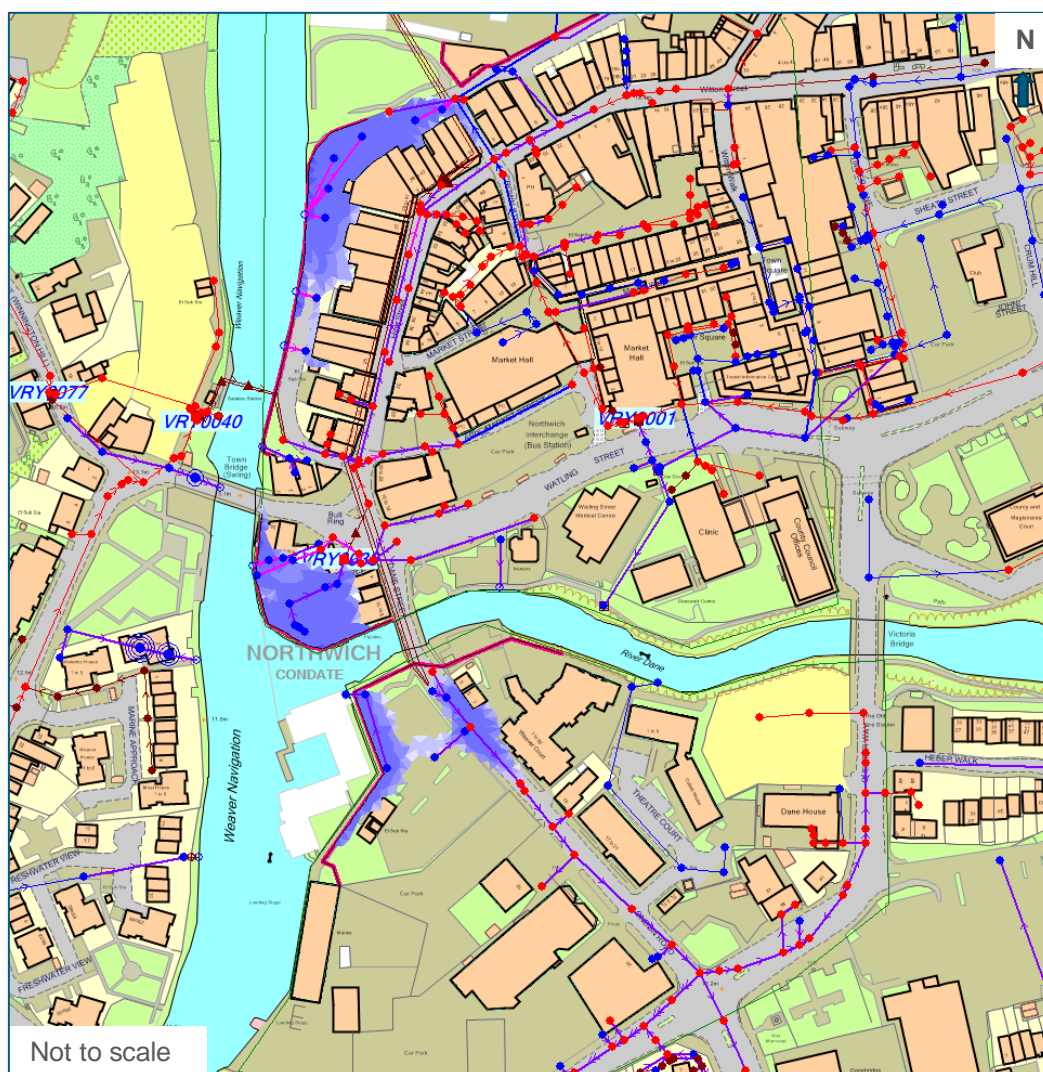
Figure 3-12 - Surface Water Flood Map – Northwiche Town Centre – UU

Surface water flood maps have also been produced by United Utilities for the Northwich Town Centre. The below map indicates the predicted surface water flood risk when the pumping station is operating at permitted levels and all flap valves to the river are in working order and closed during an event. Comparable rainfall and river levels to the October 2019 event were used to generate this map.

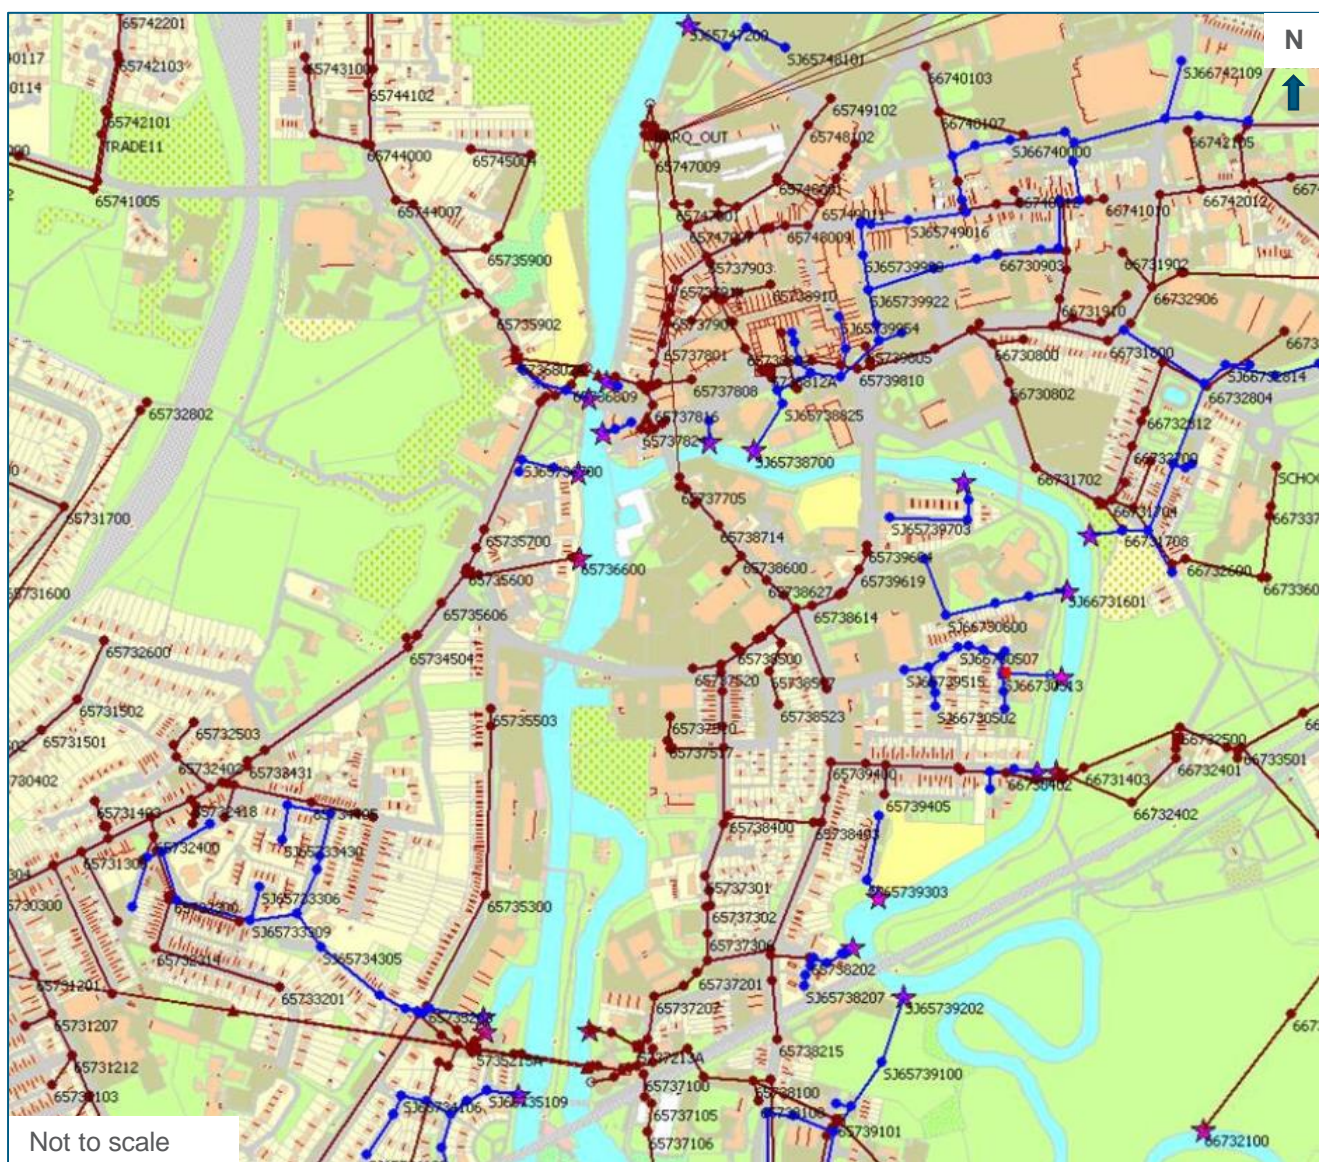
Figure 4-2 - UU Network and Outfalls– Northwich Town Centre

7200 – Barons Key Road - No flap valve- 150mm s/w overgrown
 6805- Not starred on map but Winnington Hill pumping station and Winnington Hill CSO has 2 flap valves – 375mm
 6811 – Town Bridge 150mm surface water- No flap valve
 6818 – Under Town Bridge 225mm s/w sewer – No flap valve
 6819 – South/East of Town Bridge – 100mm s/w sewer – No flap Valve
 6703 – Navigation House (Marine Approach) – 225mm S/W Unable to determine as outfall under water
 6600- Freshwater View – 450mm s/w has a flap valve
 5208 and 5210 – Waterside House – both have flap valves – 575mm s/w and 450mm comb/s
 6204 – Dock Road Edwardian Pumping station – 1200mm overflow
 6103 – Yarwood Close- No flap valve

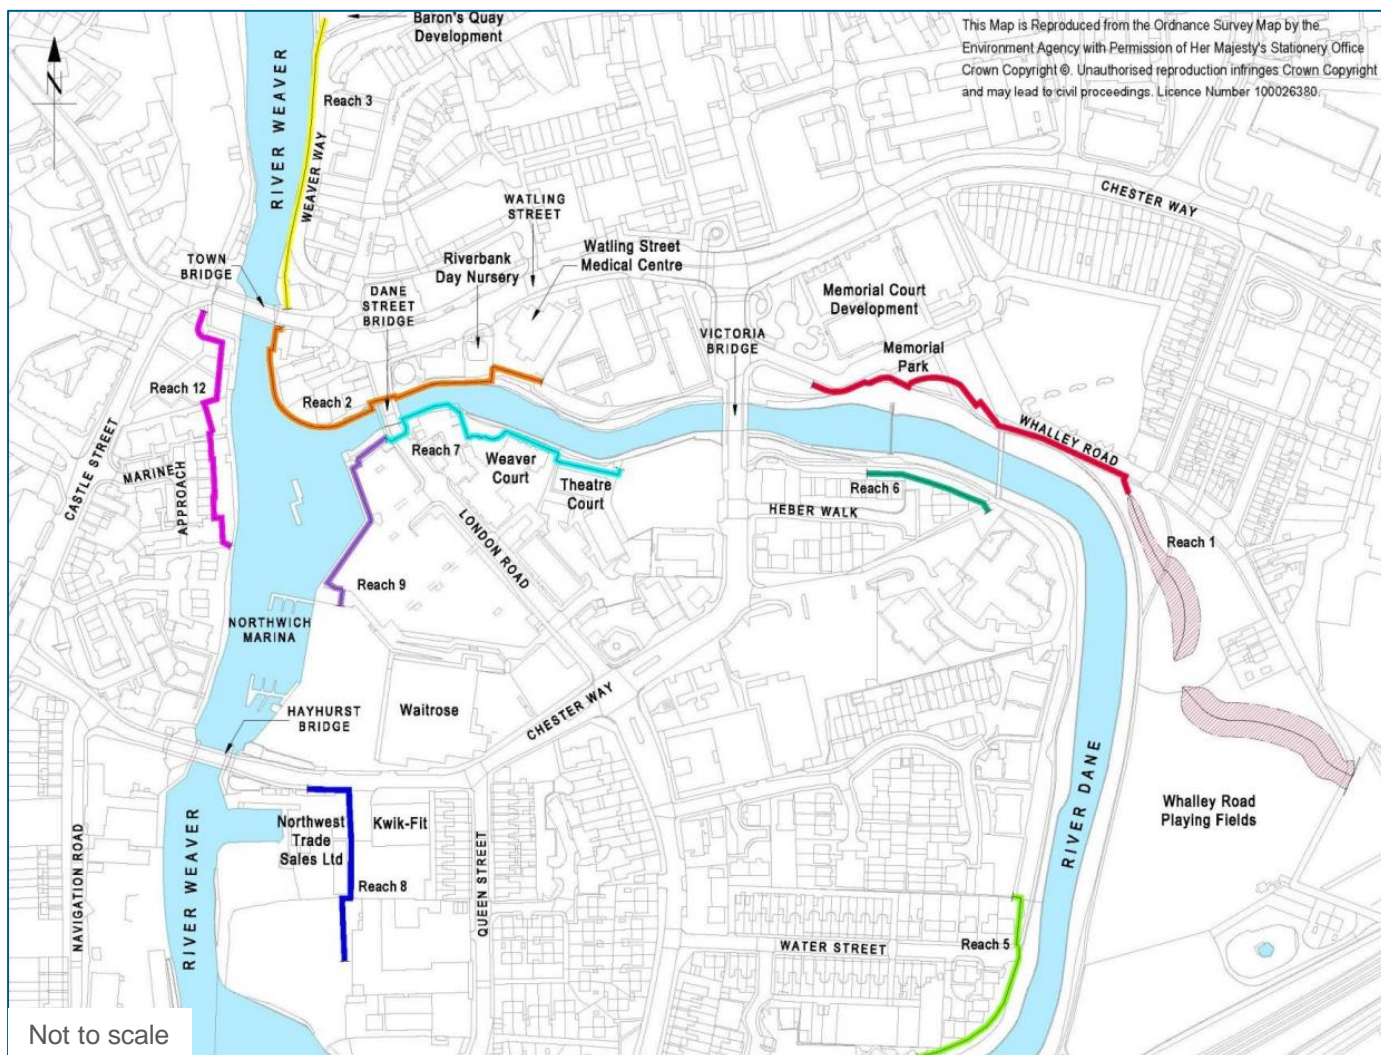
Figure 4-7 - Northwich Town Centre Flood Defences

The flood defences were designed to protect 400 properties. Many of these areas benefitted from this flood protection in the flooding that occurred October 2019. The following three areas where flood defences were present were affected by flooding in October 2019:

1. Downstream of Town Bridge – Right Bank River Weaver
 - Demountable flood barriers founded on concrete grounding beam and sheet piles
 - Continuous sheet pile wall with structural glass panels
2. Upstream of Town Bridge to Dane St Bridge – Right Bank River Weaver / Right Bank River Dane
 - Continuous sheet pile wall with structural glass panels
 - Demountable flood barriers across Dane St Bridge
3. Northwich Quay to Dane St Bridge – Right Bank River Weaver / Left Bank River Dane
 - Continuous sheet pile wall with structural glass panels
 - Demountable flood barriers and flood gate between Northwich Quay and Waitrose car park
 - Demountable flood barriers across Dane St Bridge

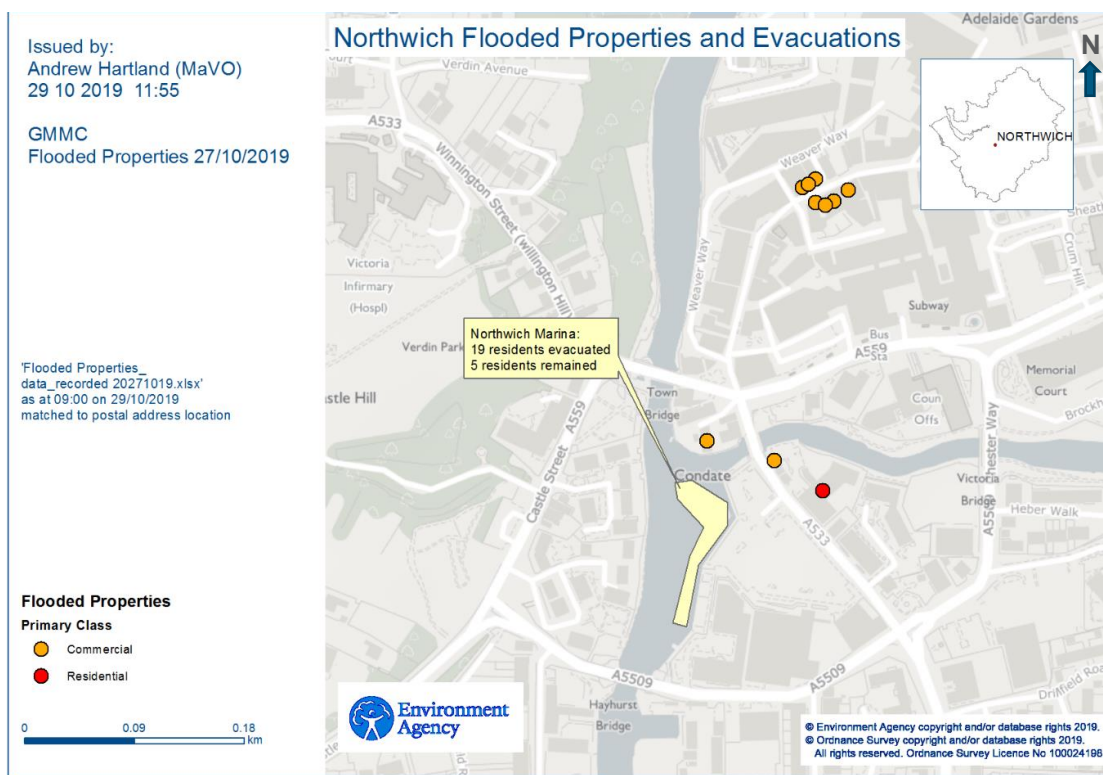
Figure 7-2 - Northwich Town Centre Flooded Properties Location Plan

Figure 7-2 illustrates the location of the properties flooded in the Northwich Town Centre as recorded by the Environment Agency after the flood event in October 2019.

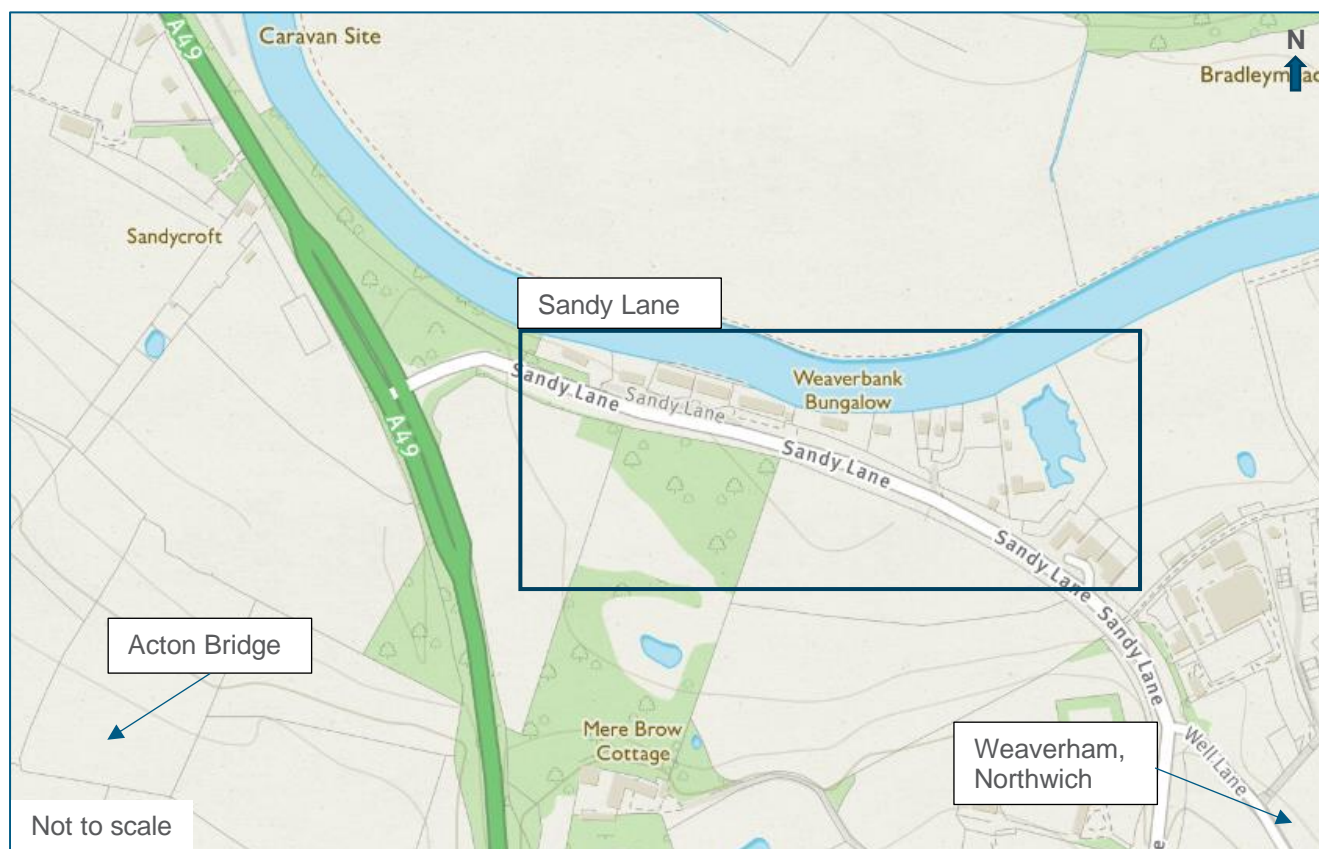
Figure 7-6 - Sandy Lane location plan

Figure 7-6 outlines the area affected by the flooding at Sandy Lane.

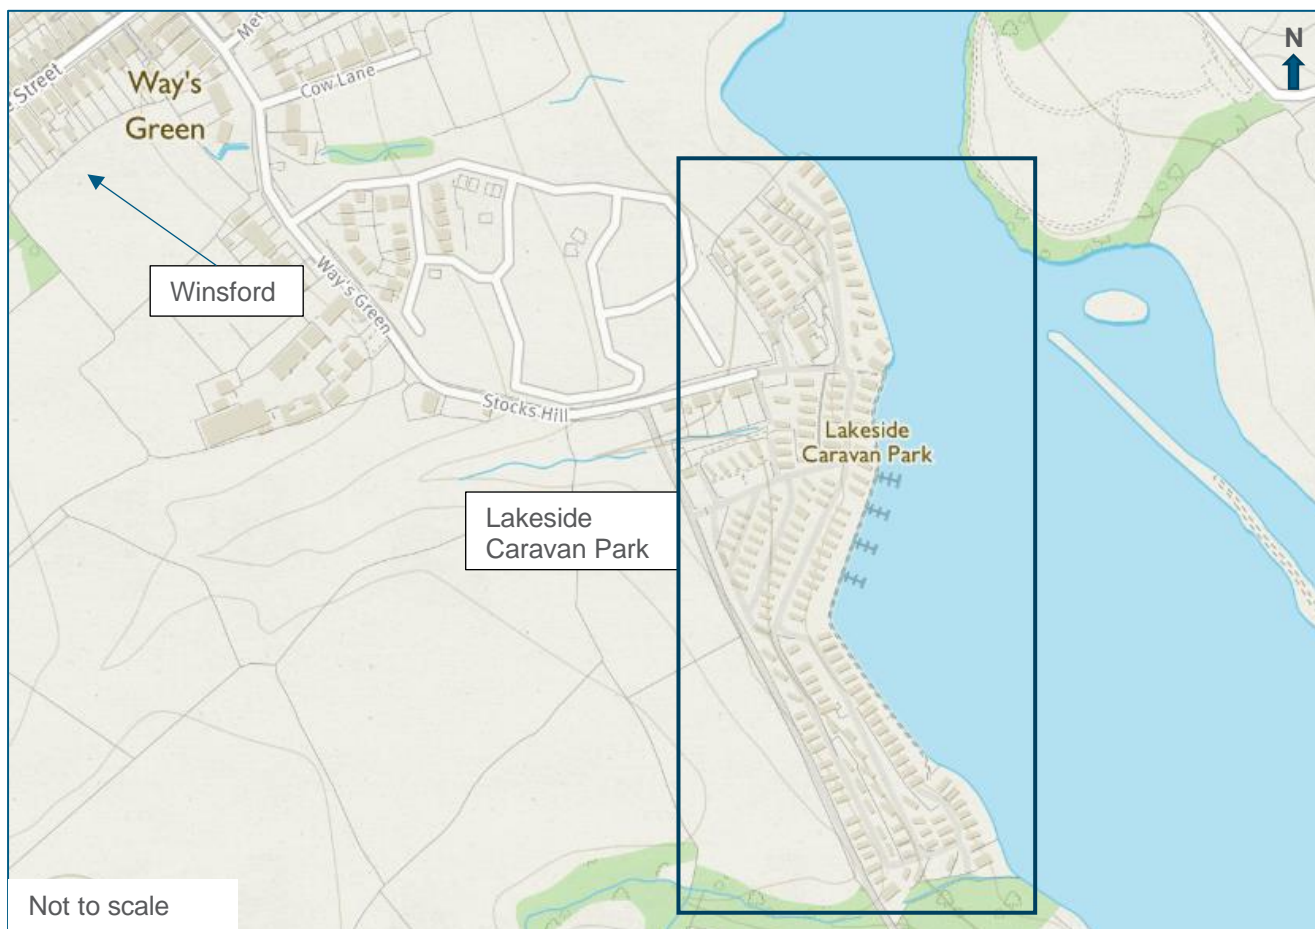
Figure 7-8 - Lakeside Caravan Park location plan

Figure 7-8 outlines the area affected by flooding at Lakeside Caravan Park.

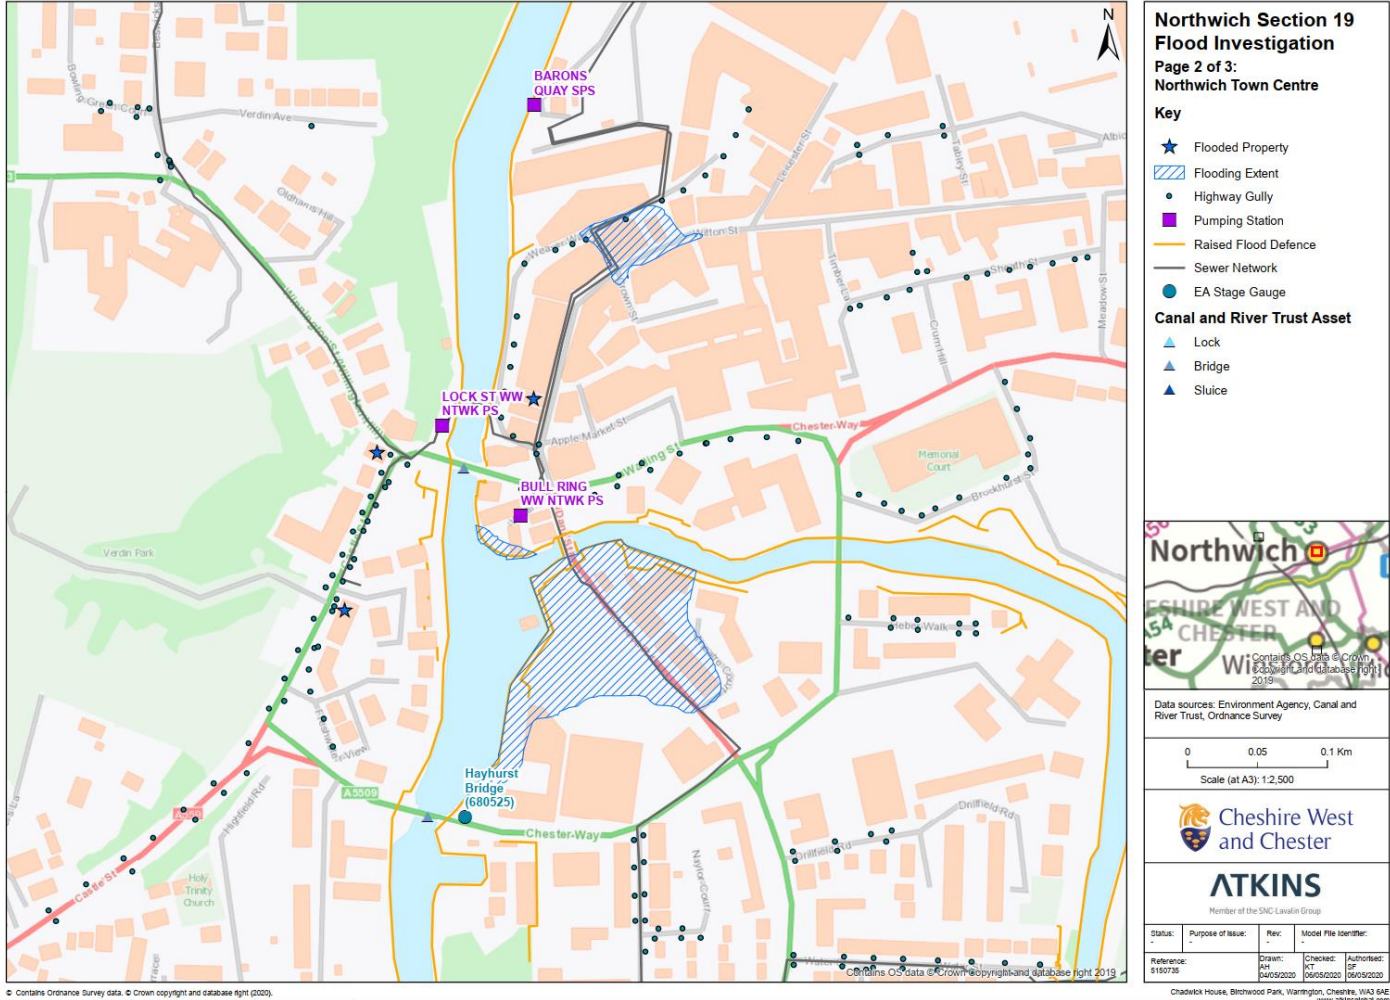
B.1. Flood Outline Map - Northwich Town Centre

Flood outline maps that detail the extent of the flooding have been developed in consultation with CWaC and affected property owners, these can be found in Appendix B.
