Winsford Main Report Details

Project:	Storm Christoph Section 19 Main Report		
Area:	Winsford		
Date:	10/8/2022	Project No.:	5150735

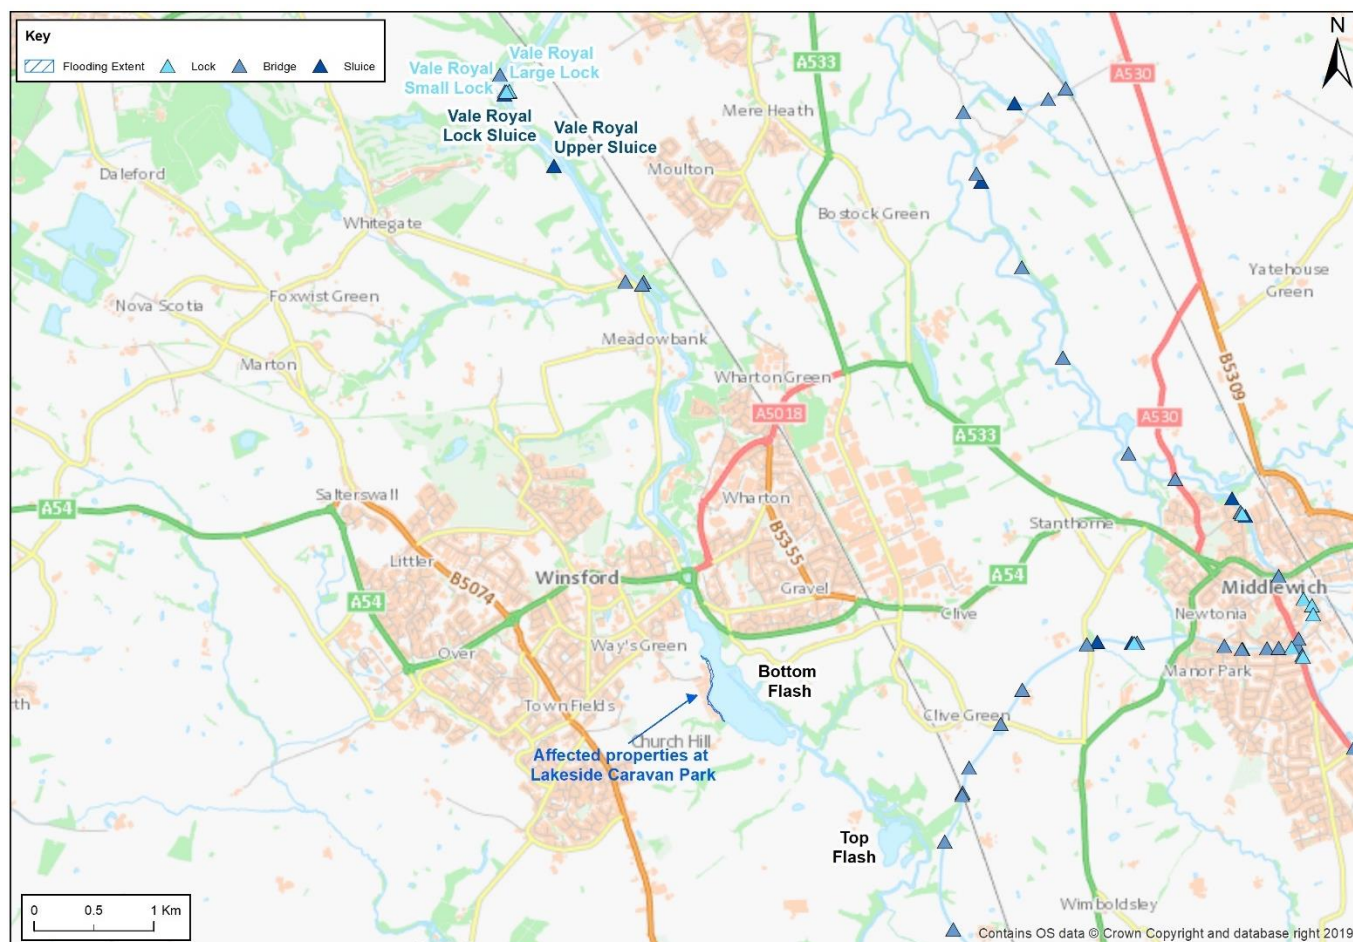
Figure 1 – The Trust’s Assets at Winsford

The Canal and River Trust (the Trust) is responsible for the operation and maintenance of the Vale Royal lock and sluice gates located 5.7km downstream of Bottom Flashes, these gates are operated for navigation purposes but can also influence water levels upstream, refer to Figure 1.
