Winsford Main Report Details

| Project: | Storm Christoph Section 19 Main Report | | |
| Area: | Winsford | | |
| Date: | 10/8/2022 | Project No.: | 5150735 |

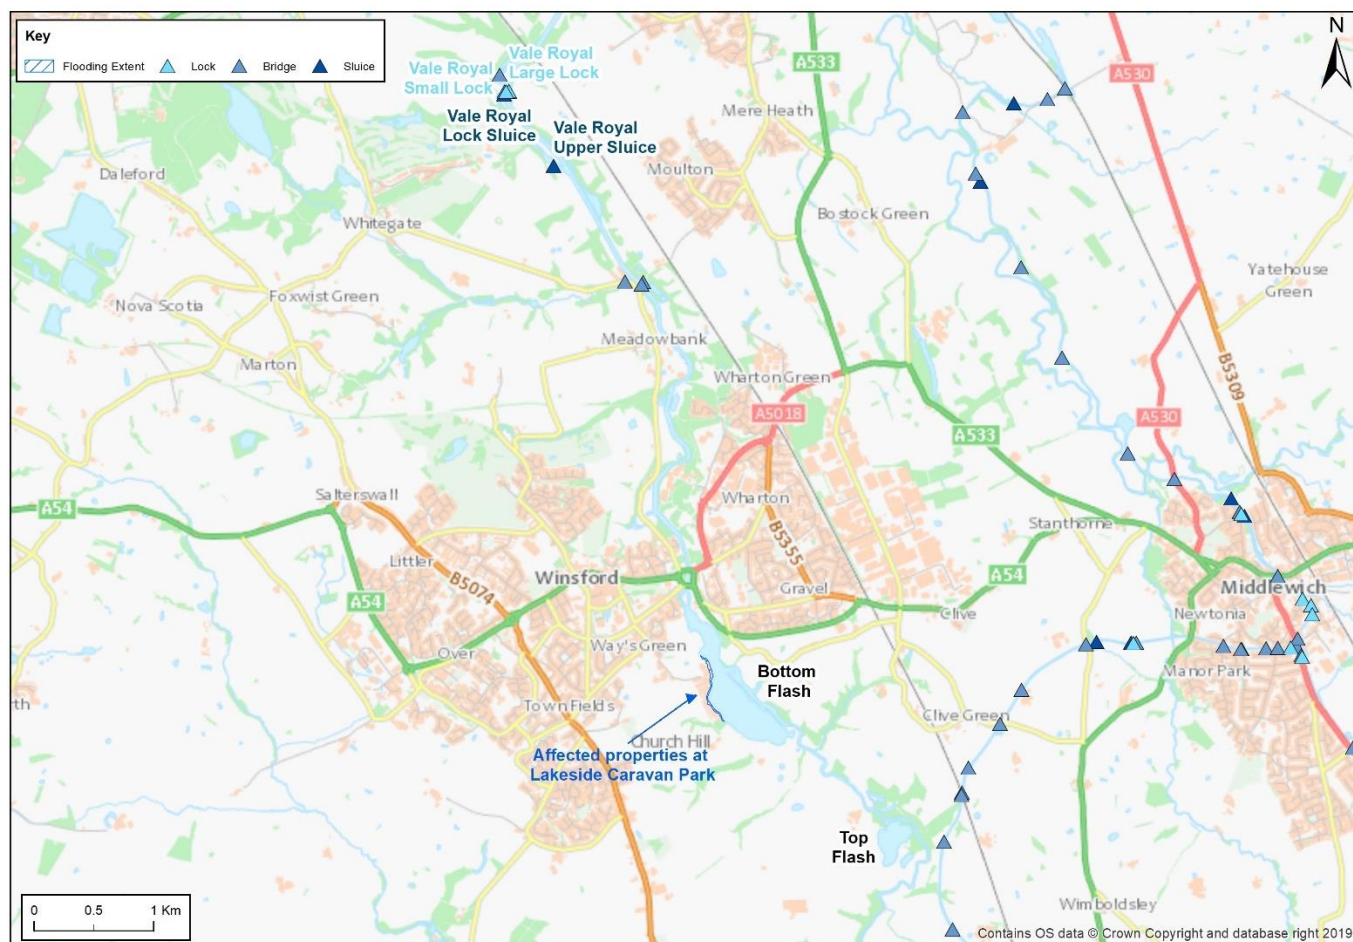
Figure 1 - C&RT Assets at Winsford

The Canal and River Trust (C&RT) is responsible for the operation and maintenance of the Vale Royal lock and sluice gates located 5.7km downstream of Bottom Flashes, these gates are operated for navigation purposes but can also influence water levels upstream, refer to Figure 1
