Northwich

Section 19 Flood Investigation Report (October 2019 Flooding Event)

March 2021

5150735-DG-002

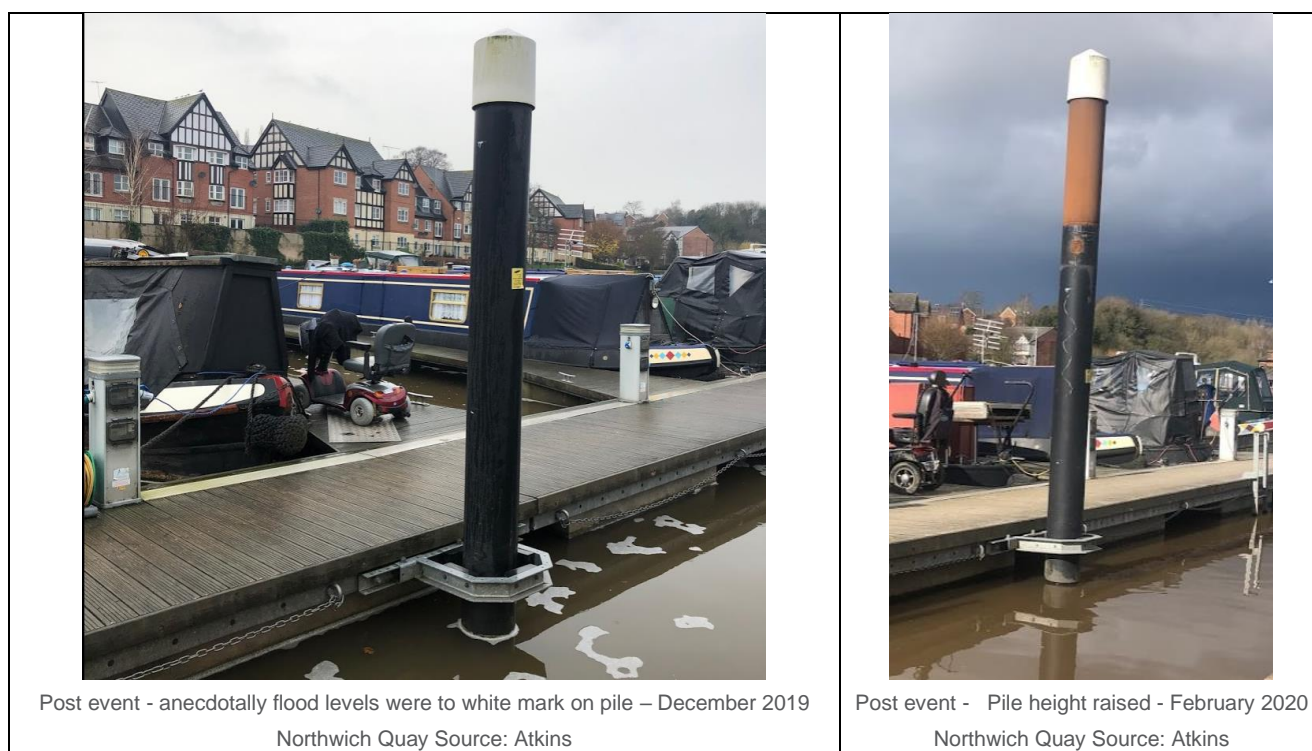
Figure 7-4 - Photograph anecdote of flooding at Northwich Quay

Photographs that show the extent of the flooding at Northwich Quay and response, can be seen in Figure 7-4.

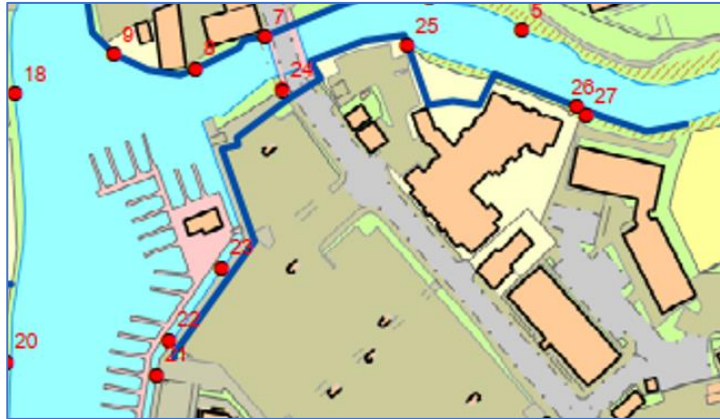
b) Unflapped or inoperable flow control on outfalls	Yes	<p>Outfalls 21 - 24 identified on the outfall map and schedule had flap valves in what appears to be working order. There is no record of flap valve performance during the event at these locations.</p> <p>Outfalls 25 -27 identified on the outfall map have flap valves which are private, however there have been reports of debris build up nearby and flap valve 26 was reported to be seized open following the event. This outfall is 300mm in diameter and thought to belong to the Weaver and Theatre Court development.</p>	<p>If flap 26 was seized open during the flood event, based on the river hydrograph and an assumed lowest cover level of 11.4mAOD, there would have been some backflow through the system.</p> <p>Based on a 300mm diameter, it is likely that this would have been a small contributing factor to the flooding on London Road.</p>

Surface Water Flooding			
3. Was water able to drain via gravity to river from the area where the flooding was observed?	No	<p>River levels compared against the invert levels of outfalls in this area, indicate that operating flap valves would have been river locked.</p>	<p>Water would have backed up and contributed to surface water flooding.</p>

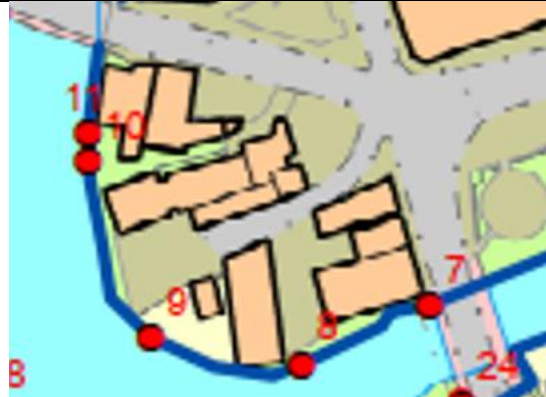
flap valve. There could have been some inflow from this outfall.

Surface Water Flooding				
3. Was water able to drain from the area where the flooding was observed?	No	<p>Reports indicate the water was not able to drain and had to be pumped away.</p> <p>Invert of drain down valves range from 10.53 – 10.92mAOD, meaning these were river locked from 12:00 26/10/2019 to 22:00 27/10/2019.</p>	Surface water would have backed up within the gravity drainage system and spilt out above ground.

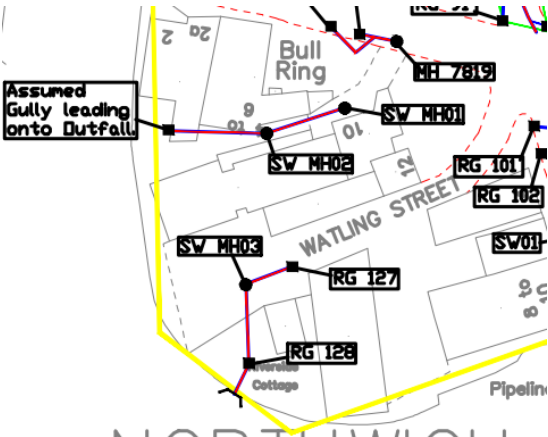
b) Highway drainage (CWaC)		<p>Two highway drains run down Watling Street. Both discharged to the River Weaver and had working non return valves.</p> <p>The CCTV drainage survey identified that one of these drains was reported to be filled with debris, no issues were reported on the second.</p>	<p>Once the flap valves were river locked surface water would have backed up within the system and contributed to surface water flooding.</p>

c) Private	Yes	A single private drain discharges to the River Weaver from a private courtyard.	This may have led to back flow or backing up within the Bullring area.

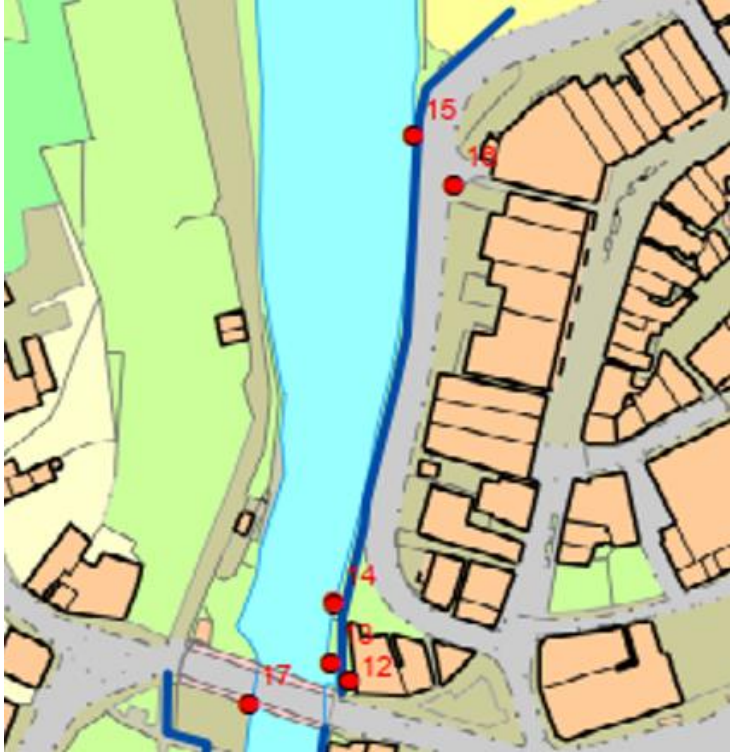
b) Unflapped outfalls	Yes	<p>2 CWaC outfalls identified, both reported to have non-return valves between the upstream MH and the outfall (refer CCTV drainage Survey).</p> <p>1 UU surface water drain outfalls through this section, this has a flap valve (UU Ref 6811).</p>	<p>Potential for back flow through the UU surface water drain from the river and backing up of the CWaC highway drains.</p>

Surface Water Flooding			
3. Was water able to drain from the area where the flooding was observed?	No	<p>Photos of ponding on Weaver Way and High Street.</p> <p>River levels within the Weaver would have caused the flap valves to river lock.</p>	<p>Consequence would have been some surface water ponding on Weaver Way.</p>
4. Are there drainage assets in the area	Yes

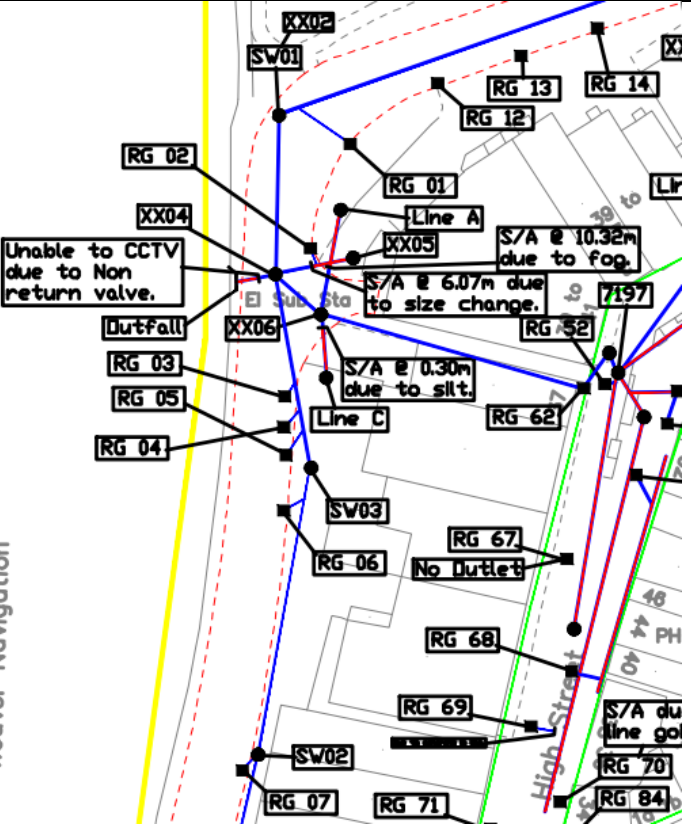
<p>b) Highway drainage (CWaC)</p>		<p>Highway drainage flows to the Weaver via a flow control (Section Inspection - 01/12/2020 - XX04X)</p> <p>Evidence of fat, grease deposits and silts resulting in reduced capacity (Section Inspection - 02/12/2020 - XX05X, Section Inspection - 02/12/2020 - XX06X of CCTV Drainage Report)</p>

<p>Fat and grease deposits would have reduced capacity of the drain to drain surface water from the area during the event, before the outfall flap valve was river locked.</p> <p>After the river level rose and the flap valve was unable to open and release the surface water, the highway drainage system would have backed up which would have contributed to surface water spilling from the lowest level gullies.</p>
<p>c) Private</p>	<p>Unknown</p>	<p>Unknown</p>
