Blacon Main Report Details

Project:	Storm Christoph Section 19 Main Report		
Area:	Blacon		
Date:	10/08/22	Project No.:	5150735

Blacon Main Report

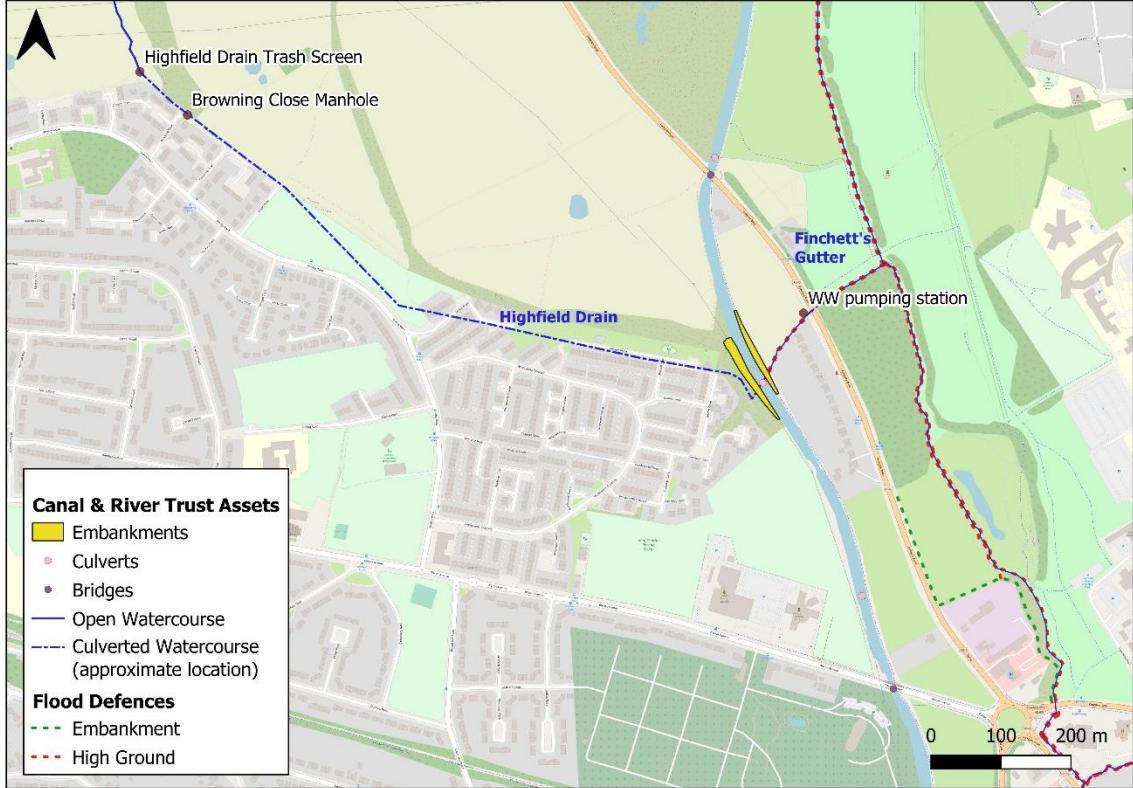
Figure 1 - Blacon overview

An overview of the watercourses and key drainage assets within Blacon is shown on Figure 1. There is an open watercourse to the north of Blacon, Highfield Drain (classified as an ordinary watercourse), which flows south towards Browning Close, the Highfield Drain catchment includes land upstream and to the north of Chester around the A540 between Mollington and Saughall as far north as Two Mills.

Just north of Browning Close, Highfield drain is culverted in a 900mm pipe. This pipe conveys the water from west to east, under the Shropshire union canal and A540 (Parkgate Road) before discharging into Finchett's Gutter (classified as an ordinary watercourse), after it is culverted under Parkgate Road. In November 2019, the Environment Agency (EA) surveyed this drain and found it to be in good condition.

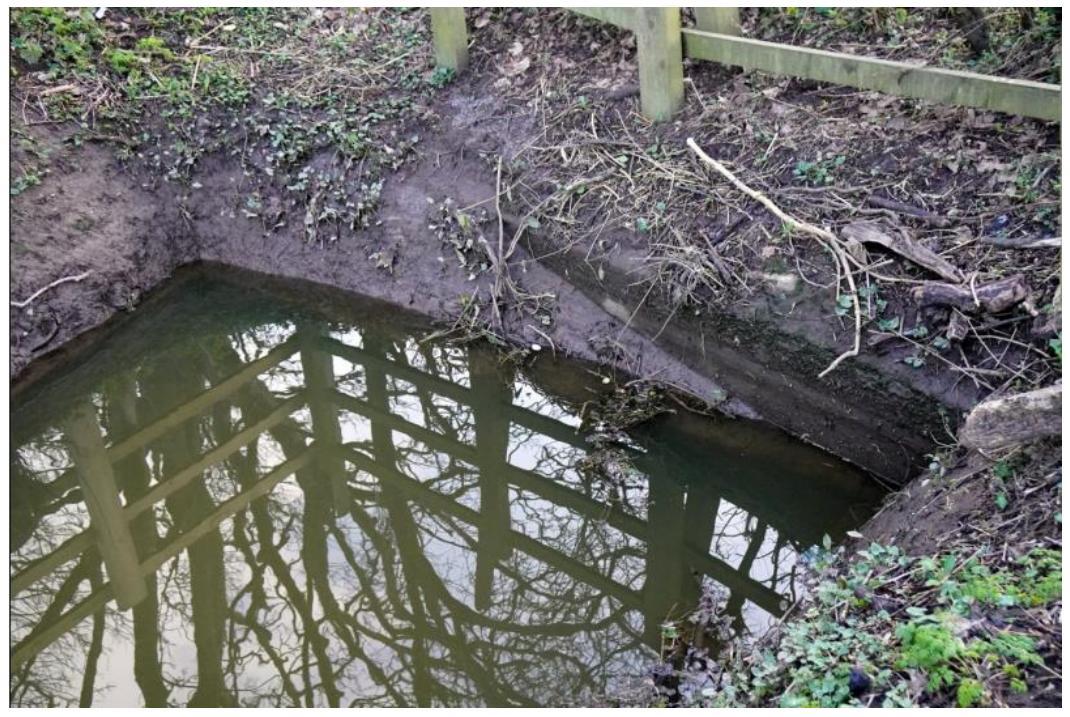
Figure 2 - Parkgate Road Culvert Outlet

Figure 2 shows the submerged outlet structure of the Parkgate Road culvert and Figure 3 shows Finchett's Gutter downstream of Parkgate Road.

- Clean and de-silt the Finchett's Gutter/ Highfield Drain culvert under Parkgate Road (The EA completed a survey of Highfield Drain in November 2019 which was in a good condition at the time). EA to confirm maintenance programme for Finchett's Gutter to ensure it remains clear of debris and vegetation.

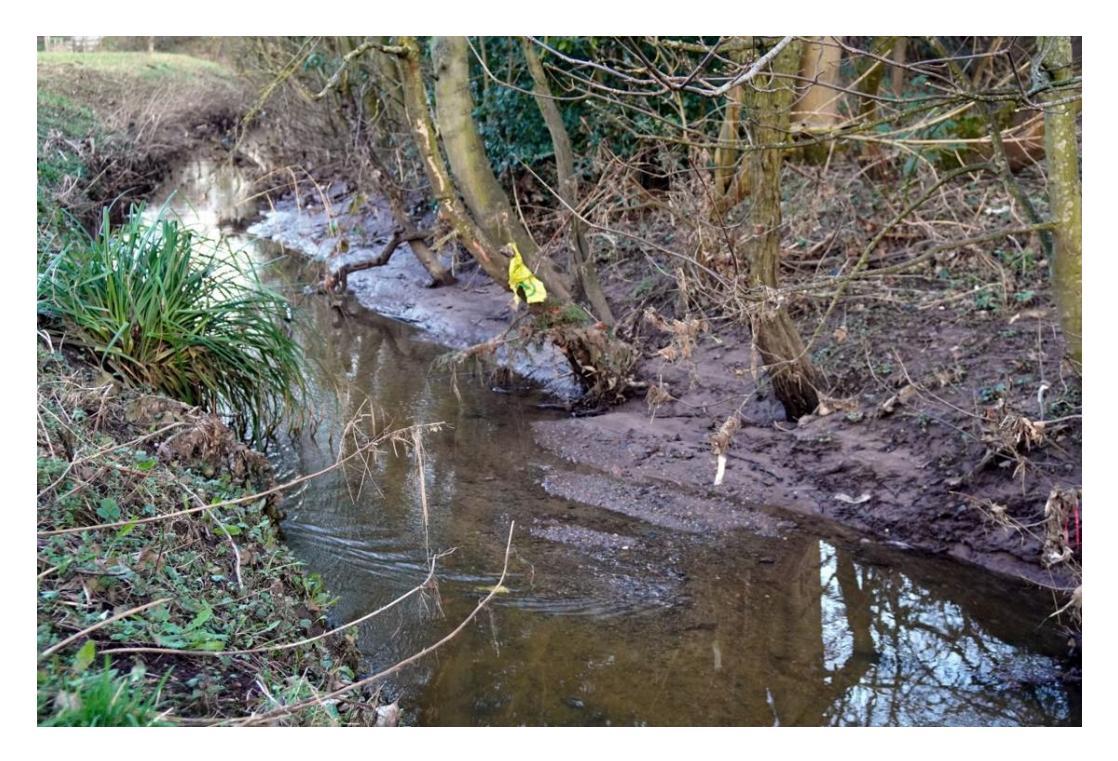
Figure 3 - Highfield Drain, downstream of A540 culvert

This open channel then takes the water south and west before it discharges into the River Dee. The change in water levels from Finchett's Gutter to the River Dee is not large, therefore, the water levels where Highfield Drain enters Finchett's Gutter are potentially influenced by tidal levels in the River Dee.

- EA to check and maintain the capacity of Highfield Drain downstream of the Parkgate Road culvert to the confluence with Finchett's Gutter.
- CWaC, as Highways Authority, to review whether there are sufficient gullies on Browning Close, Chaucer Close and Parkgate Road to take runoff from the highway.

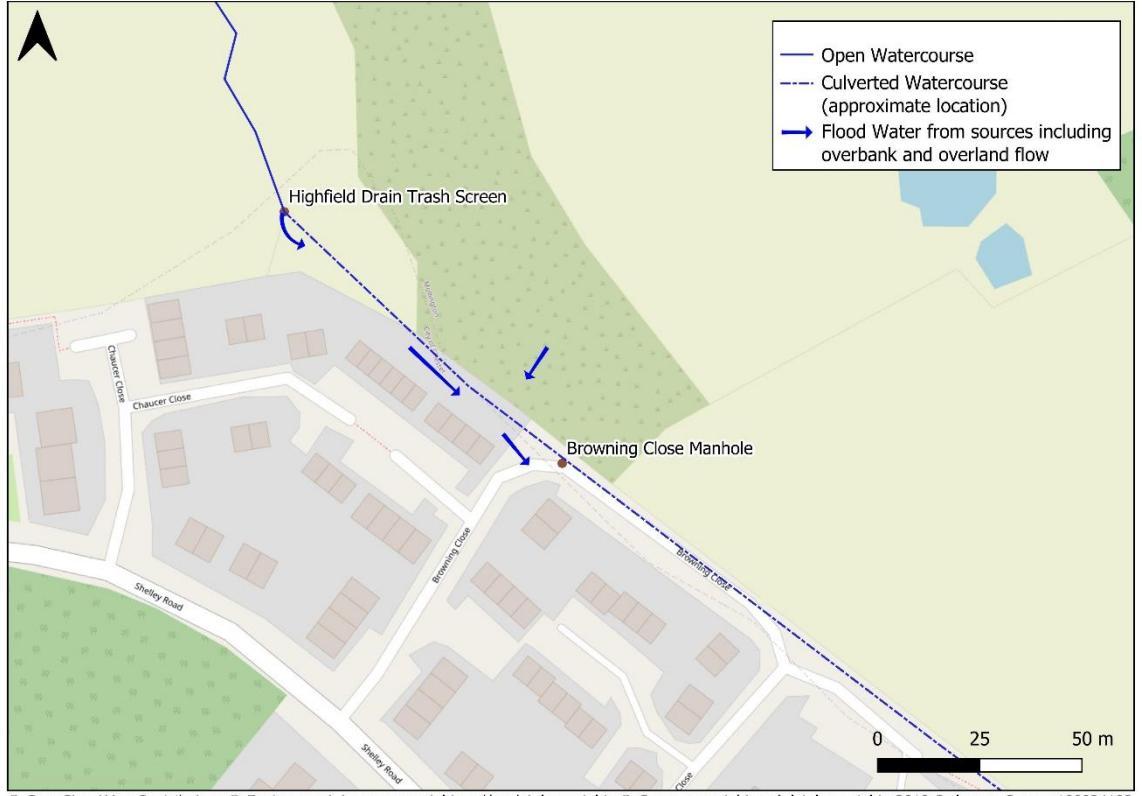
Figure 4 - Browning Close/ Chaucer Close Flood Overview

During the Storm Christoph event, Highfield Drain trash screen, north of Blacon, became blocked. Water began to back up and was observed to flow overland and through the back gardens of properties on Chaucer Close and Browning Close, before flowing onto the Browning Close highway and then into properties. It was also reported that water was running from the fields north of Browning Close, adjacent to the A540. Refer to Figure 4.

- CWaC, as LLFA, and the EA to remind landowners of trash screen and drainage channel maintenance obligations.
- CWaC, as LLFA, and the EA to investigate whether improvements could be made to the trash screen arrangement to reduce the risk of blockage and subsequent out of bank flow.

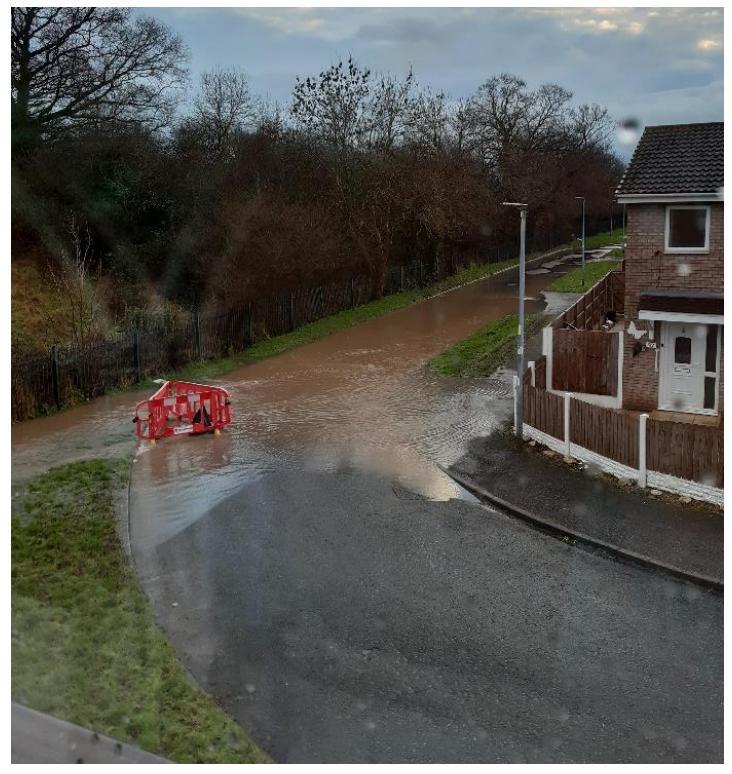
Figure 5 - Browning Close and the Lifted Manhole. 20/01/2021

During the event, a manhole cover was lifted in the northern corner of Browning Close (refer to Figure 5), allowing the flood water back into the culvert which was observed to still have capacity during the event.

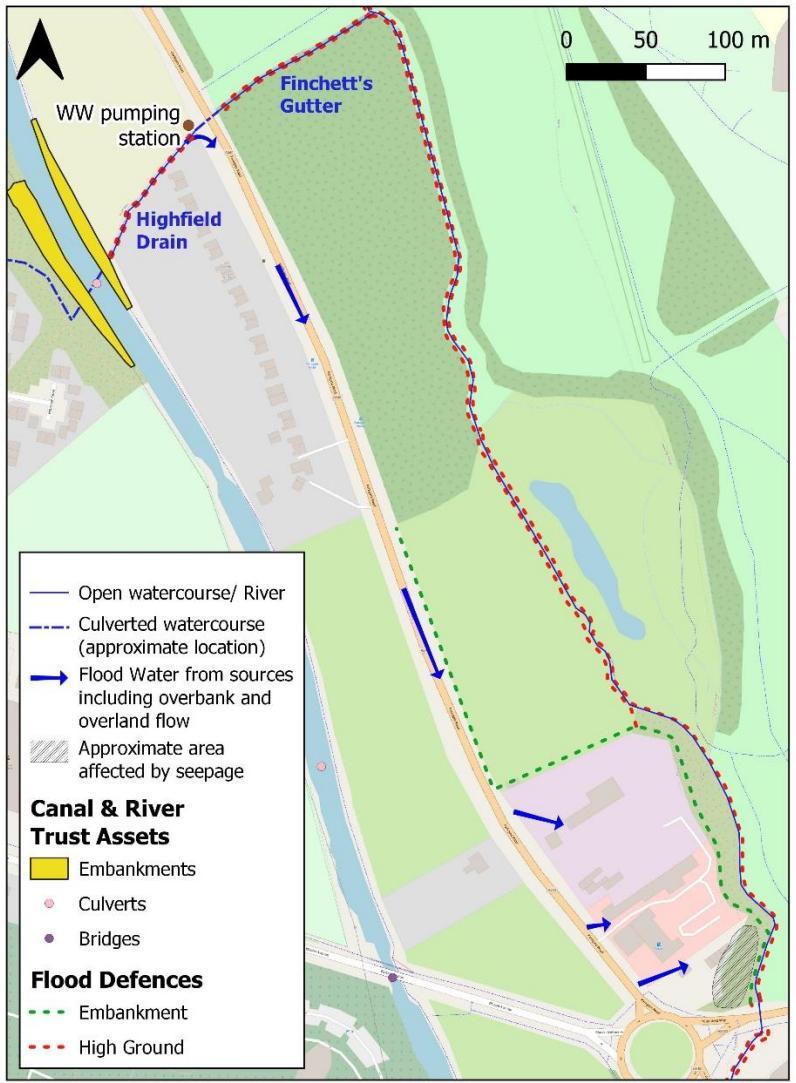
Figure 6 - Parkgate Road Flood Overview

During the Storm Christoph event, water backed up at the inlet to the culvert under Parkgate Road into Finchett's Gutter and water overtopped and ran down Parkgate Road to Abbotts Mead properties (Figure 6). Finchett's Gutter flood defences held during the event.

Residents affected by the flooding on Parkgate Road have reported that in previous years when the water overtopped Highfield Drain at Parkgate Road, the water would run over the road and flow back into Finchett's Gutter. Residents are concerned that a highway surfacing scheme, carried out in the last few years, has changed the surface levels of the road, causing the water to be directed down Parkgate Road, towards properties at Abbots Mead.

- Water flowed southwards down Parkgate Road towards the Abbot's Mead roundabout.
- Traffic coming down Parkgate Road caused bow waves which entered properties.
- The watercourse behind the properties at Abbots Mead was reported to be contained within bank top.
- Water collected in the back gardens of the properties at Abbots Mead that entered from Parkgate Road to the front of the properties.

- CWaC, as LLFA, to investigate localised kerb/ verge lowering to allow water to flow back into Highfield drain around the culvert under Parkgate Road, and at multiple locations further down to allow floodwaters to exit from Parkgate Road to Finchett's Gutter. This work is now underway, confirmed by the Environment Agency.

- Support affected residents explore property protection measures.
- Implement more stringent traffic management measures, particularly on Parkgate Road to mitigate the risk of vehicles pushing water into property.
