Vale Royal Borough Council

FRODSHAM (OVERTON, FIVE CROSSES) (ALSO KNOWN AS FIVELANES END) CONSERVATION AREA APPRAISAL

AUGUST 2005

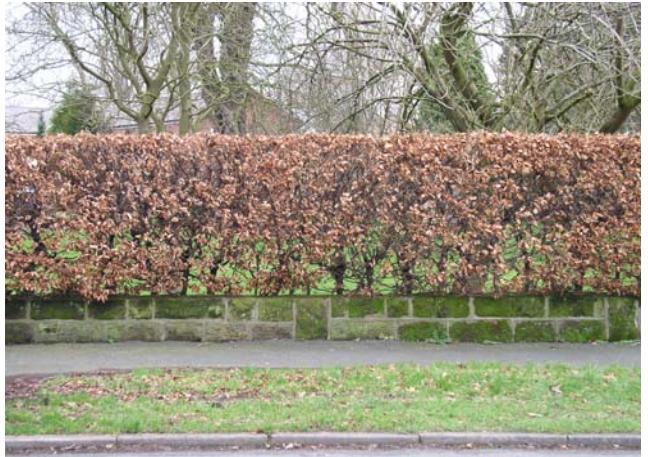
• Most common form is a sandstone wall in conjunction with formal maintained hedging, railings or wooden fencing.

Beech hedge and low wall at Overton Hall

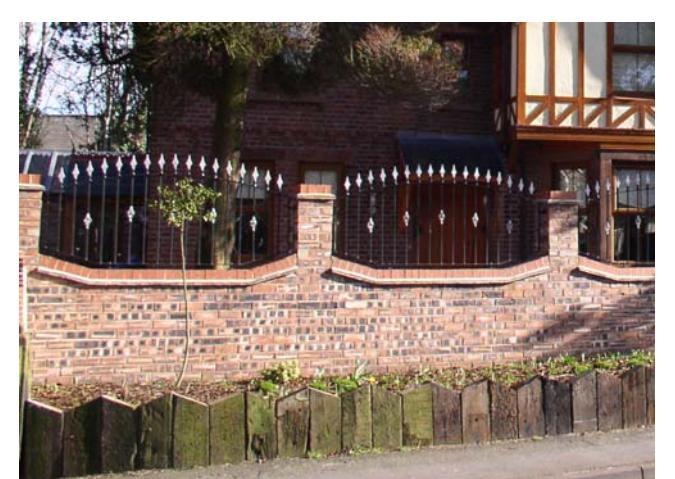
• Modern, high common brick wall and ornate railings to 'Little Hurcot' – has no reference to local or traditional character.

Ornate railings and brick wall at 'Little Hurcot'

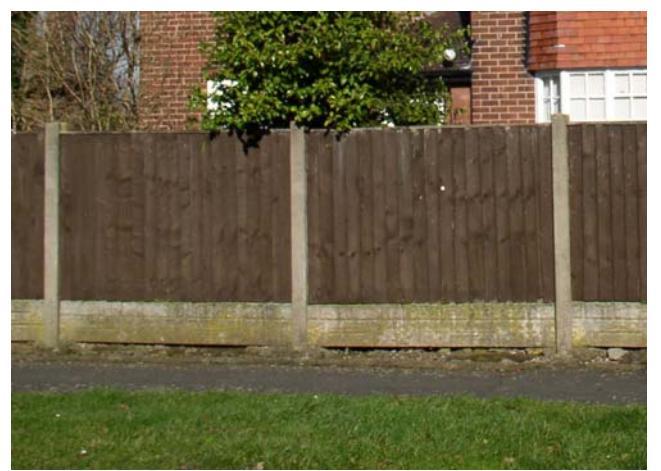
• Modern slatted wooden and concrete post fence to No. 9 Bradley Lane – design unsympathetic to the local character.

Unsympathetic fence at No. 9 Bradley Lane

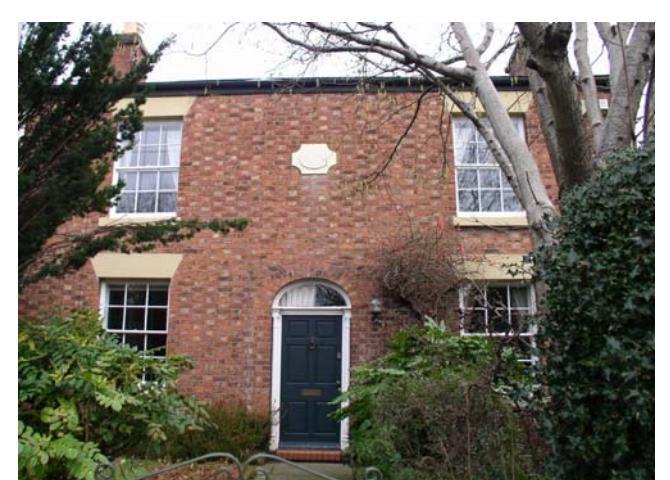
• 'West View', Vicarage Lane – example of late Georgian style;

- Simplistic, symmetrical design.
- Pale headed Flemish bond brickwork.
- Vertical sliding sash windows.
- Plain lintels and plain projecting sills.
- Original 6-panel front door.

'West View', typical late Georgian property

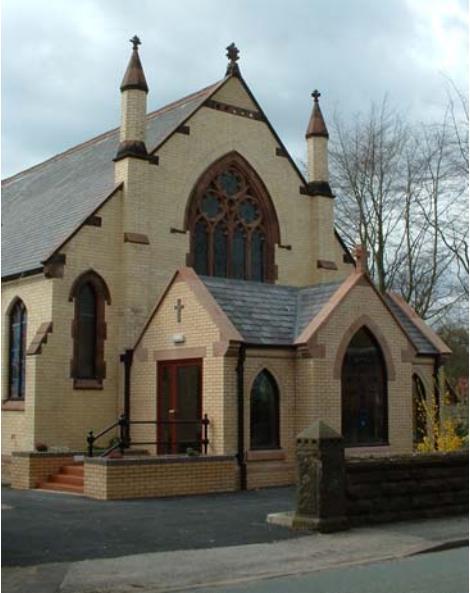
• Five Crosses Methodist Church – late Victorian gothic church with simplistic common revival detailing;

- Pointed arched and tracery windows.
- Buttresses

Five Crosses Methodist Church

• Ornate cross finials to gables and pinnacles.

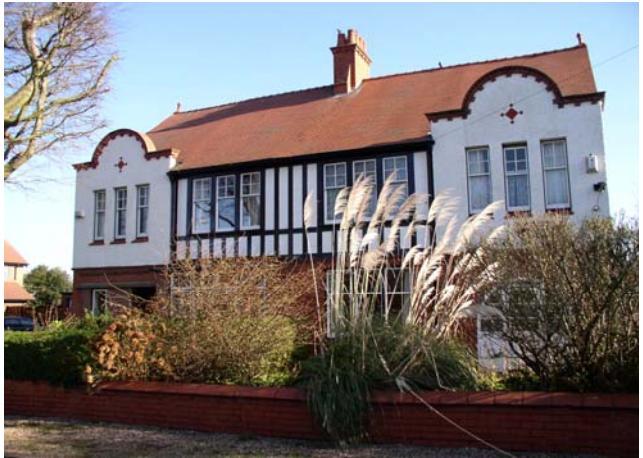
• Oakdale Avenue features good Edwardian examples with typical features such as Dutch gables and timber framing.

'The Beeches' and 'The Elms' Edwardian properties with Dutch gables

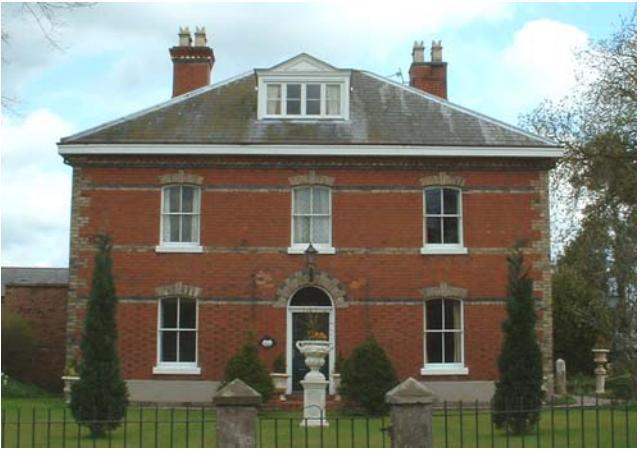
• Contrasting brickwork including pale headed Flemish bond.

'Overton Hall' - contrasting brickwork and decorative banding

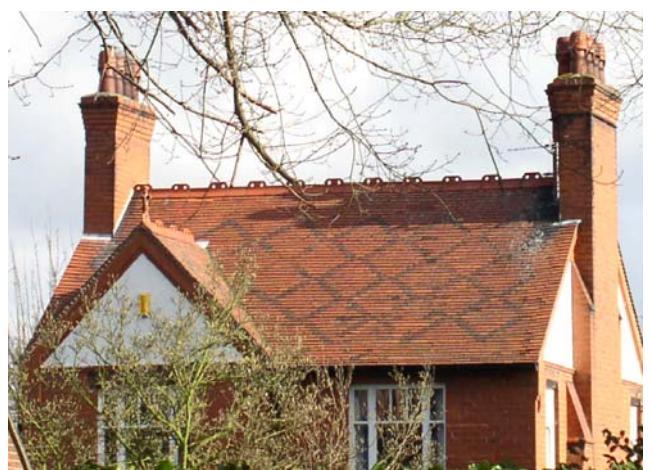
• Diaper tile work and decorative ridge tiles on the roof of 'The Limes'.

Diaper tile work on the roof of The Limes, Oakdale Avenue.

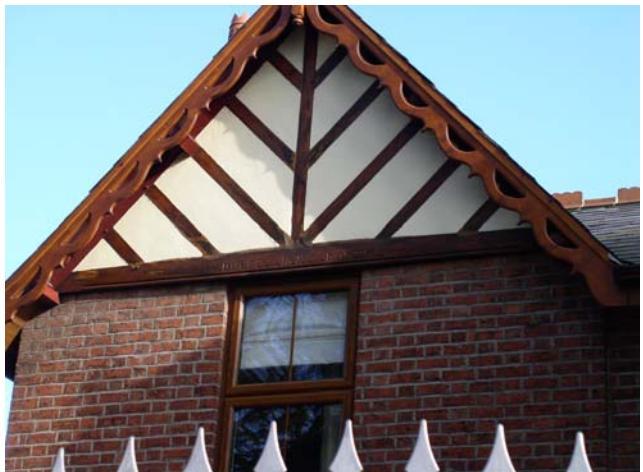
• Decorative, interesting barge boards on many Victorian properties throughout.

Recently renewed decorative barge boards on 'Little Hurcot'

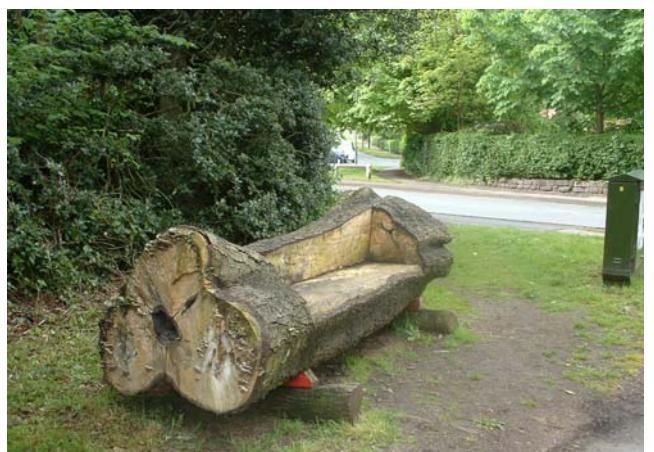
- Seating is provided at the grassed area junction of Bradley Lane with Kingsley Road.
 - A modern steel and timber bench.
 - Also a decaying log seat carved from a horse chestnut formerly on the site.

Carved log seat at the junction of Bradley Lane and Kingsley Road

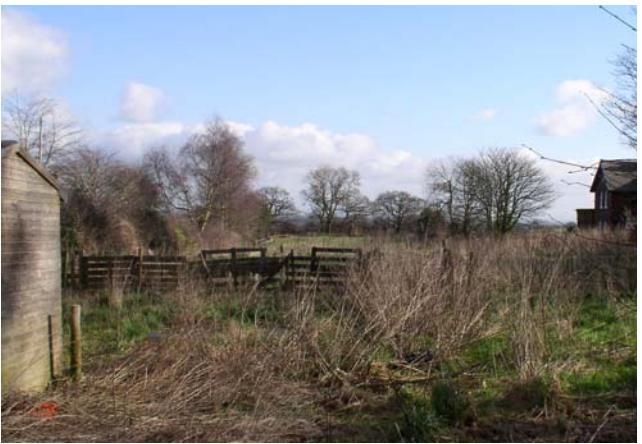
• Paddock adjacent to Royleen Drive although currently un-maintained and overgrown is an important link to open countryside.

Unkempt paddock adjacent to Royleen Drive

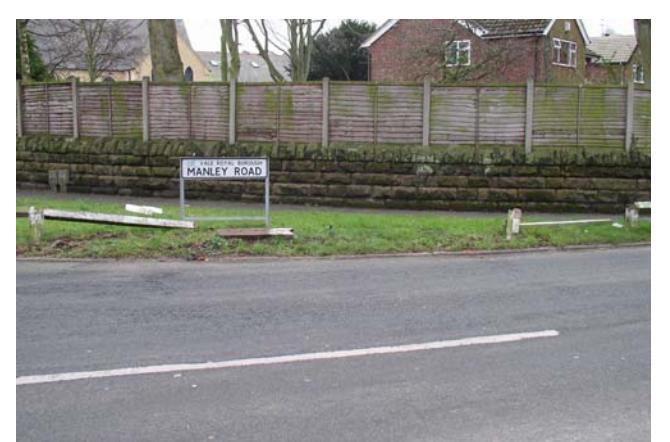
• Timber knee rails at junction of Manley Road with Kingsley Road badly damaged due to frequent vehicular impact – alignment encourages fast cornering.

Vehicular damage to knee rails at road junction

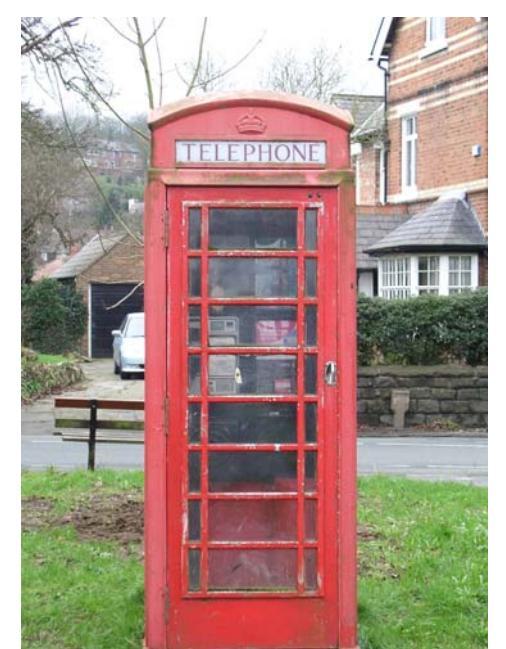
• K6 telephone kiosk at the junction of Bradley Lane and Kingsley Road is badly discoloured, faded and damaged.

Faded and discoloured K6 telephone kiosk

- Condition of pathways and roads could be generally improved throughout.
 - In particular, Oakdale Avenue entrance.
 - Royleen Drive could be surfaced with a more permanent finish.
- K6 telephone kiosk could be repainted.
